# AHEAD OF THE STORM

Site: Thorp Brook Headwaters Restoration

Location: Big Oak Lane Neighborhood, Charlotte, Vermont

Ahead of the Storm  
Existing Conditions Photo Documentation Summary  
Big Oak Lane Neighborhood

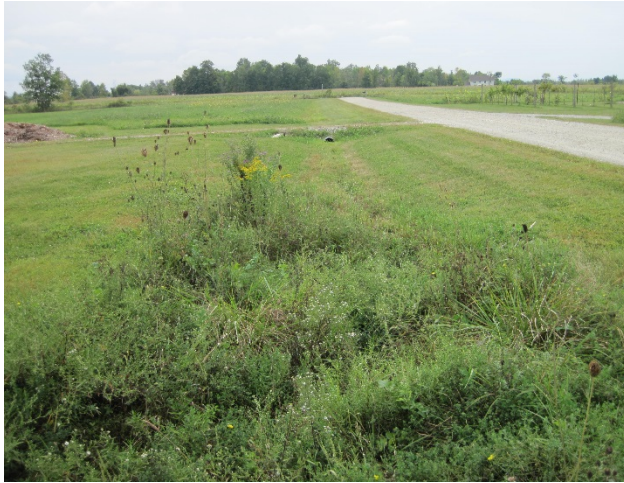
*Figure 1: This swale is collecting runoff from the gravel road and field.*

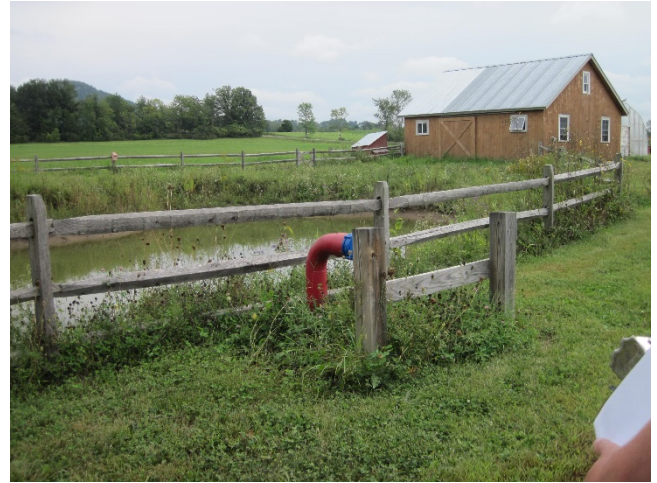
*Figure 3: A fire pond is located on the site, but does not have significant stormwater storage capacity.*

EXCAVATE TEMPORARY PONDING AREA AROUND EXISTING FIRE POND. DEPRESSION TO DRAIN AFTER STORMS. DEPTH ~ 2 FEET AREA ~ 0.35 ACRE VOLUME ~ CPv ~ 0.77 ACRE-FEET

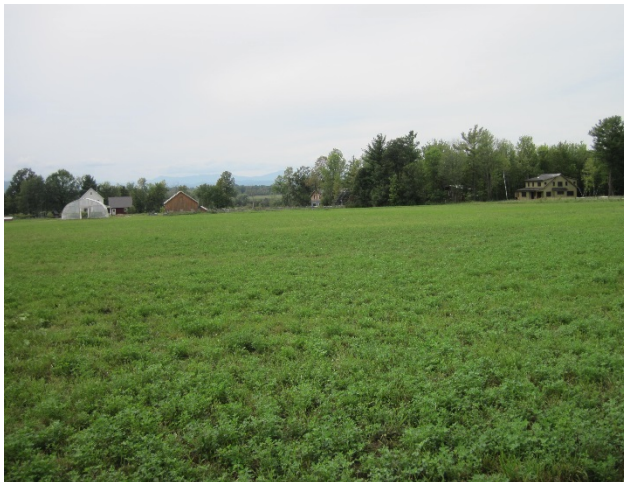
*Figure 2: The mowed field /open space for neighborhood is shown, looking towards the homes and the swale leaving the neighborhood.*

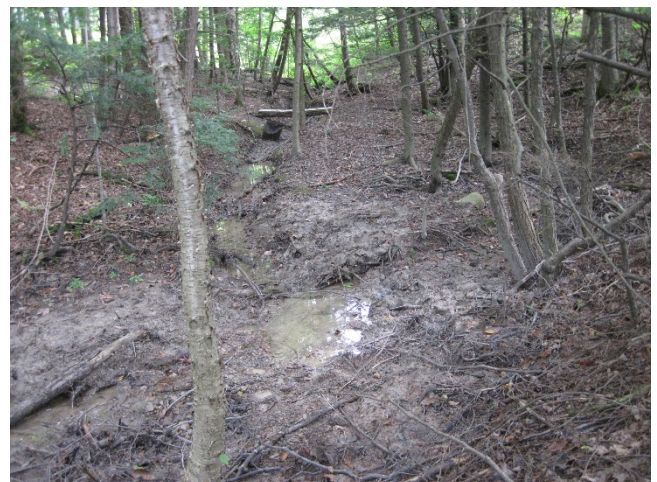
*Figure 4: Deposition is occurring at the downstream end of the swale, prior to water joining the tributary.*

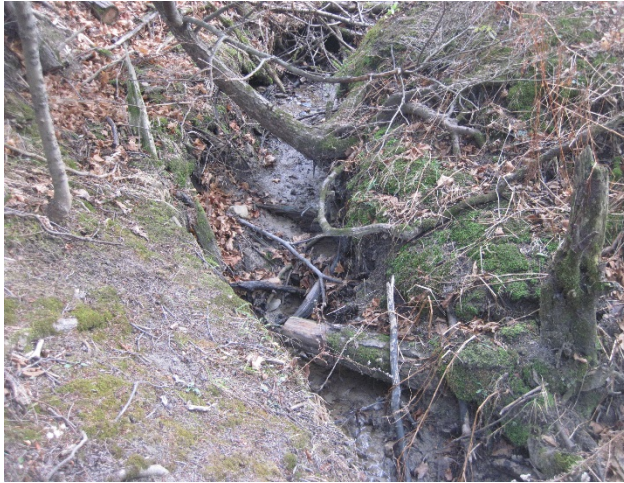
Water from the two flow paths converge behind #95 Big Oak Lane for a total drainage area of 16.9 acres. Erosion in the small stream channel has created a gully that is up to 4 feet deep and 7 feet wide. Residents report that the severity of erosion is rapidly increasing in recent years. This gully is close to the home at #95 Big Oak Lane and is transporting sediment to the downstream stream channel. The swale discharges to the north to a headwater tributary of Thorp Brook.

Soils at the site are Vergennes clay that are highly erodible. This indicates that erosion will likely continue in the gully unless steps are taken to stabilize the existing gully erosion. The soils have a Hydrologic Soil Group of D, indicating that infiltration potential is low so runoff is likely to continue and increase with larger storms that is predicted for the area.

*Figure 5: Gully erosion occurring in the channel leaving the neighborhood.*

INSTALL BRUSH & SMALL LOG APPLICATION ALONG 280 FEET OF ERODING GULLY (SEE DETAIL)

INSTALL 4 LOG CHECK DAMS. FINAL PLACEMENT TO BE APPROVED BY ENGINEER DURING CONSTRUCTION. (SEE DETAIL)

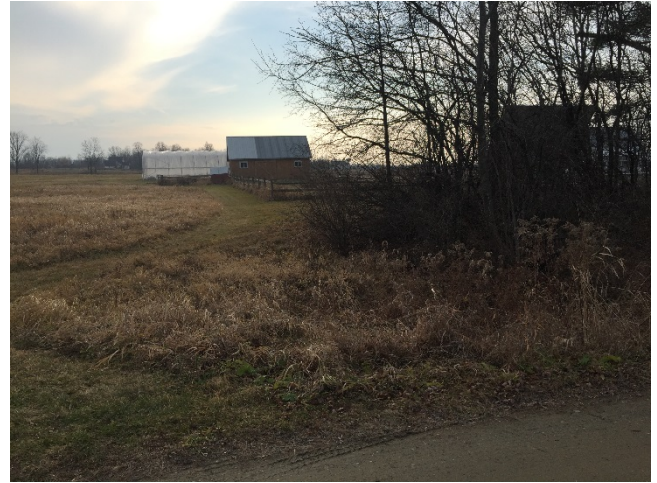
*Figure 7: Possible location of a bioretention area adjacent to the farm field, gravel road, and existing stand of trees.*

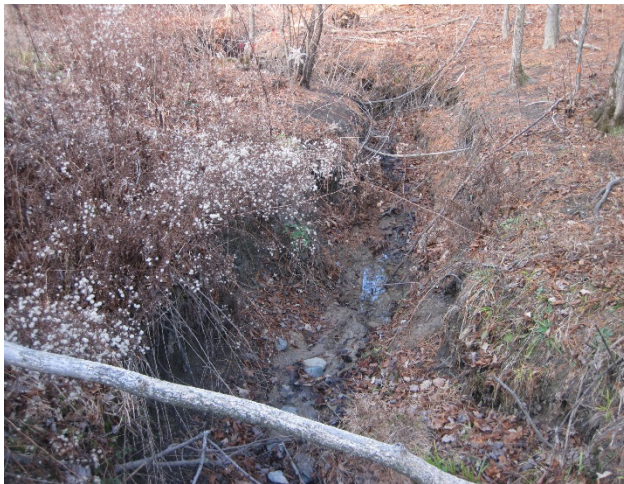
*Figure 6: Gully erosion occurring in the channel leaving the neighborhood.*

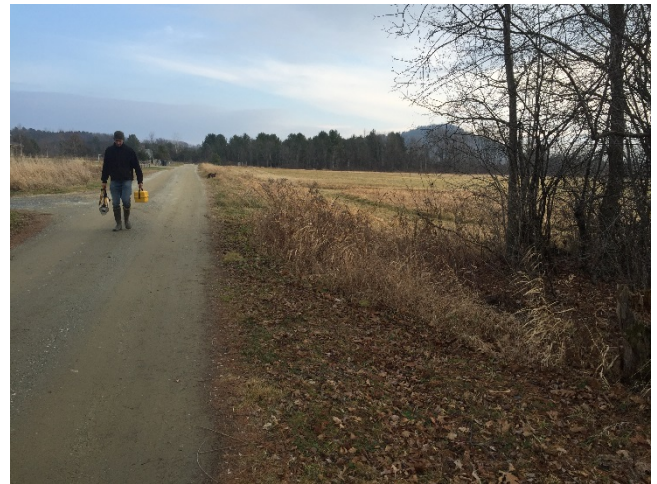
*Figure 8: Possible location of a bioretention area adjacent to the farm field, gravel road, and existing stand of trees.*
