## AHEAD OF THE STORM

Site: Champlain Valley Union School

Location: 369 CVU Road, Hinesburg, Vermont

### Greenhouse Area Concept Design

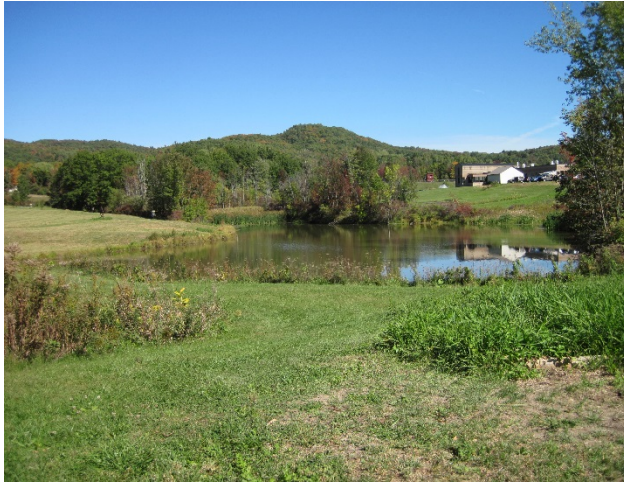
*Figure 1: Existing fire pond provides treatment for water quality, channel protection, and Q10 and Q100 attenuation (Recommendation 5).*

SITE 9: PLANTED VEGETATED BUFFER AROUND FIRE POND FALL 2016

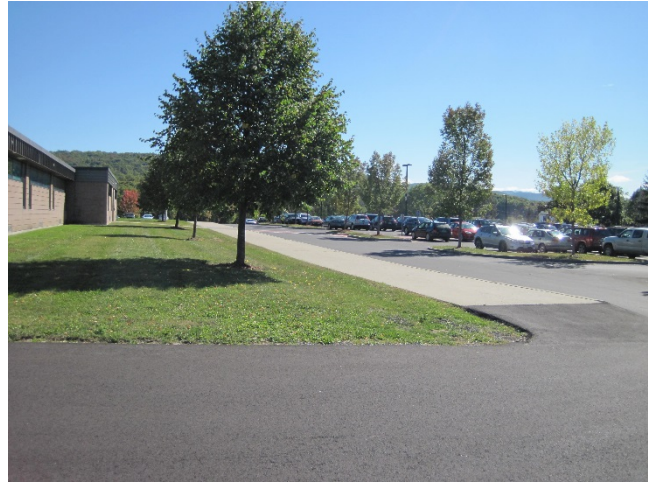
*Figure 3: West side of parking lot at front of school drains to fire pond.*

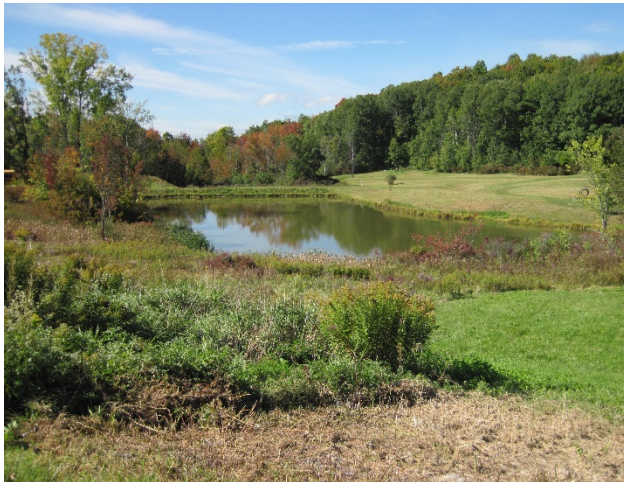
*Figure 2: Existing fire pond and wooded area at west side of property (Recommendation 5).*

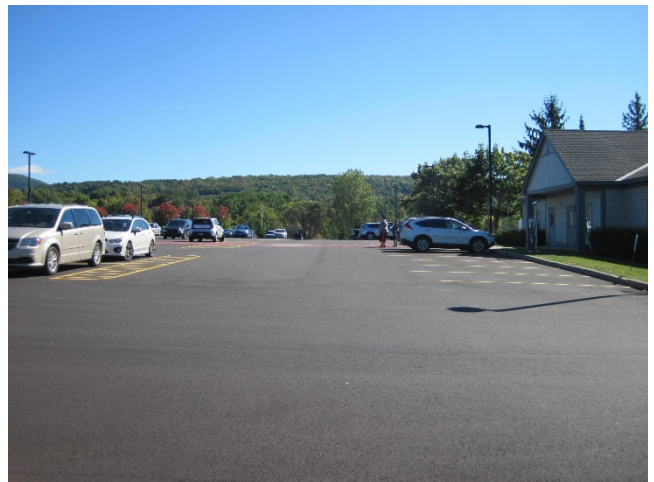
*Figure 4: Southwest portion of parking lot and annex building drains to eroding swale at southwest corner of parking area (Recommendation 2).*

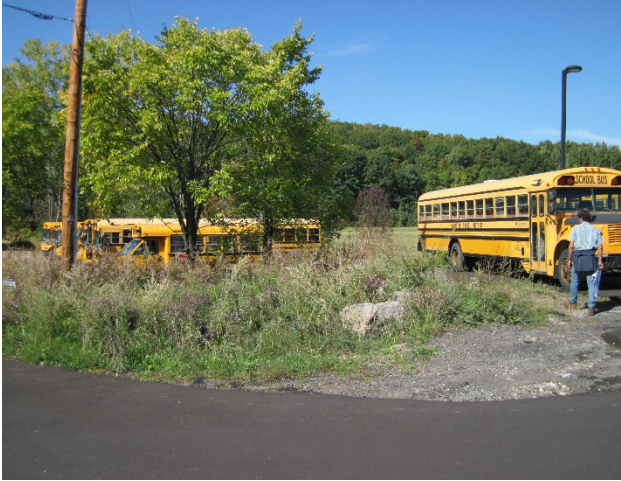
*Figure 5: Eroding swale and sparsely vegetated area at southwest corner of parking area could be improved to create bio-retention area and pre-treatment for the fire pond. A catch basin exists in this area, but the grate is set too high to function properly (Recommendation 2).*

SITE 7: CREATE BIORETENTION AREA BY EXCAVATING AND MODIFYING BERM AND CATCH BASIN AND IMPROVE SWALE WITH CHECK DAMS

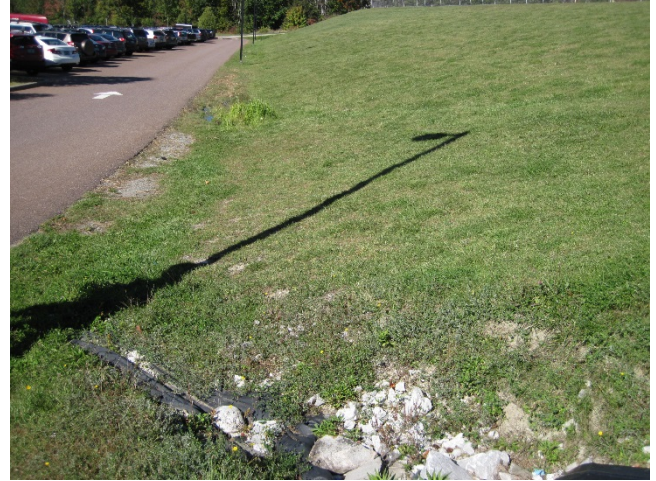
*Figure 7: The discharge from the swale at the upper playing fields has some erosion. Swale improvements could help improve water quality as a pre-treatment for the receiving wetland, eventually draining to the fire pond (Recommendation 1).*

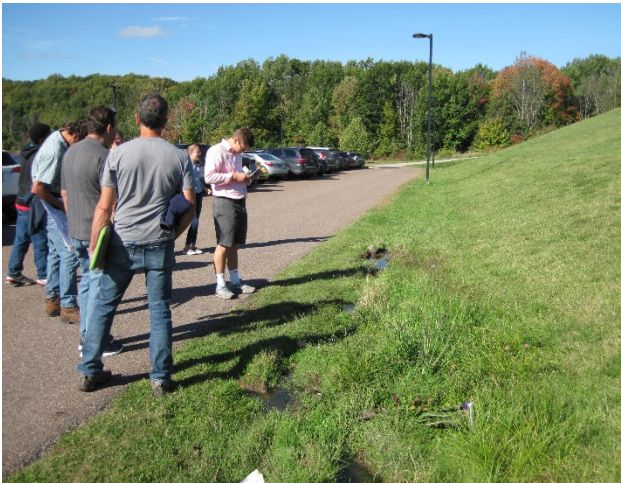
*Figure 6: Erosion, puddling, and rutting occurring at the toe of slope between the athletic field/track and north parking lot. This area receives water from underdrains, sheet flow from the parking lot, and a swale draining some of the upper playing fields (Recommendation 1).*

SITE 3: IMPROVE SWALE WITH INFILTRATION TRENCH, FILTER STRIP, AND VEGETATED SWALE

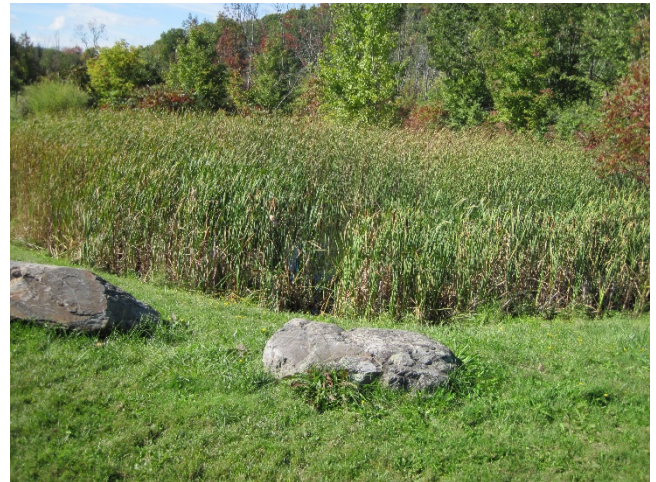
*Figure 8: Existing vegetated stormwater forebay collects water from the north parking lot, prior to it flowing to the fire pond.*

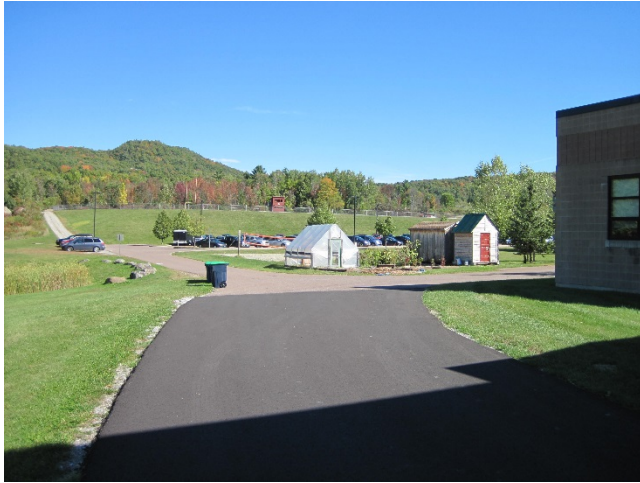
*Figure 9: A greenhouse is proposed to replace the small garden buildings at the northwest side of the school. Runoff from the new building should be collected or properly treated (Recommendation 4).*

SITE 1: CREATE BIORETENTION AREA, INSTALL RAINWATER HARVEST TANKS, AND PERVIOUS PAVEMENT AT PROPOSED GREENHOUSE

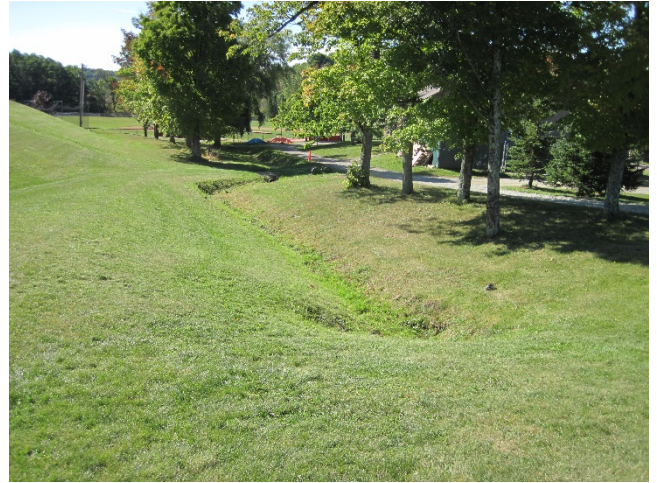
*Figure 11: Swales carrying water from the upper playing fields discharges at the east side of the northern parking lot into a steep, eroding swale. This could be a site for a bio-retention area to slow the water (Recommendation 3).*

SITE 5: CREATE BIORETENTION AREA ALONG EXISTING SWALE

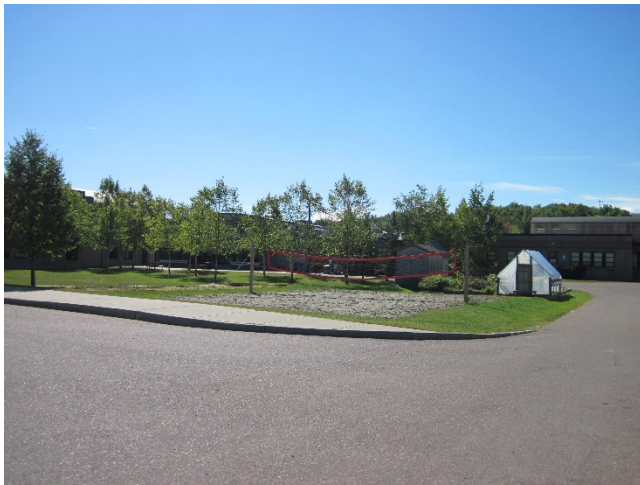
*Figure 10: Location of proposed greenhouse (Recommendation 4).*

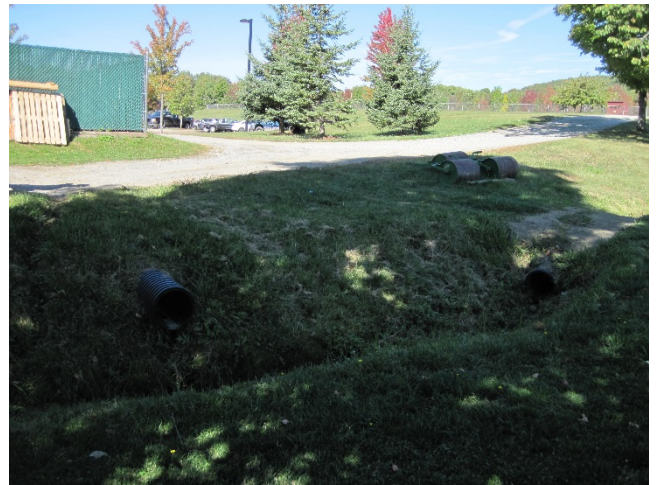
*Figure 12: Erosion is occurring in the steep swale and at the entrance and exit of a maintenance driveway crossing. Swale and culvert improvements could slow water and reduce erosion (Recommendation 3).*

SITE 4: IMPROVE SWALE BY RESHAPING AND REVEGETATING. REPLACE CULVERTS WITH LARGER SIZE.
