# AHEAD OF THE STORM

Site: Charlotte Congregational Church

Location: Church Hill Road, Charlotte, Vermont

Ahead of the Storm  
Existing Conditions Photo Documentation Summary  
Charlotte Congregational Church

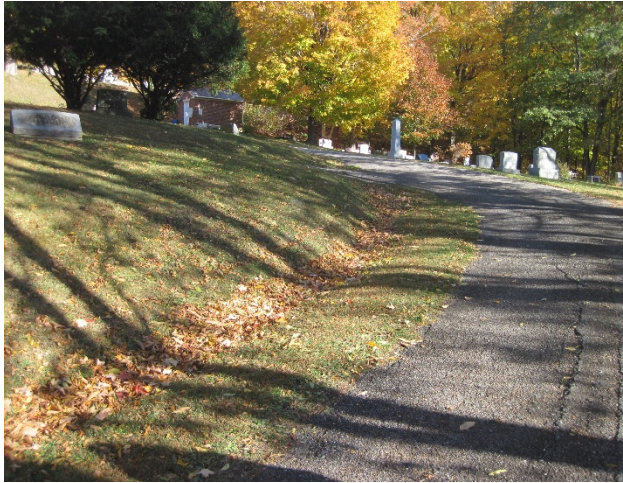
*Figure 1: Runoff from the cemetery and hillside behind the church flows through the church property.*

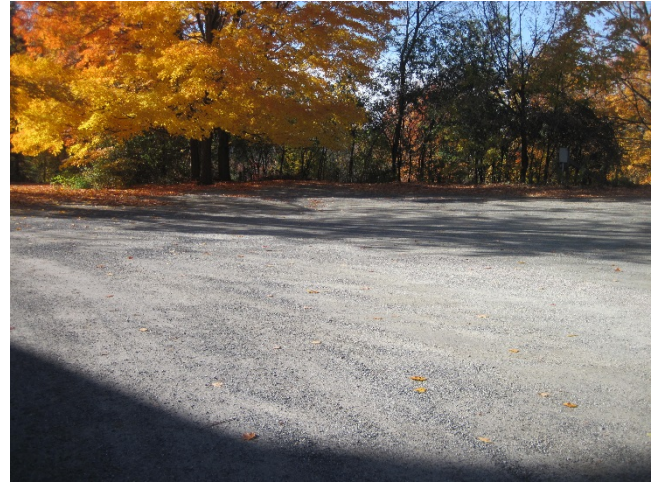
At the west side of the site drainage from the church roof, cemetery, and gravel parking lot are concentrated causing erosion of the gravel parking area surface. This water travels across the church front lawn and off of the property. Eroded gravel is collecting under the trees at the edge of the parking area.

*Figure 3: A parking lot to the west of the church has experienced erosion of the gravel surface during rain events.*

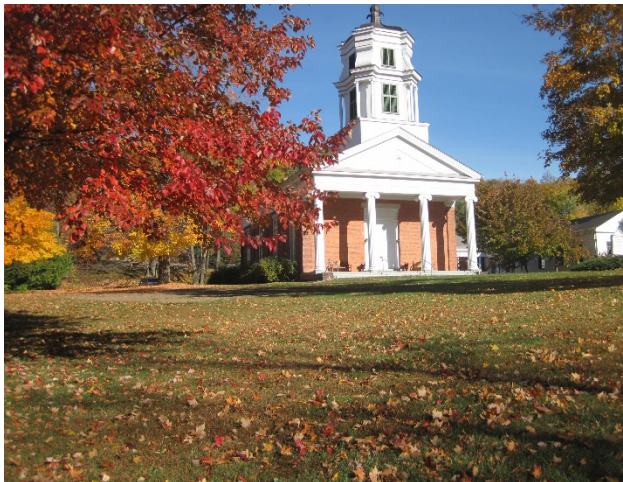
*Figure 2: The church sits on a hill, with runoff flowing south towards Church Hill Road.*

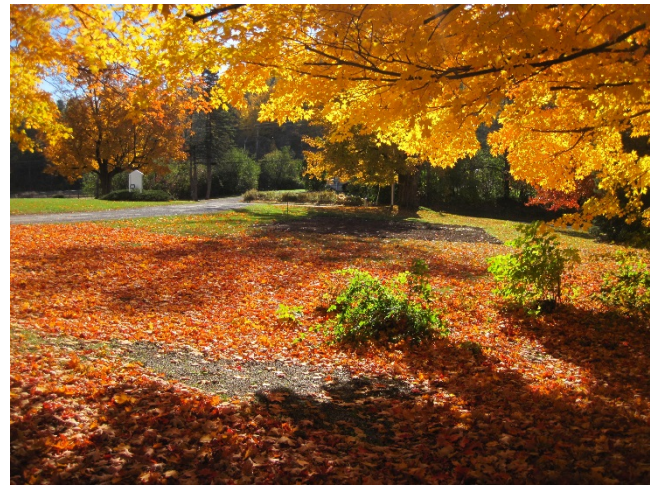
*Figure 4: A bioretention area could be installed in the lawn adjacent to the gravel parking lot.*

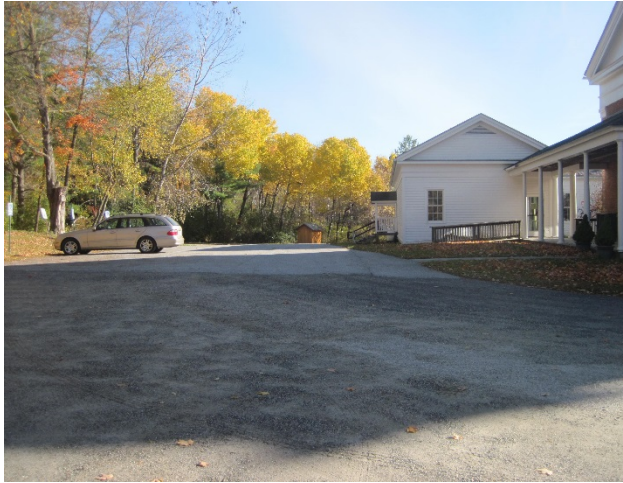
*Figure 5: The drainage at the property is split in the middle of the parking area behind the church.*

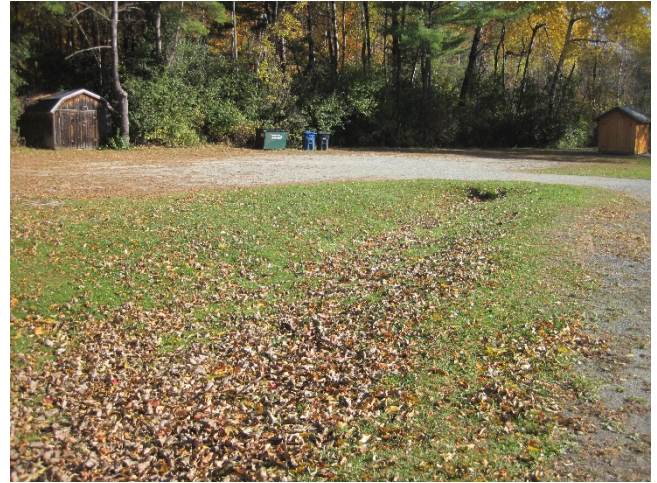
*Figure 7: A swale carries water from the parking area and cemetery to the east and into the wetland.*

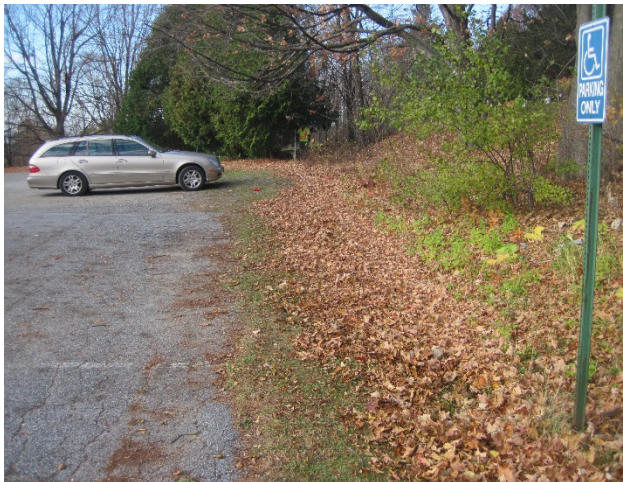
*Figure 6: A swale carries water from the parking area and cemetery to the east and into the wetland.*

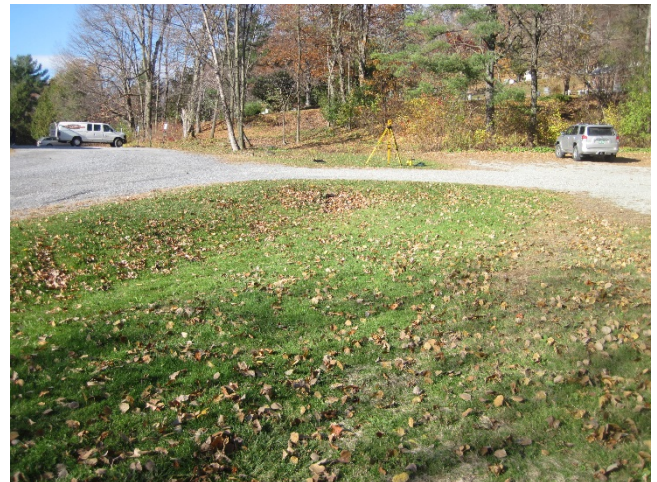
*Figure 8: A possible bioretention area has been identified between the driveway and the shed and gravel parking area.*

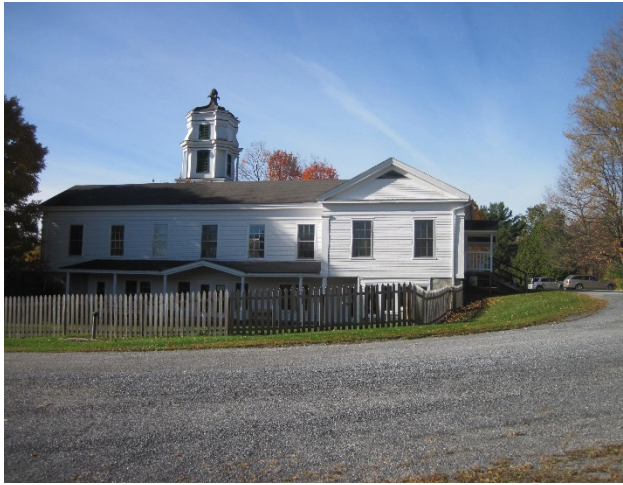
*Figure 9: A portion of the church building and gravel drive and parking drain to a former small pond.*

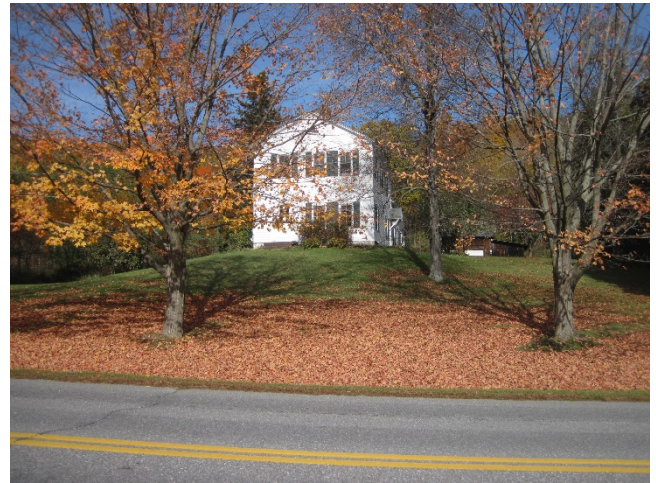
*Figure 11: A portion of the parsonage property drains to the roadside swale and eventually flows through a culvert under Church Hill Road.*

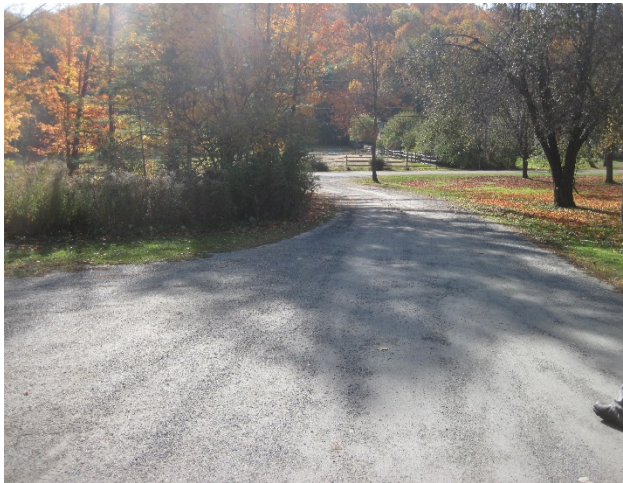
At the east side of the church a portion of the church building, parking and driveway are collected and directed to a former stormwater pond. The pond berm has breached and no longer impounds water.

*Figure 10: A former small pond exists in the vegetation to the east of the driveway.*

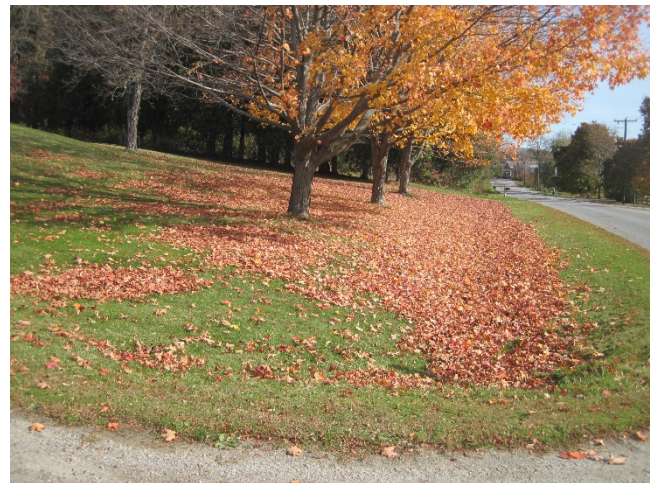
*Figure 12: Possible bioretention area could be installed on the parsonage property in the swale adjacent to Church Hill Road.*
