LaPlatte River Corridor Plan Reaches M6 – M11 Towns of Charlotte and Shelburne, Vermont

Prepared by the LaPlatte Watershed Partnership

April, 2008

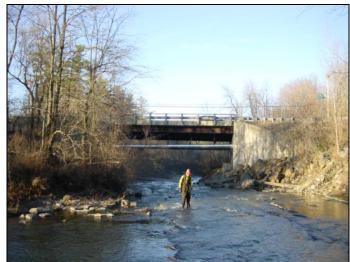
Figure 6.1. Shelburne Falls Road Bridge in M05.

The Shelburne Falls Road Bridge is equal to the channel width for reach M06 so was smaller than the recommended width. However, it is located just upstream of Shelburne Falls, a naturally constricted and bedrock controlled area. So although the bridge constricts and fills the floodplain in this area, the concern is less because of the natural constriction of the falls. Higher pressures would be exerted on the bridge abutments during floods, as it constricts the floodplain, so widening it could increase the lifespan of the structure.

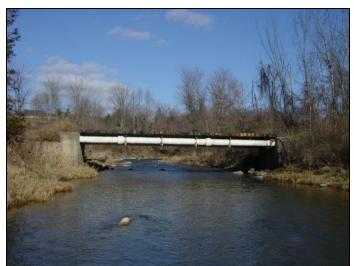
Figure 6.2. Farm access bridge in M06.

In reach M06, a farm access bridge constricts the channel width. Minor scouring of the channel bed was present downstream of the structure. Reach M06 did appear to be incised, so additional

pressure would be placed on the banks in higher than bankfull flows that are not high enough to reach the floodplain. This structure could be at risk of failure from erosion due to it constricting the channel, however, the floodplain did not appear to have been filled for the roadway or the approaches to the structure. Therefore flood flows that reach the floodplain could pass over the road and around the structure.

Replace structure (bridge) with appropriately sized structures (see structures table 6.1 and summaries for bridge details).

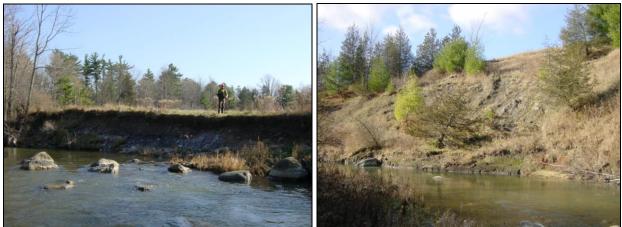
The reference stream type for this reach appeared to be a meandering, gravel bed stream with Riffle-Pool features. However, due to channel incision (ratio 1.95), the reach experienced a stream type departure to a more incised, less meandering, Plane Bed type. Floodplain access was limited, although old channels and/or flood chutes on the upper terrace could provide additional floodplain access and relief from high flows. Incision appeared to be historical, as did channel widening. Current channel adjustments appeared to be aggradation and major planform. Bank erosion, islands, and multiple mass failures were indicators of these adjustments with significant contributions to sediment loads. Also contributing sediment were rejuvenating tributaries in the reach and gullies from stormwater inputs. Shelburne Falls at the downstream end of the reach provided grade control. The river corridor was largely undeveloped except for some short sections of road and some houses on the fringes.

Figure 6.7. Bank erosion on an outside bend, contributing sediment (L) and one of many mass failures in M06 (R).

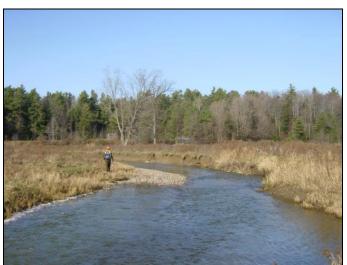
Figure 6.9. Right bank erosion and diagonal bar.

Reach M08 flowed through a broad valley dominated by herbaceous and shrub/sapling vegetation. The stream type appeared to be a meandering, riffle-pool type stream with mostly gravel bed material. Multiple sediment deposits (mid, point, side, and diagonal bars) were present. Many areas of bank erosion were observed as well as flood chutes (where high flows access chutes across the inside of a bend), signaling lateral channel migration.

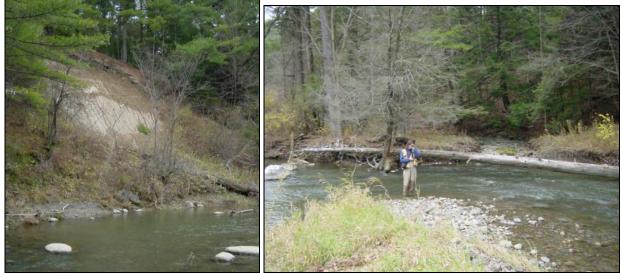
Habitat condition appeared "Fair," affected by bank instability, infrequent riffles, sediment deposition, and lack of cover. Some crop areas encroached into the corridor on both banks with forest in the majority of the corridor. Bank vegetation was dominated by herbaceous species. Multiple sediment deposits (bars) were present. A bridge at Spear Street constricted the channel width, with signs of sediment deposition upstream.

Figure 6.13. Mass Failure in M09A, a source of sediment to the system. Several flood chutes were seen in M09A, signaling planform adjustment.

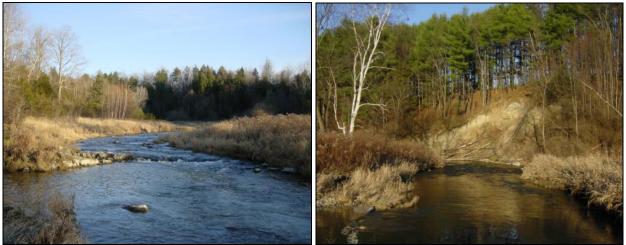
Reach M10 appeared to be a meandering, sandy bed, Riffle-Pool stream type in a broad valley setting with steep adjacent hill slopes. Bank vegetation was herbaceous, as was the majority of the corridor vegetation with some saplings and forested areas. Many wetland areas were near the channel, which could account for some of the herbaceous vegetation. Many sediment deposition types (mid, point, side, diagonal bars) were noted in the reach along with two islands. Much bank erosion and several mass failures were present in the reach, contributing sediment. Current adjustments were major planform and minor aggradation and widening. The channel did not appear incised. Overall RGA condition was "Fair" and the channel appeared to be in stage IV of channel evolution. RHA condition appeared "Fair" with sediment deposition, embeddedness, and bank instability the main factors affecting habitat scores. Some ledges provide grade control in the reach, and one bridge constricts the flood prone width.

Figure 6.16. Ledge grade control and herbaceous bank vegetation (L), and one of several mass failures in the reach (R).

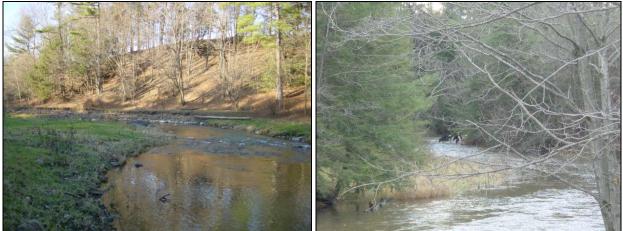
Some sections of stream ran through pasture areas, especially in M11. Allowing animals free access to the channel causes problems for stream stability and water quality. Animal waste and therefore nutrients are added directly to the water when livestock is near or in stream channels and negatively affects water quality of streams and Lake Champlain. Additionally, bank and bed trampling by livestock contributes sediment and nutrients to waterways. Programs such as CREP work with landowners to fence pasture areas away from waterways and look for alternate drinking arrangements. Tree planting can be a component of such buffer projects as well, providing filtration and additional water quality and habitat benefits.

Reach M11 had a fairly shallow slope for its confined valley setting. The stream type appeared to be an somewhat incised, Dune-Ripple type having a fairly shallow slope. Beaver activity increased toward the upstream end of the reach, with a large dam and pond on a tributary. The riparian corridor was forested, however downstream of the bridge, cows had free access to the channel and many crossing areas and areas where banks were trampled noted. The channel did not appear incised, however tributary erosion was noted, possibly due to beaver activity in the upstream areas, and land use at the downstream end as well as possible channel adjustment in the tributary itself. One bridge constricted the floodprone width and had scour downstream. Trash and deer carcasses were seen dumped on the banks at the bridge. Trash and old farm equipment were dumped on the right bank roughly in the middle of the reach. RGA condition appeared "Good" with only minor aggradation observed. The reach was considered "in regime." RHA condition was also "Good." Few substrates for food and cover were present. Riffles and diversity of velocity/depth patterns were infrequent.

Figure 6.19. Animal access to channel and bank trampling (L) and cows with full access to the channel (R) in M11.
