AHEAD OF THE STORM

Site: LaPlatte Headwaters Town Forest

Location: Gilman Road, Hinesburg, Vermont

MANAGEMENT PLAN AT GULLY EROSION ON HEADWATER TRIBUTARY

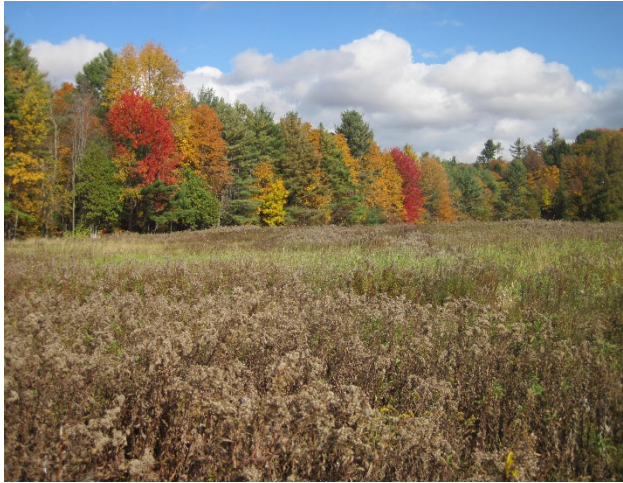
Figure 1: The hidden meadow is well vegetated and partially drains to the main gully.

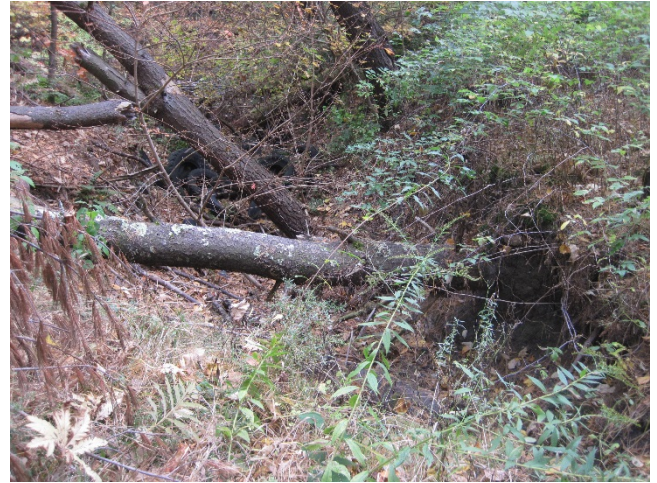
Figure 3: The upstream end of the gully has a headcut and changes elevation abruptly.

An estimated 800 tires were placed in the gullies to slow the flow of water and reduce the rate of erosion. It is believed that the tires were installed by a previous landowners in the 1970’s and 1980’s. The streambed has continued to erode since the tires were installed (LHTFMP, 2009). Headcutting upstream of the tires and erosion underneath the tires were observed in 2015. Observations by park uses indicate that the headcutting upstream of the tires has progressed upgradient 3-4 feet every year since 2005.

Description: The upstream extent of the gully erosion has continued to move upgradient. It is recommended that brush and logs are placed in the upper gully to slow water and catch sediment. This will slow the rate of erosion. This technique replicates the natural storage of sediment. In the narrow upper section of the gullies volunteers can likely perform the labor by hand. Logs and brush could be accumulated from the forest during routine management. Examples of natural wood applications are included below that apply to this and the following recommendation. Wood was observed holding back sediment in the channel downstream of the gullies and can be used as an example (Photo 1). A nearby recent gully erosion repair project was completed using natural wood techniques that could be applied here (Photo 2). Typical engineering details of this type of natural wood application are found below including “Brush and Small Log Application”, “Log Stack Application”, and “Log Check Dam” (Figures 1, 2, and 3).

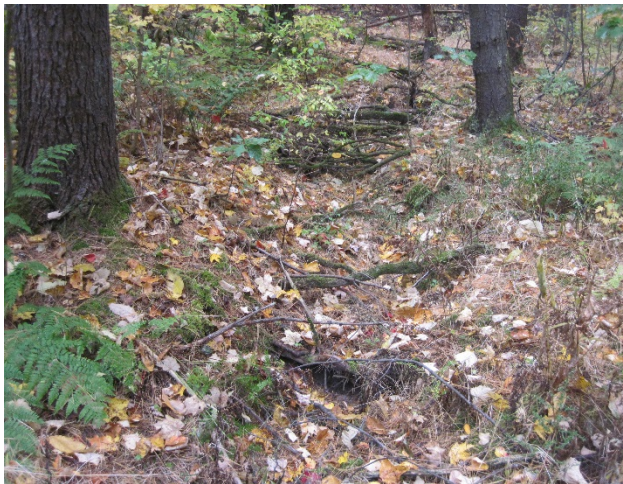
Figure 2: Upstream of the actively eroding gully top, a small channel is well vegetated and has a lot of roots.

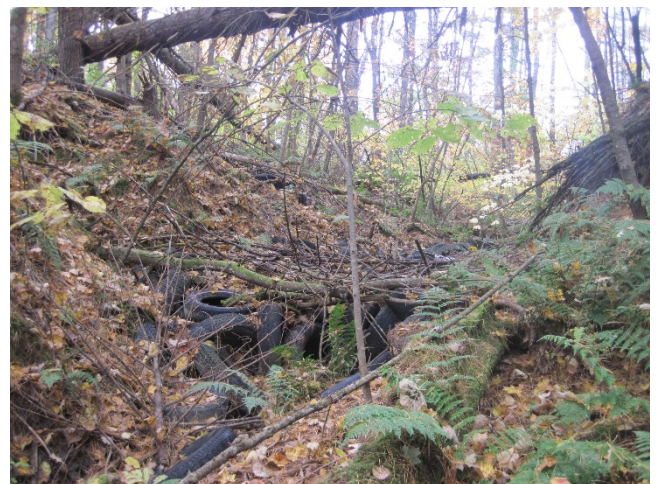
Figure 4: Tires have been dumped into the main gully.

“Remove tires from the gully where it is eroding the main access trail at the intersection of the trail loop at Owl’s Knoll. These were placed in the gully under old government recommendations for erosion control. Removal will likely result in increased erosion, but the tires are ineffective and leach pollutants into the stream.” Taken from Page 74. The walking trail referenced has been rerouted since this was written.

4. Consider changing the LHTFMP High Priority Action to leave the tires in place and manage around them.

Description: The LHTFMP lists removal of the tires from the gullies as a High Priority Action. It is recommended that the committee consider the pros and cons of this action using information summarized in the above sections, based on the LHTF management goals. If the original basis of this Action was to improve water quality in the downstream receiving water, then the Committee should consider leaving the tires in place instead of disturbing the area and transporting the tires and their water quality impacts to another location. If the Action was to improve aesthetics, then the Committee should consider implementing one of the following restoration recommendations. If the Action was to remove non-natural materials from the LHTF, then the Committee should weight this against the impact of removal. If the ultimate decision is to remove the tires, then a safe disposal site would need to be located, a contractor would likely need to be hired to remove the tires, and significant stabilization would be required. Stabilization should be in the form of revegetation and natural log and brush structures, similar to recommendations in the following restoration recommendations.

7. Cover tires with soil and revegetate the gullies.

Description: This recommendation would include hauling topsoil or other fill suitable for growing vegetation to the gully locations and spreading over the tires. This would require access for trucks and an excavator to place the soil. This would smooth the slope between the downstream channel and gully erosion occurring upstream. This area would remain steep, so some grade control such as the “Log Check Dam” is also recommended to reduce erosion potential on the newly graded slopes (Figure 3). Vegetation is recommended that is compatible with the surrounding forest and will help resist erosion.

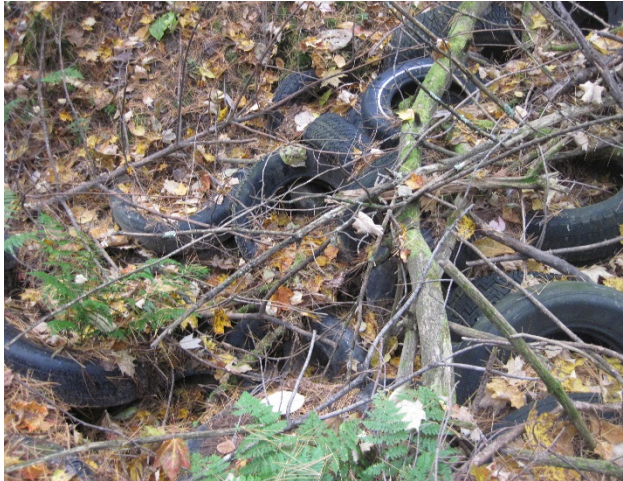
Figure 5: The tires are accumulating some sediment and debris in the gully.

Local wood, roots, and tires resist some erosion at the gully site. In some locations the tires are capturing sediment and debris. Material that is eroded may be permanently or temporarily captured in the downstream wetlands, connected forested floodplains, and in the slow water area created by the small culvert at Brookside Road. A portion of the sediment is likely transported to the LaPlatte River during floods.

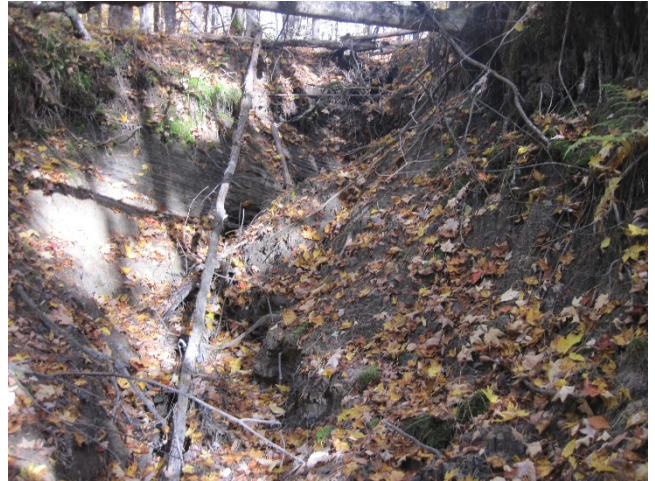
Figure 7: The side gully is not very long, but has steep, tall side slopes.

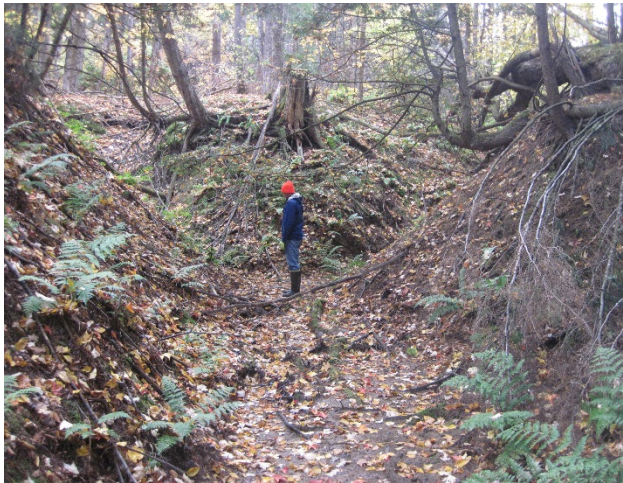
Figure 6: A side gully enters the main gully.

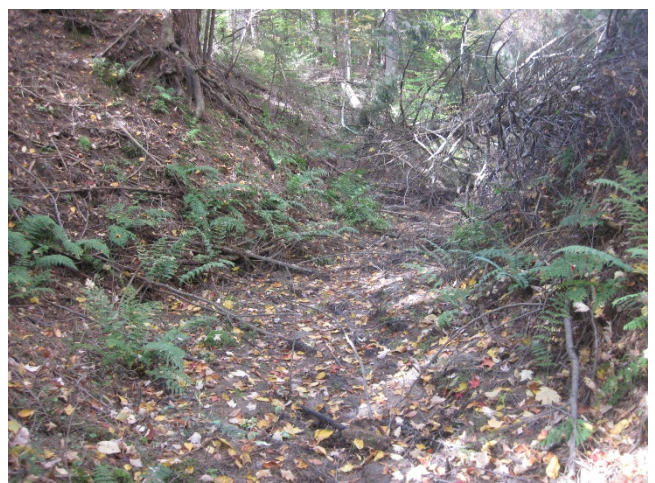
Figure 8: The channel downstream of the gully has little erosion on the banks.

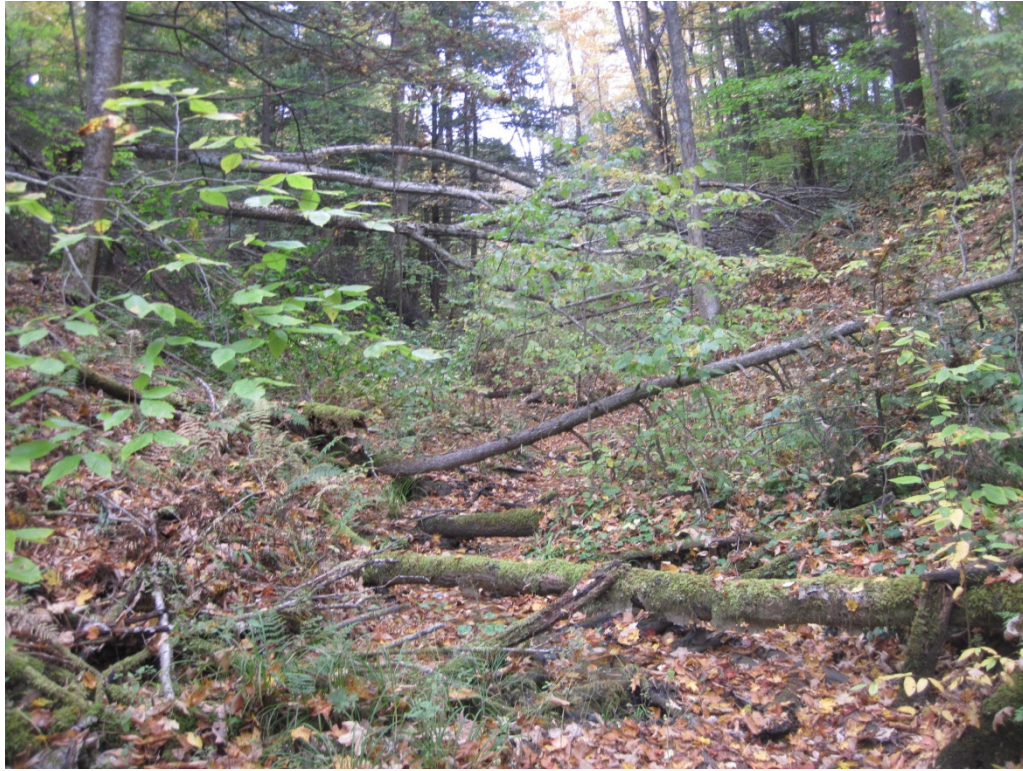
Photo 1. Logs across the downstream channel are stabilizing the channel bed and catching sediment and debris.
