LaPlatte Watershed Partnership

Phase 2 Stream Geomorphic Assessments
Lower LaPlatte River & McCabe's Brook
Shelburne and Charlotte, Vermont
June 2007

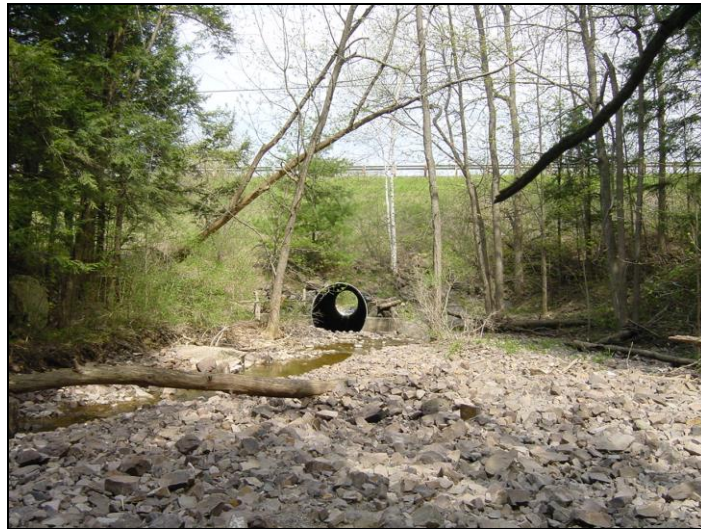
Both structures in segment T1.05A constrict the channel and block the floodplain. The Bostwick Road culvert has significant sediment deposits and channel widening upstream, with bed degradation downstream. This signals a break in sediment continuity where the culvert traps sediment upstream and resulting "hungry water" scours the bed and banks downstream. The floodplain is entirely blocked by the elevated and filled roadbed. Erosion and floodwater buildup could undermine the structure eventually, however more importantly from a geomorphology perspective this scenario has led to significant channel adjustments downstream including bed incision and bank erosion.

Bostwick Rd crossing in T1.05A with large sediment deposits and channel widening upstream.

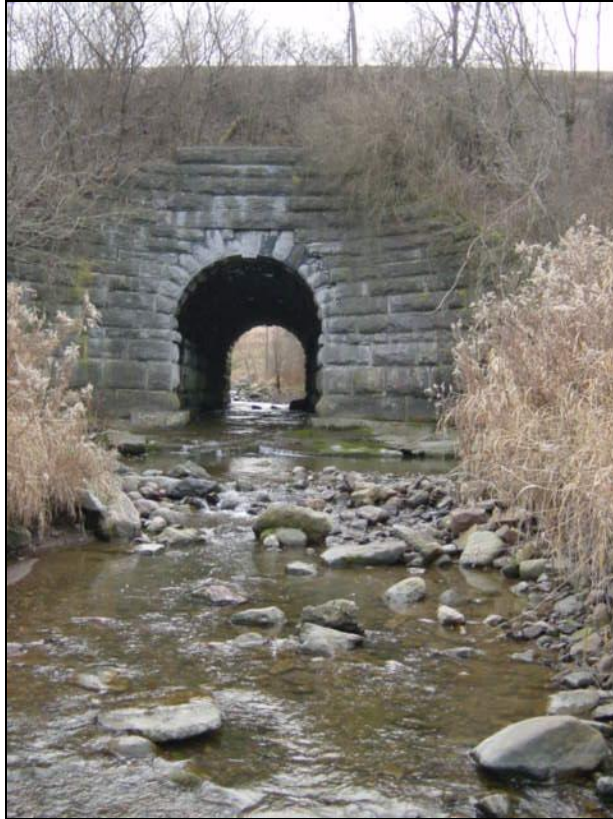
Along the stream, this structure is followed closely by a railroad bridge with similar effects. Again, the floodplain is entirely filled by the rail bed and the structure constricts the channel. Extreme bed degradation including headcuts was observed downstream. Bed degradation continued into segment T1.04B. Replacement of these structures with appropriately sized structures is important to help the stream regain equilibrium. The size and age of the railroad structure, an old stone structure, complicates replacement.

Railroad crossing on T1.05A from downstream looking upstream.

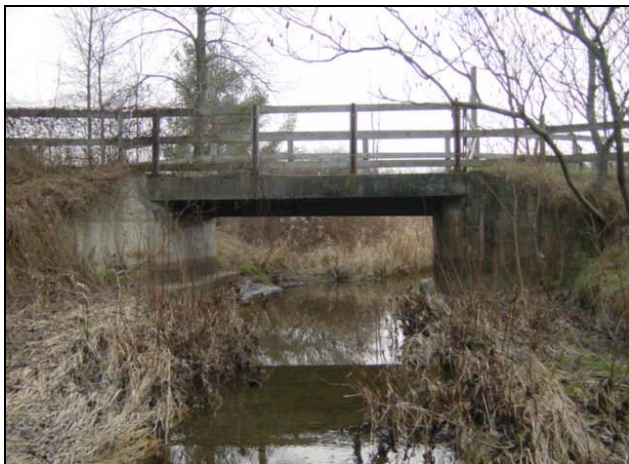
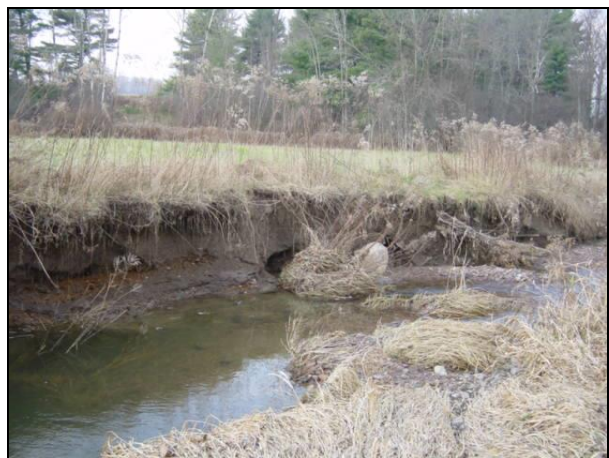
The bridge in segment T1.04B also appeared to be affecting channel geomorphology. This structure constricted the channel and the road approaches completely filled the floodplain. Sediment was deposited upstream with severe bank erosion and channel migration observed downstream. Widening this structure and lowering to approaches to allow for passage of flood flows and sediment could help alleviate these problems.

Bridge in T1.04B (L) and erosion downstream (R).

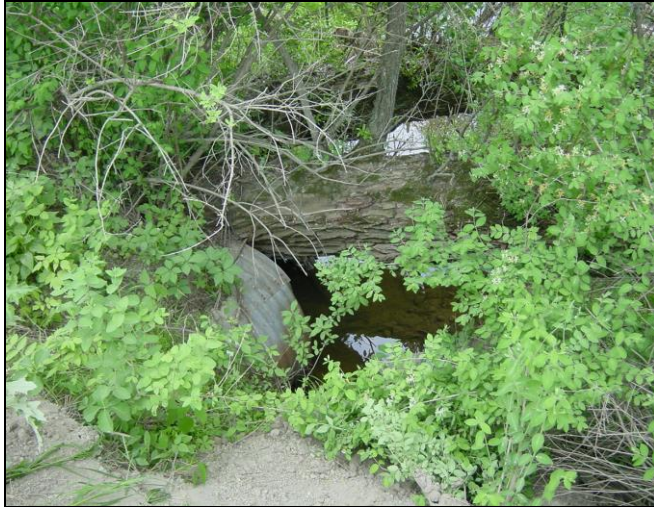
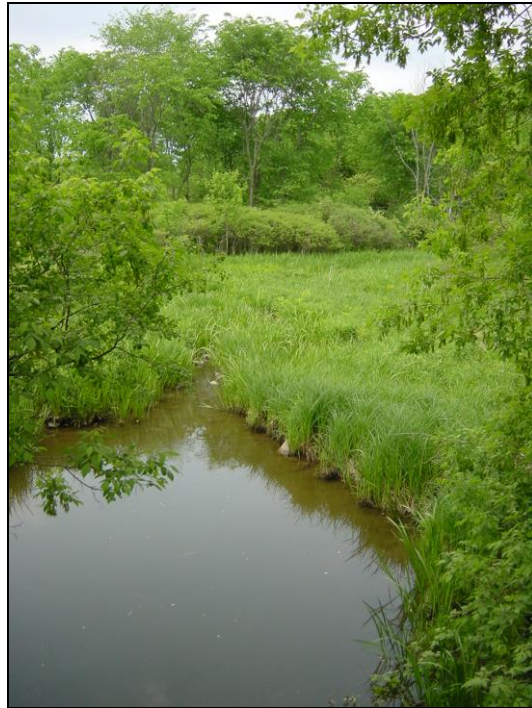
The structure on Lime Kiln Road in T1.06 was significantly smaller (20%) than the channel width (as estimated in Phase 1 SGA). This structure was also obstructed at the upstream end by a

fallen tree. Downstream, the high velocities produced by the culvert had scoured a large pool. This structure appears at risk of failure by washing out due to being undersized and blocked by a large tree upstream. Furthermore, sediment from the dirt road appeared to wash into the channel at this point. Resizing the culvert and removing the debris is recommended.

Lime Kiln Rd culvert with upstream obstructions (L) and scour pool downstream (R).

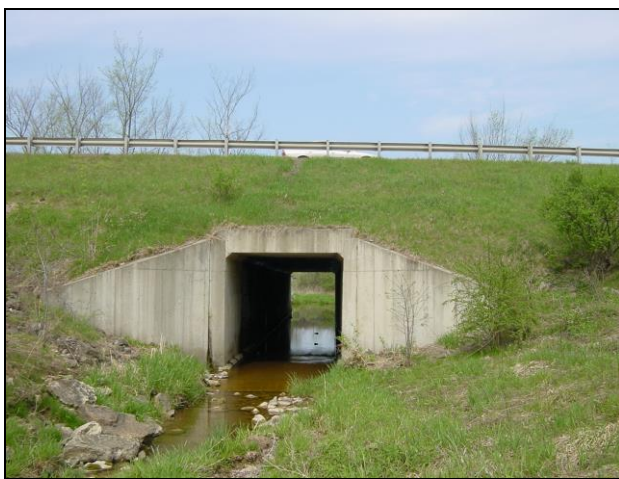
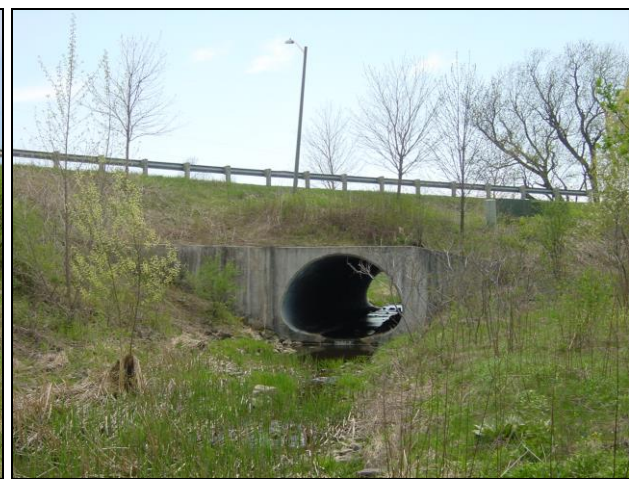
Two structures, closely spaced, in segment T1.05B constricted channel width. Both had scour pools at the downstream end, the one at the Route 7 bridge was particularly large. Again, entirely filled floodplains cause all flow to pass through these narrow structures, increasing velocities and scouring the bed and banks downstream. While the structures themselves appeared well built and not likely to fail in the near term, they interrupted geomorphic functions and contribute to channel adjustments.

Structures in T1.05B: Route 7 crossing (L) and VT Teddy Bear drive (R).

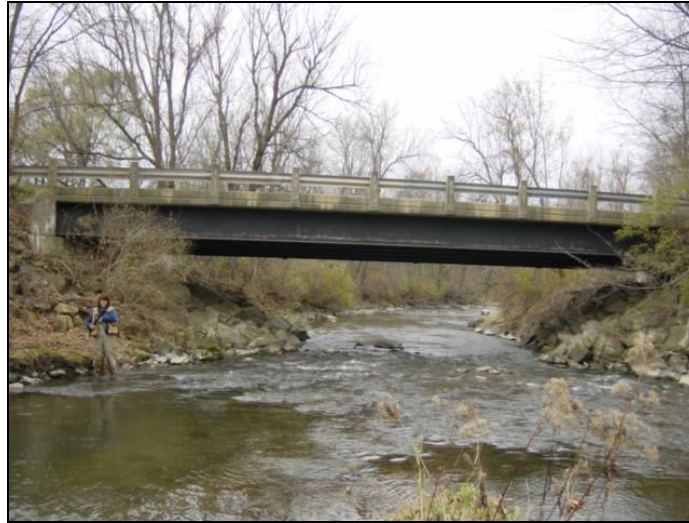
The Spear Street Bridge in segment M09A did slightly constrict the channel width (88%) and had sediment deposition upstream and bank erosion present. Again, the floodplain was entirely filled by the road approaches, forcing all flood flows through this structure. Bank armoring was present as well, but resizing this structure could alleviate bank pressure and reduce erosion.

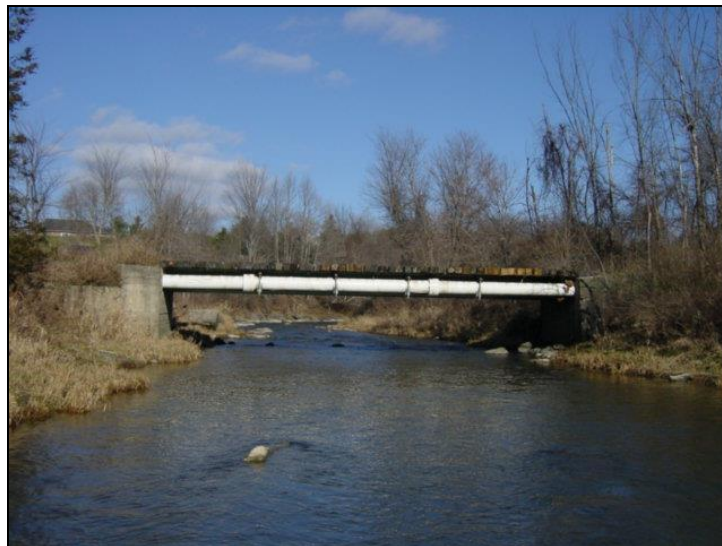
In reach M06, a farm access bridge constricts the channel width. Minor scouring of the channel bed was present downstream of the structure. Reach M06 did appear to be incised, so additional pressure would be placed on the banks in higher than bankfull flows that are not high enough to reach the floodplain. This structure could be at risk of failure from erosion due to it constricting the channel, however, the floodplain did not appear to have been filled for the roadway or the approaches to the structure. Therefore flood flows that reach the floodplain could pass over the road and around the structure.

Farm access bridge in M06.

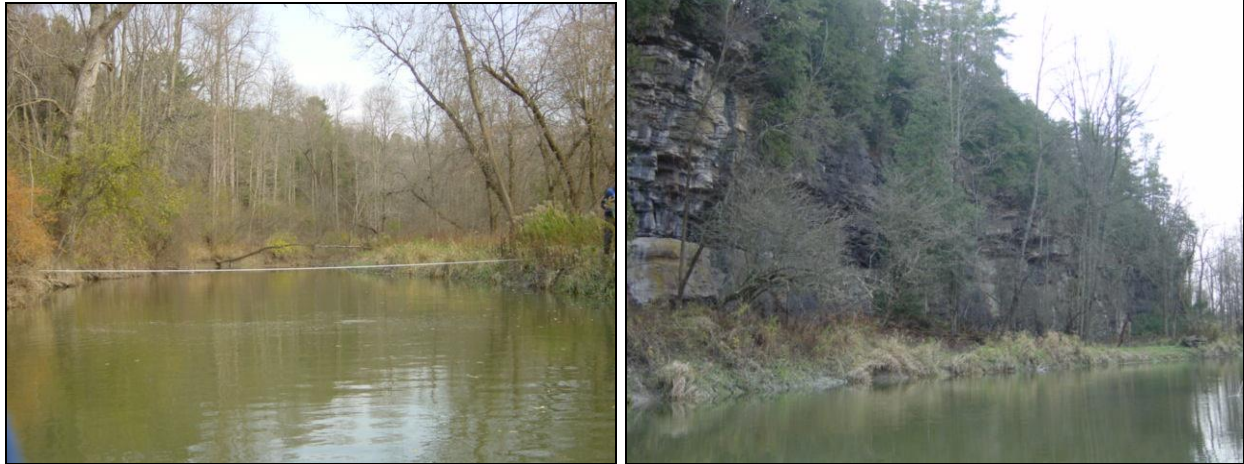
Reach M03 (L) and spectacular cliffs along the right bank between M03 and M04A (R).

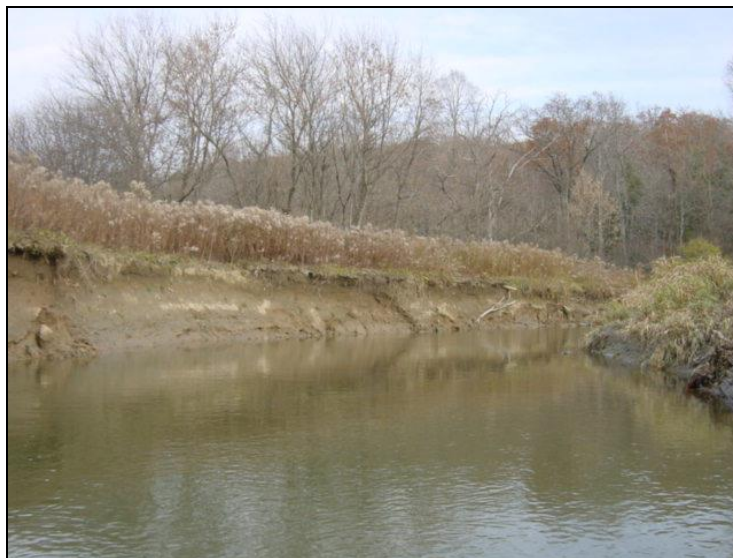
Bank erosion signaling planform adjustments and contributing sediment.

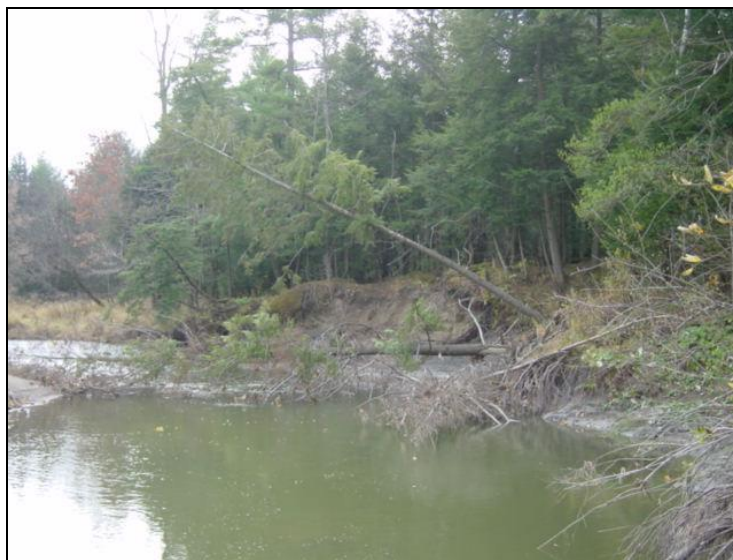
Mass Failure on an outside bend with trees falling into the channel to become LWD.

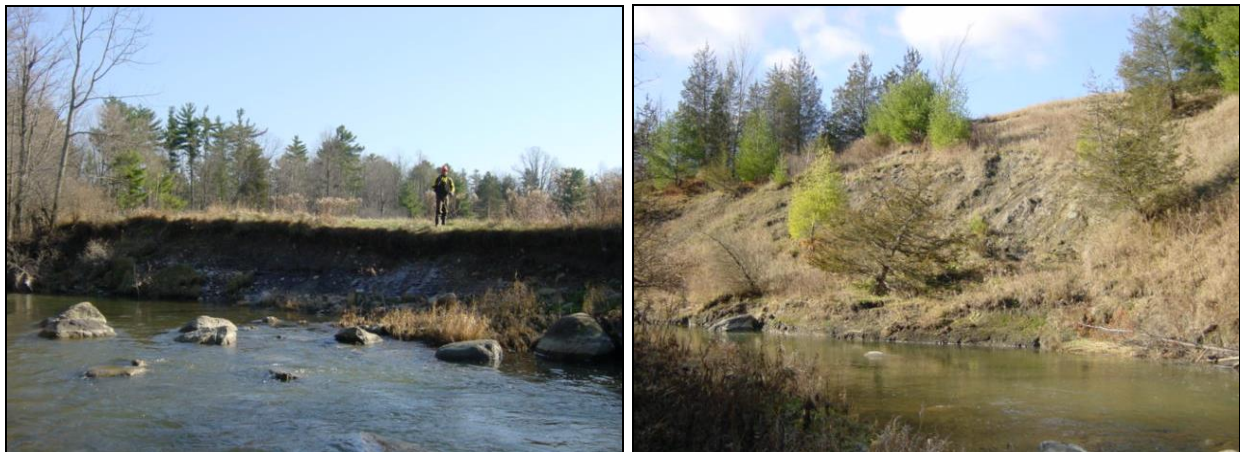
Bank erosion on an outside bend, contributing sediment (L) and one of many mass failures in M06 (R).

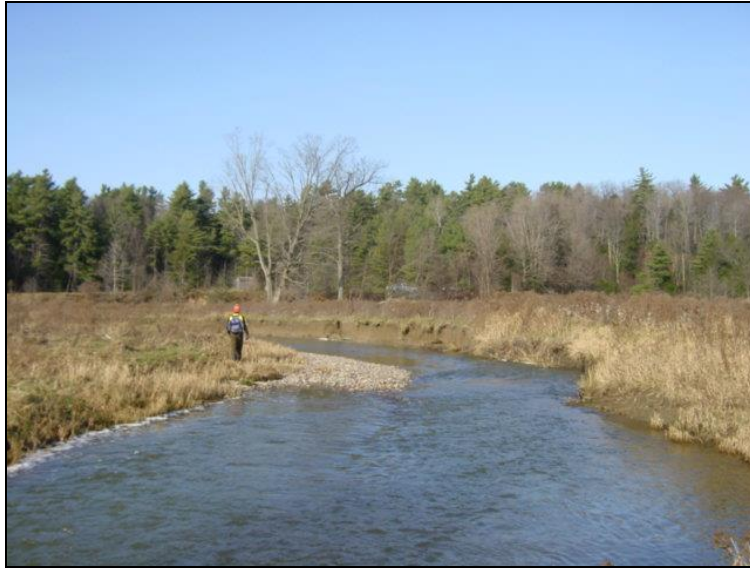
Right bank erosion and diagonal bar.

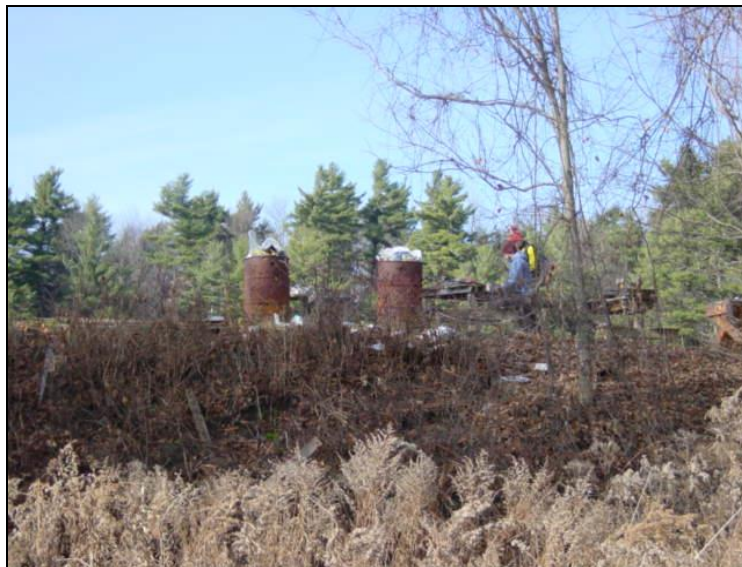
Trash close to the channel at the shooting range. Photo taken from the top of the left bank.

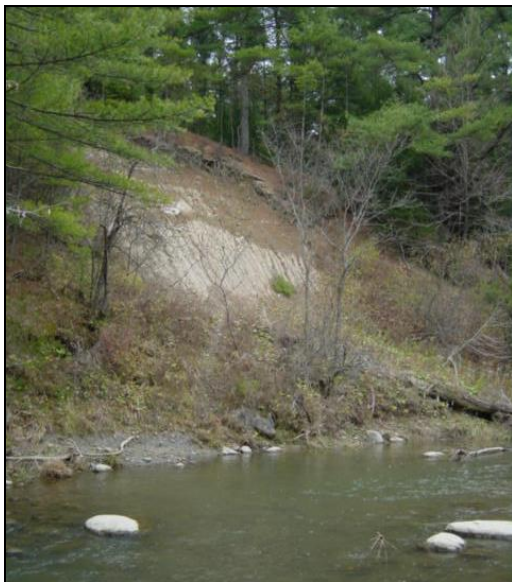
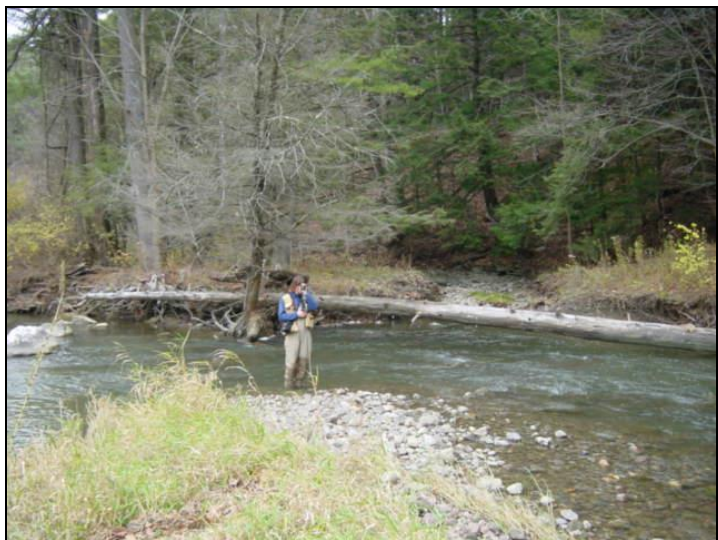
Mass Failure in M09A. Several flood chutes were seen in M09A, signaling planform adjustment.

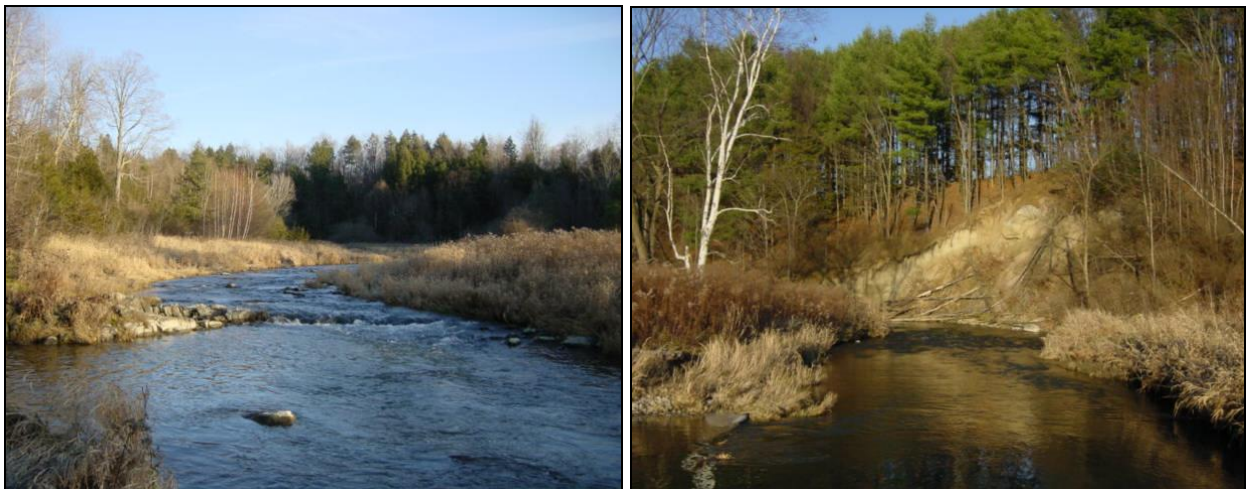
Ledge grade control and herbaceous bank vegetation (L), and one of several mass failures in the reach (R).

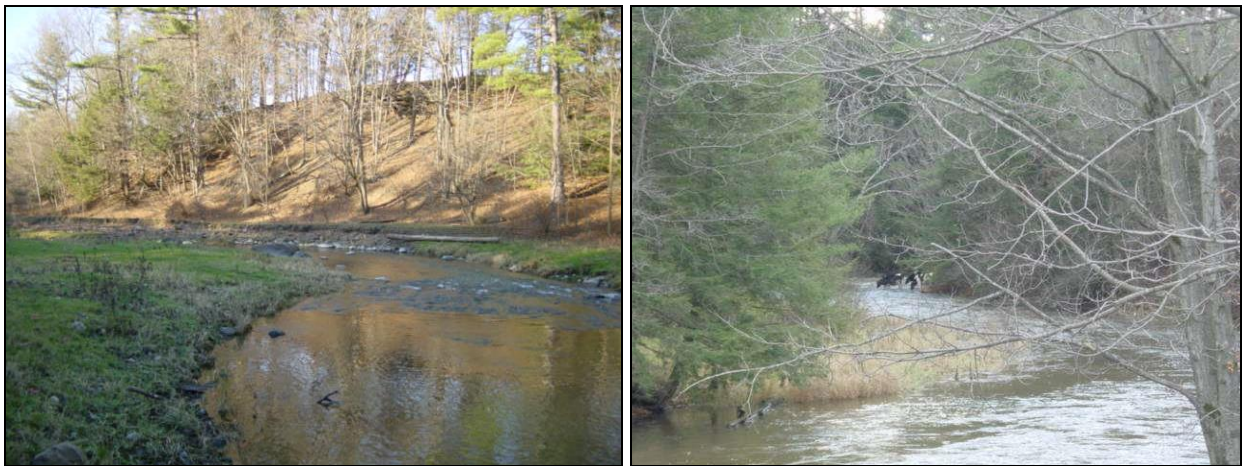
Animal access to channel and bank trampling (L) and cows with full access to the channel (R).

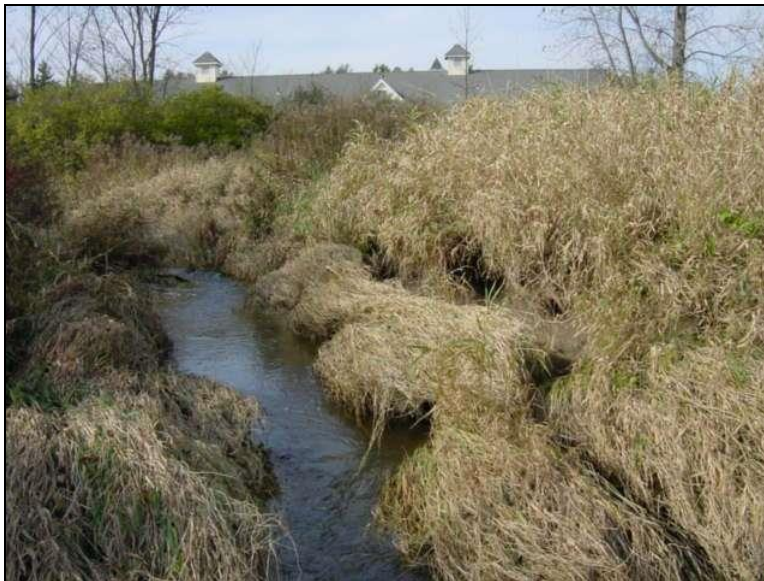
Bank slumping in T1.03.

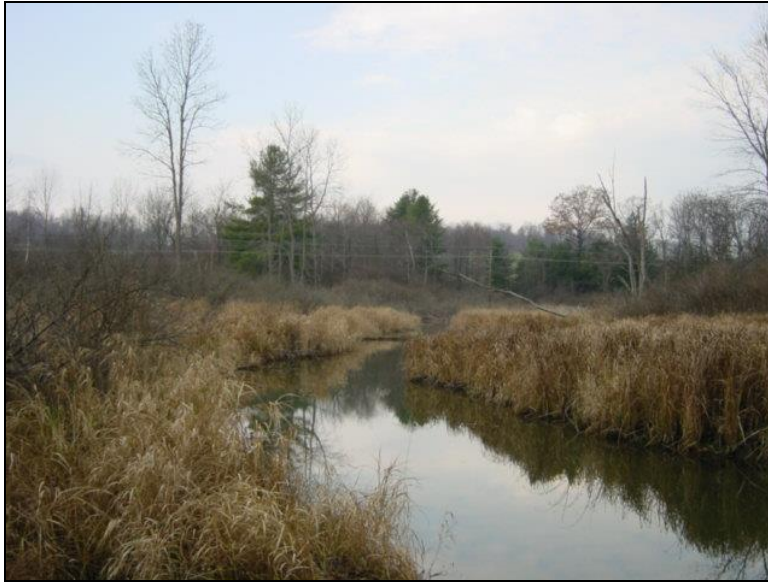
View of segment A with a beaver dam and lodge and backed up water.

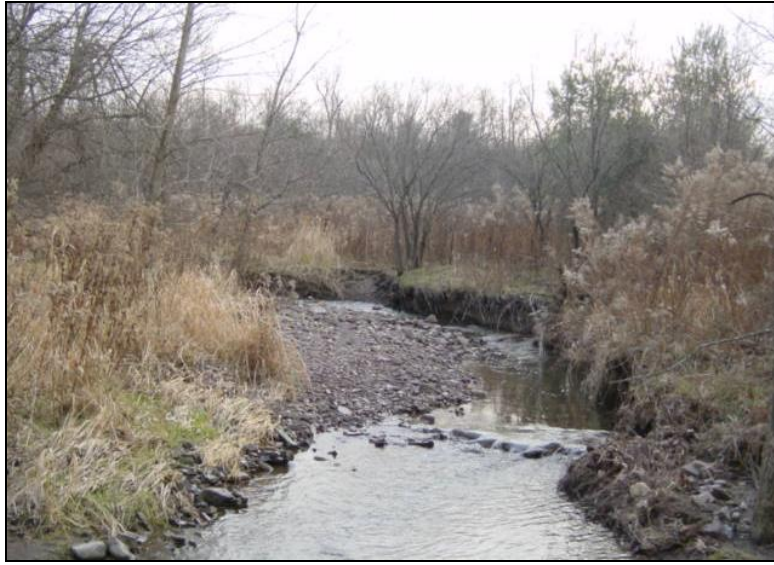
Bank erosion and point bar in T1.04B

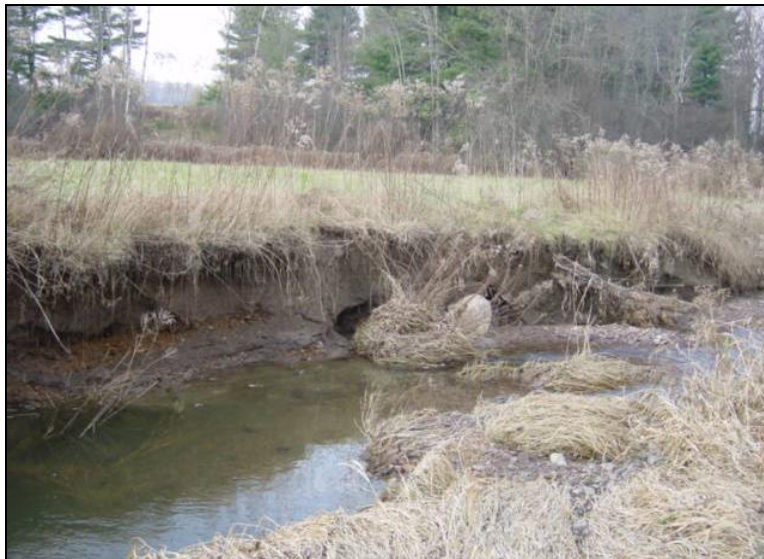
Left bank erosion with closely cropped herbaceous bank vegetation offering little bank protection.
