# AHEAD OF THE STORM

Site: Thorp Brook Headwaters Restoration

Location: East Thompson Point Road, Charlotte, Vermont

## EXISTING CONDITIONS SUMMARY

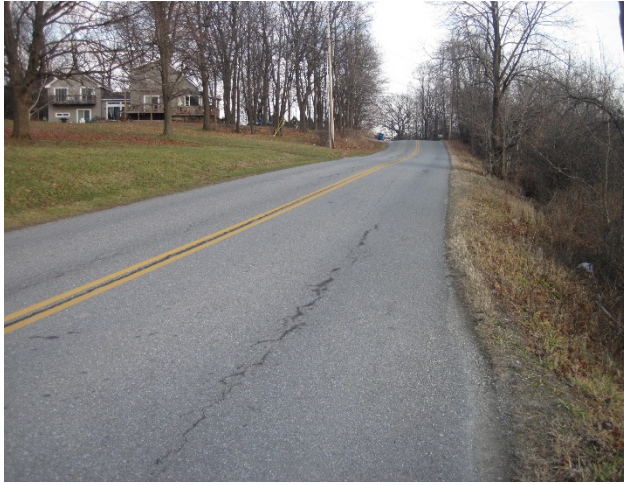
*Figure 1: Runoff from Greenbush Road and homes on the far side of the road travels through the adjacent farm fields to Mack's farm field.*

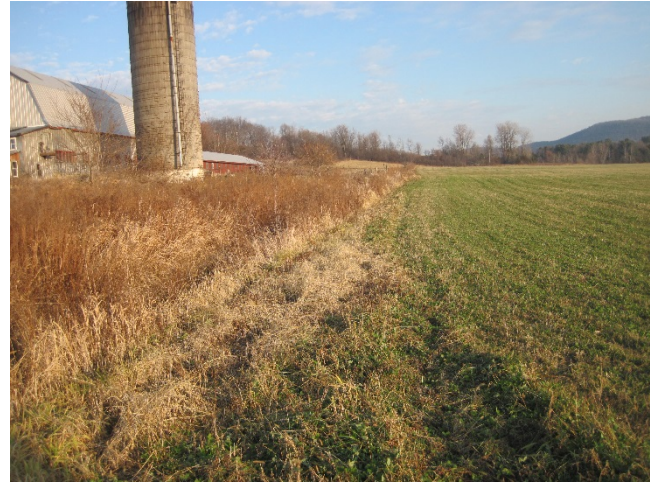
*Figure 3: A swale runs from north to south along the west edge of the Mack's farm field, carrying water to the East Thompson Point Road swale.*

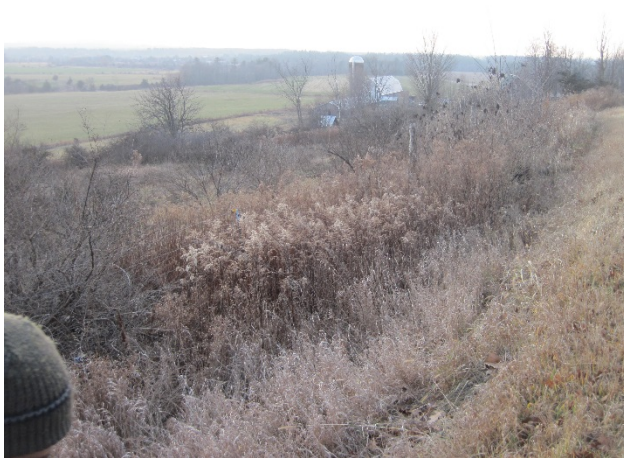
*Figure 2: Runoff from fields and Greenbush Road travel through farm fields down to the site.*

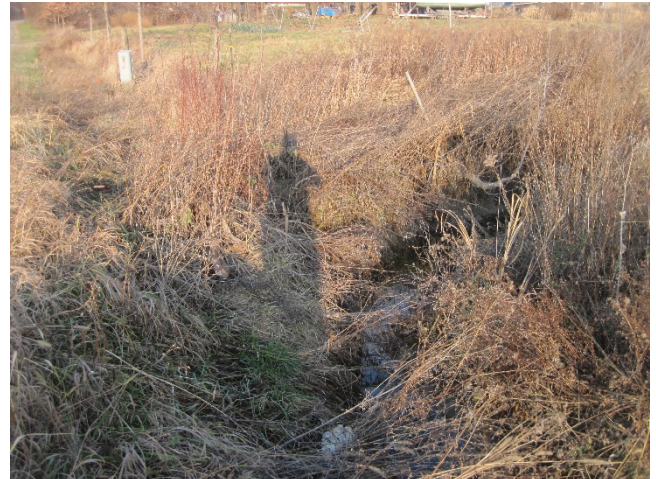
*Figure 4: The swale from the north turns sharply to the east, joining the East Thompson Point Road swale.*

REALIGN SWALE AT CORNER TO ELIMINATE SHARP BEND AND PROVIDE FOR MORE SNOW STORAGE

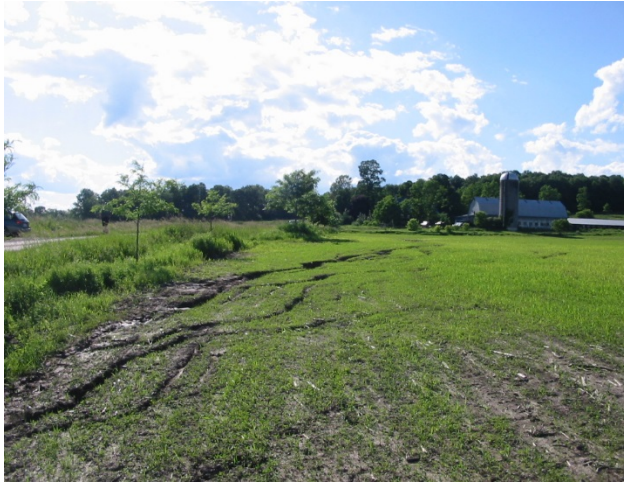
*Figure 5: Rill erosion has occurred in the Mack farm field when water in the swale traveling from the north leaves the swale and cuts across the field to the road swale.*

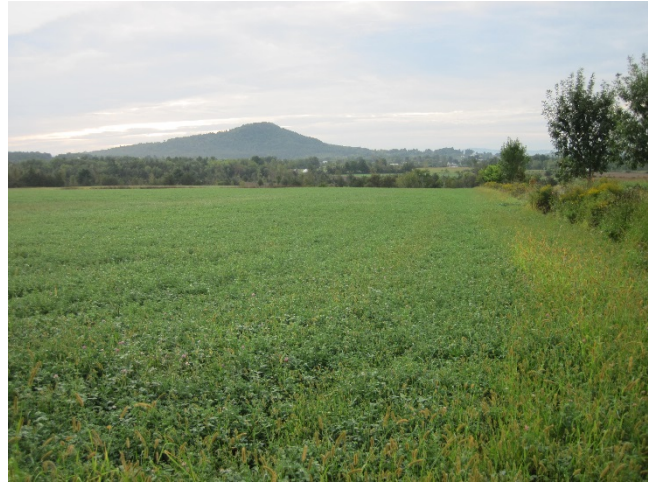
*Figure 7: The Mack farm field is harvested close to the edge of the swale. The trees in this photo have been moved.*

ADJACENT LANDOWNER TO ESTABLISH 10' VEGETATIVE BUFFER BETWEEN EDGE OF SWALE AND ACTIVE AGRICULTURE FIELD (NOT SHOWN)

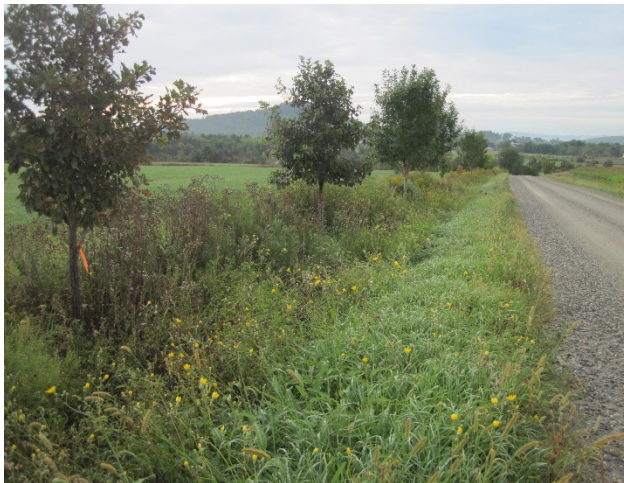
*Figure 6: A vegetated swale travels along East Thompson Point Road. The trees in this photo have been moved.*

RESHAPE 575' OF GRASS SWALE AND REVEGETATE (SEE DETAILS)

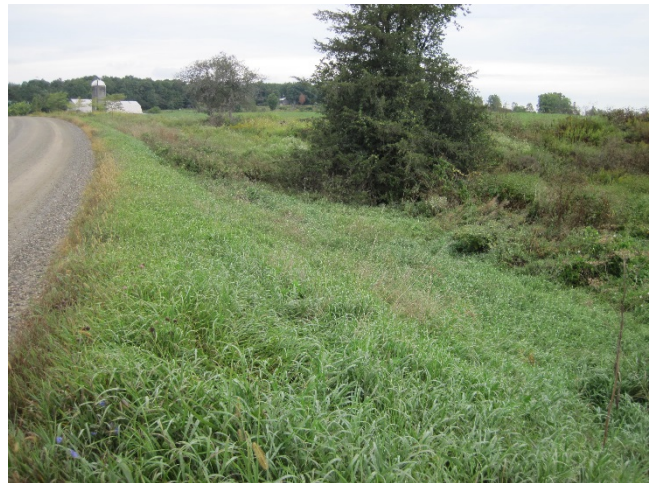
*Figure 8: Possible location of a bioretention area adjacent to East Thompson Point Road, prior to water entering Thorp Brook*

BIO-RETENTION AREA WITH 3 STONE FILTER BERMS (SEE DETAIL) FOOTPRINT ~ 2,300 SQUARE FEET AVG. DEPTH ~ 1 FOOT VOLUME ~ 2,300 CUBIC FEET

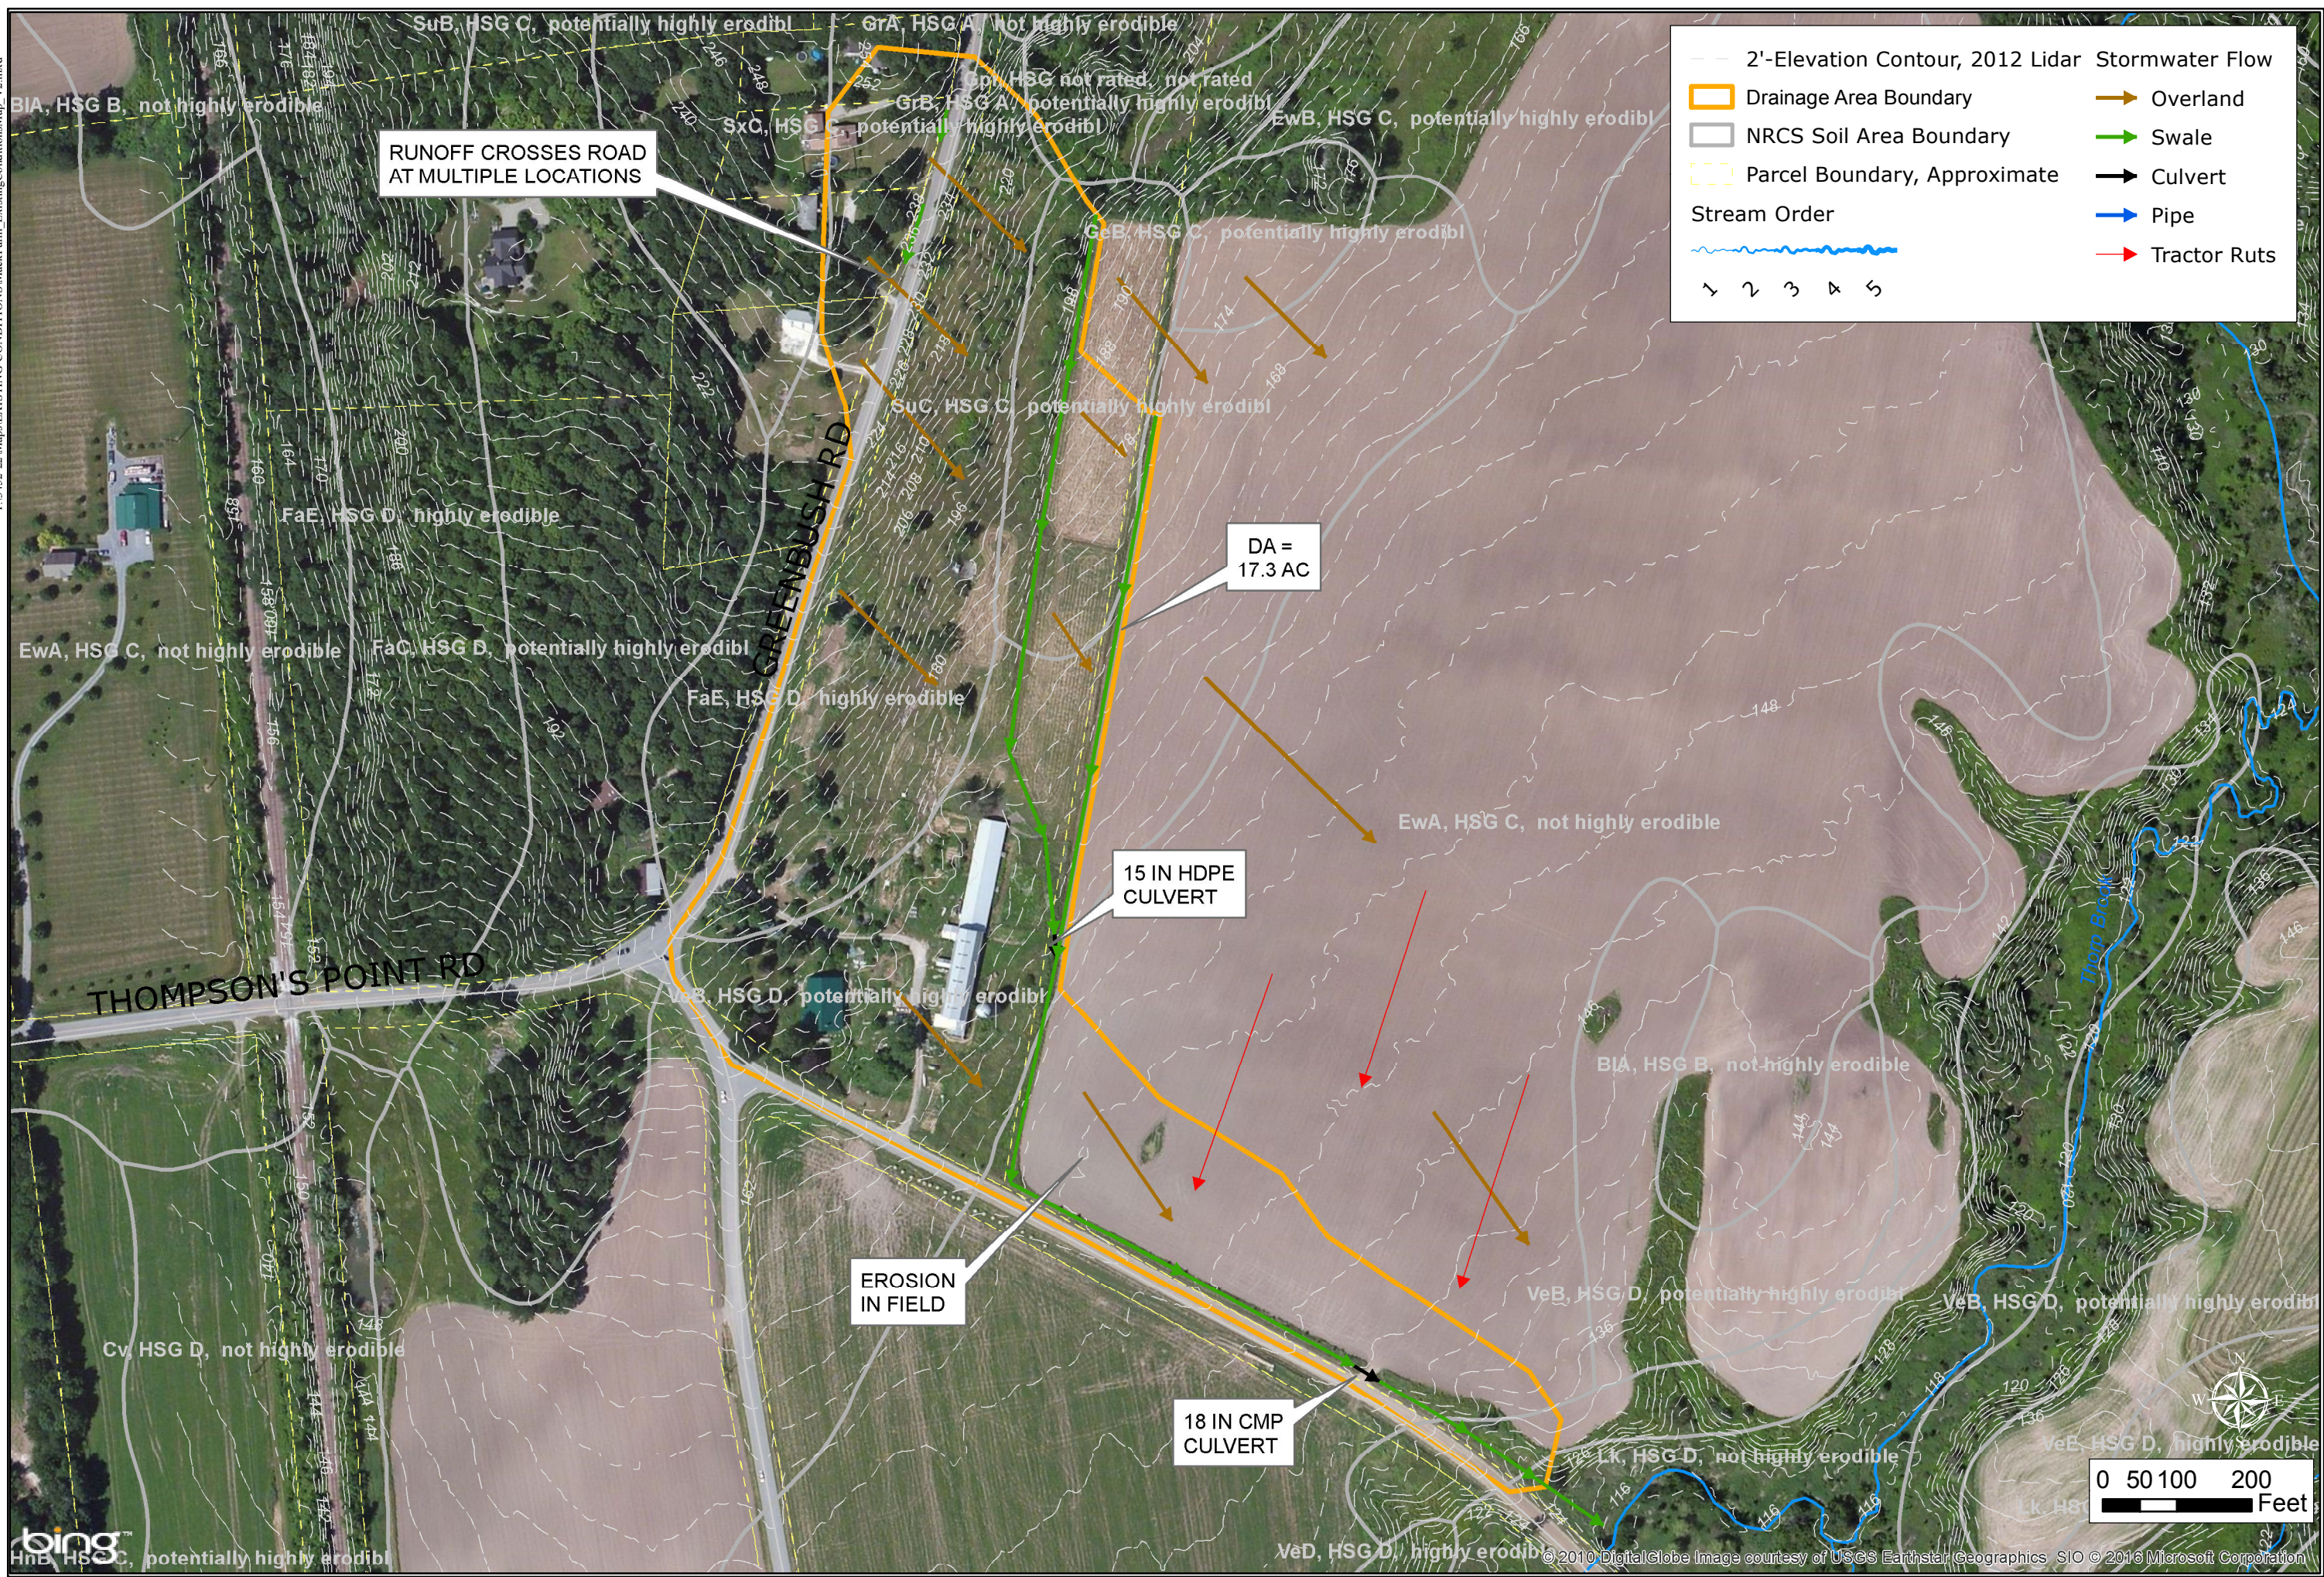
**EXISTING CONDITIONS**  
**AHEAD OF THE STORM**  
**THORP BROOK HEADWATERS RESTORATION**  
 EAST THOMPSON POINT ROAD  
 CHARLOTTE, VERMONT

RUNOFF CROSSES ROAD AT MULTIPLE LOCATIONS

EROSION IN FIELD

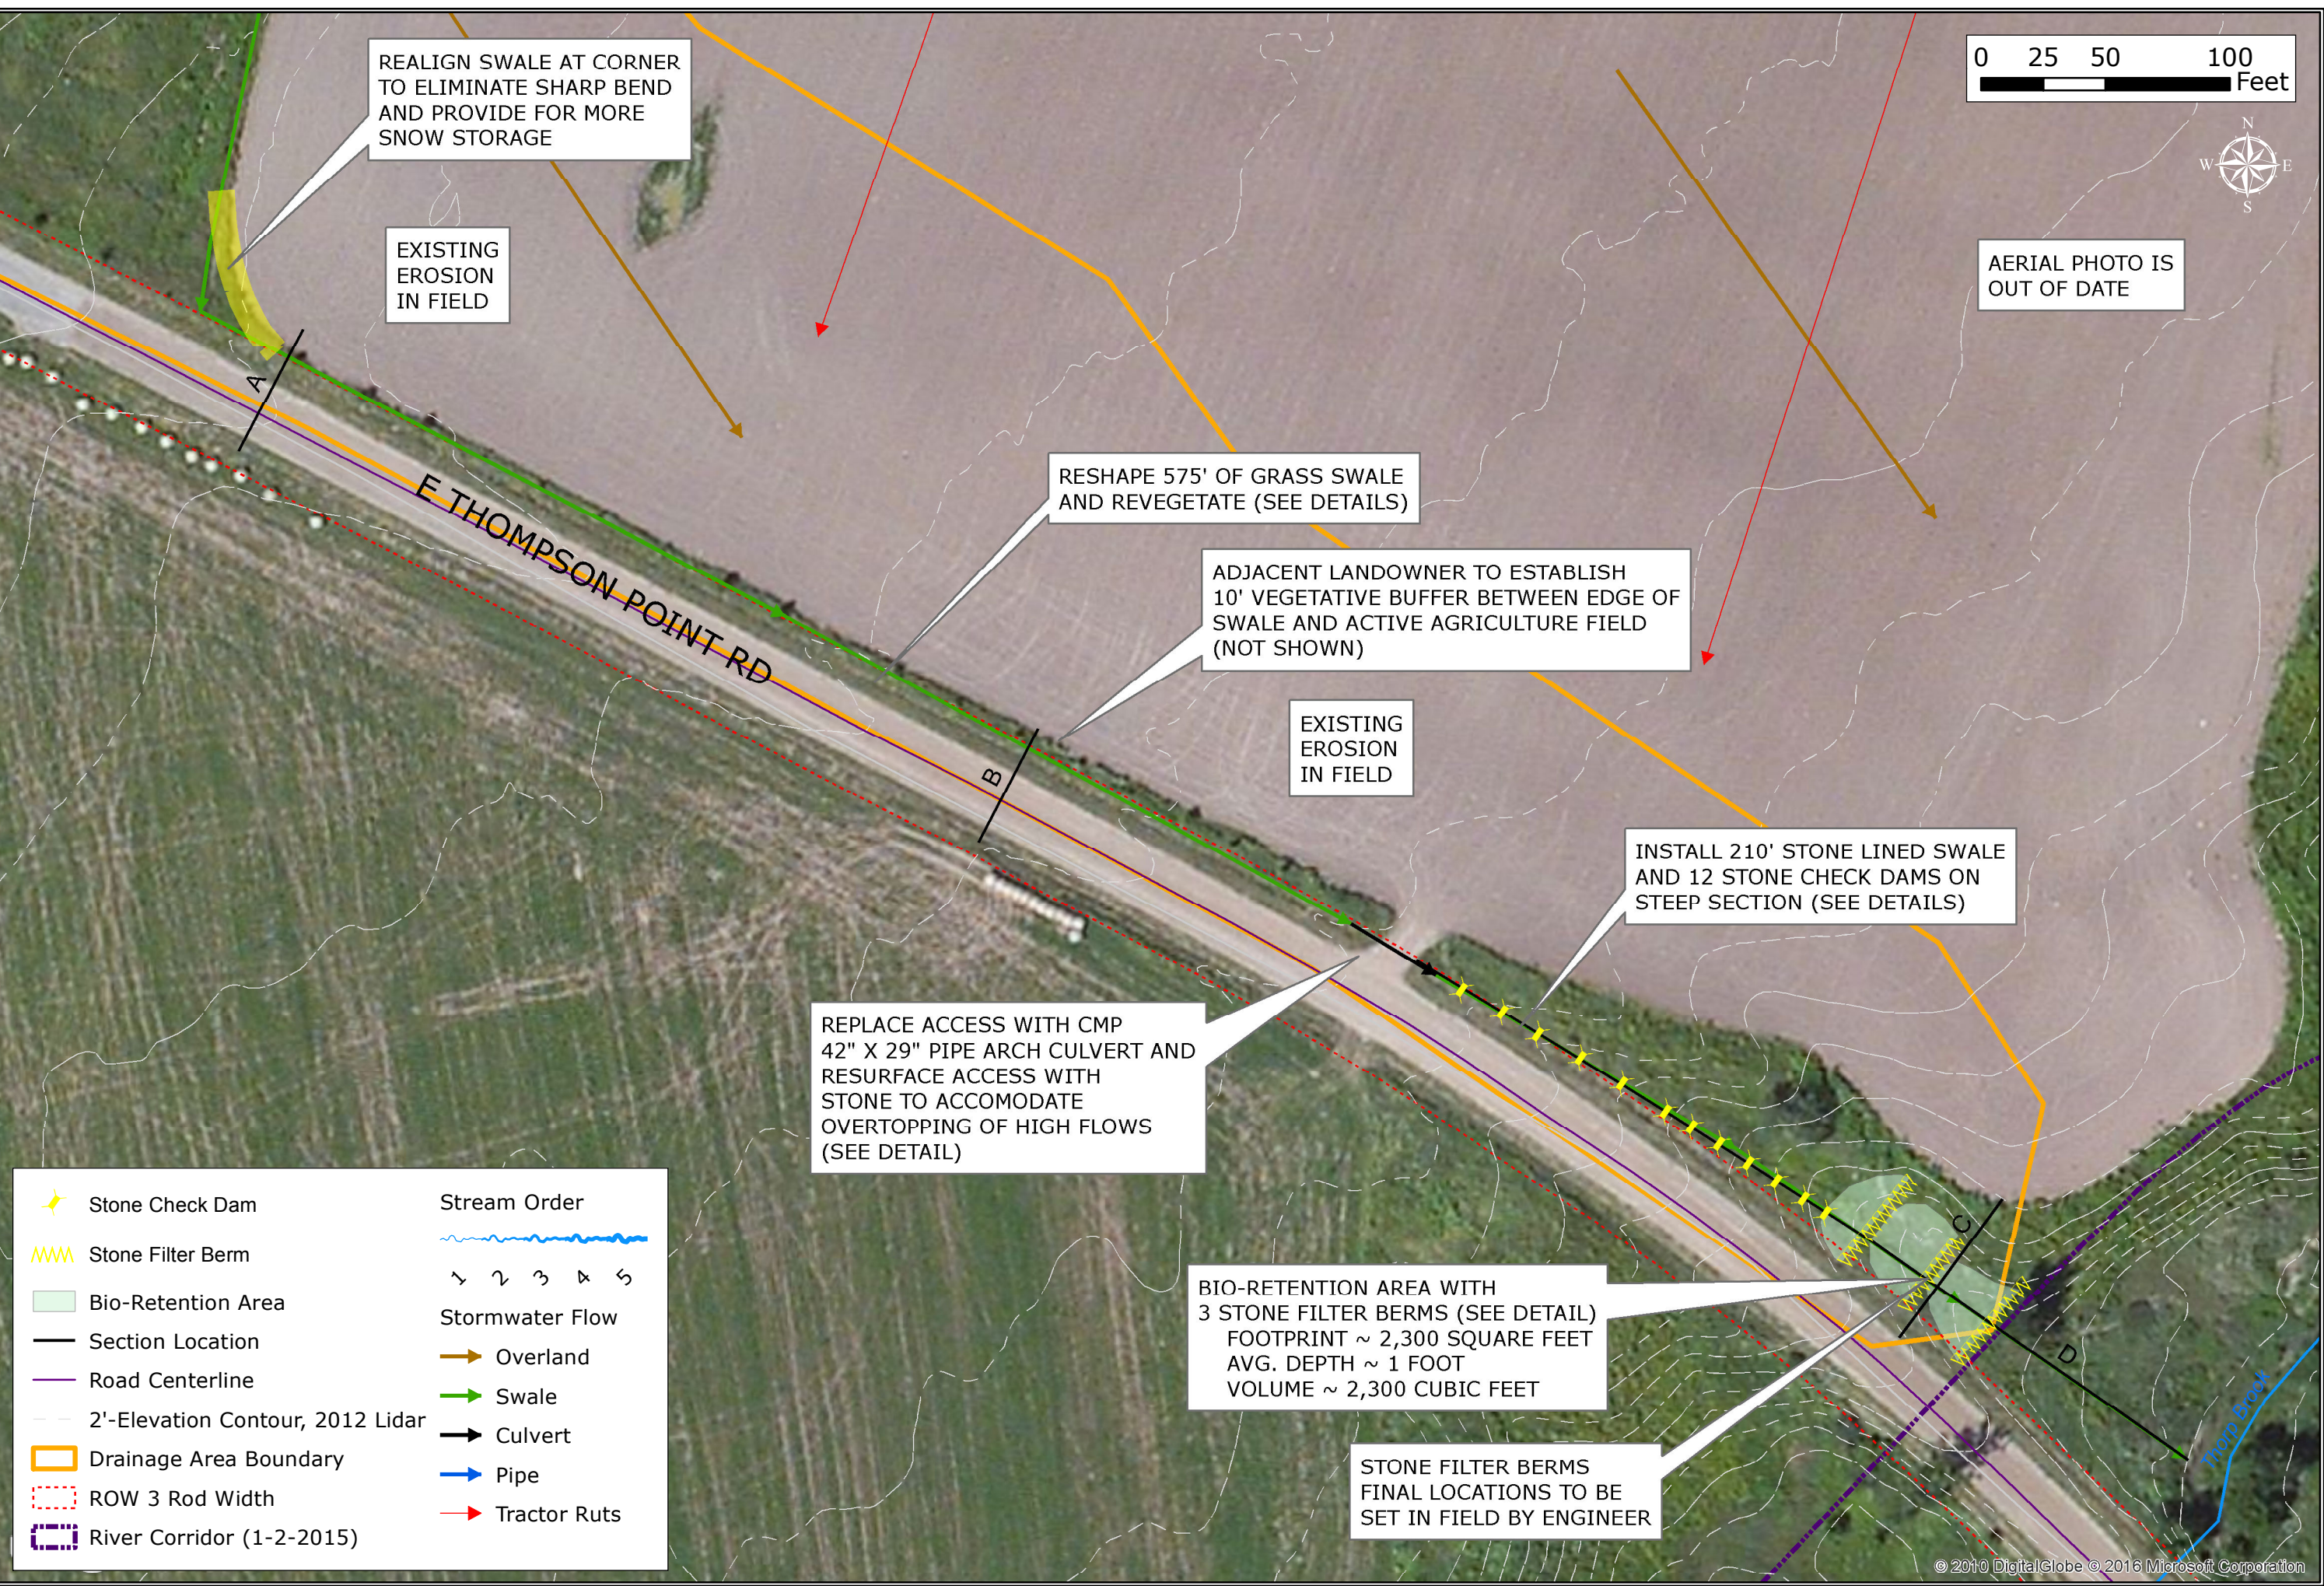
**LAYOUT**  
**AHEAD OF THE STORM**  
**THORP BROOK HEADWATERS RESTORATION**  
 EAST THOMPSON POINT ROAD  
 CHARLOTTE, VERMONT

EXISTING EROSION IN FIELD

INSTALL 210' STONE LINED SWALE AND 12 STONE CHECK DAMS ON STEEP SECTION (SEE DETAILS)

REPLACE ACCESS WITH CMP 42" X 29" PIPE ARCH CULVERT AND RESURFACE ACCESS WITH STONE TO ACCOMODATE OVERTOPPING OF HIGH FLOWS (SEE DETAIL)
