**PHASE 2 GEOMORPHIC ASSESSMENT AND CORRIDOR PLANNING  
MCCABE'S BROOK WATERSHED  
CHARLOTTE AND SHELBURNE, VERMONT**

FEBRUARY 10, 2012

MILONE & MACBROOM, INC.  
1233 Shelburne Road, Suite 150  
South Burlington, Vermont 05403  
802.864.1600  
[www.miloneandmacbroom.com](http://www.miloneandmacbroom.com)  
MMI #3452-13

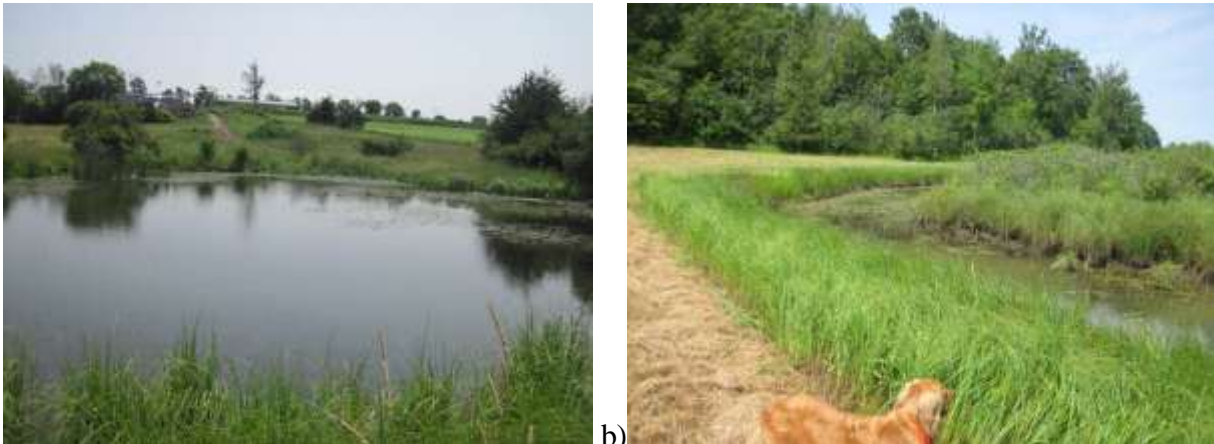
a) *Photo 1: T1.08 has an inline farm pond formed by a farm road and culvert on the downstream end and b) a wide ponded section with minimal buffer.*

There are many crossings in this reach. A driveway at Homesteader Road dams the channel, creating a pond. The channel then passes under Hinesburg Road in a culvert. These culverts consolidate the otherwise wetland flow into a concentrated path. There are four farm crossings with culverts. Most of the pools observed in the reach were caused by the scour at the downstream end of the crossings. A tractor ford crosses near the downstream reach break.

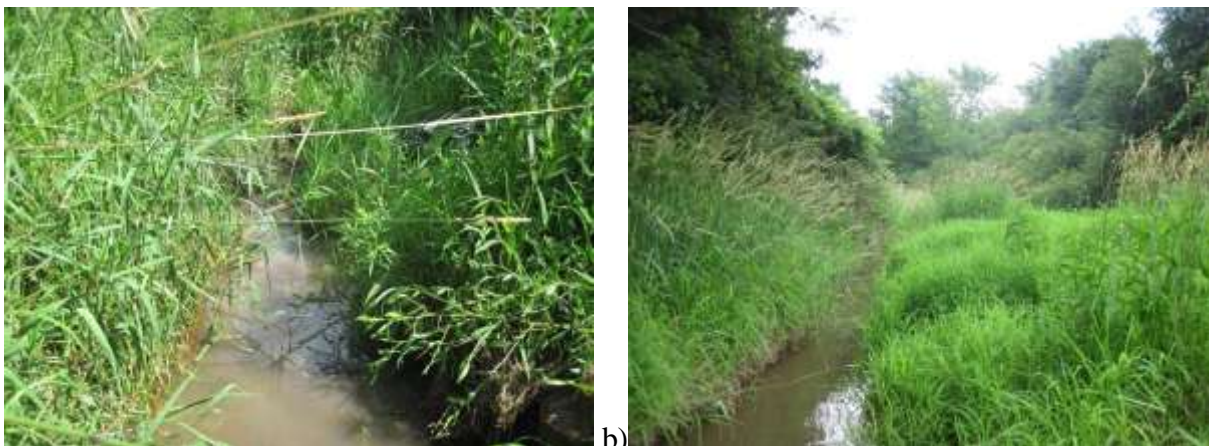
T1.07B has fair habitat (RHA score = 63%). Trees are lacking on the banks, in the buffer, and in form of Large Woody Debris (LWD). There is evidence of sediment mobility and high fining degrading the bed substrate cover. Bed features are poorly formed and the reach has a low number of pools and riffles. The nearbank vegetation is herbaceous, but does include invasive honeysuckle shrubs. The valleywalls are wooded. There is approximately a 100 foot wetland and wooded buffer on either side of the channel before hayfields.

a) b)  
*Photo 2: a) T1.07B flows through a herbaceous wetland area and is b) bordered by forest.*

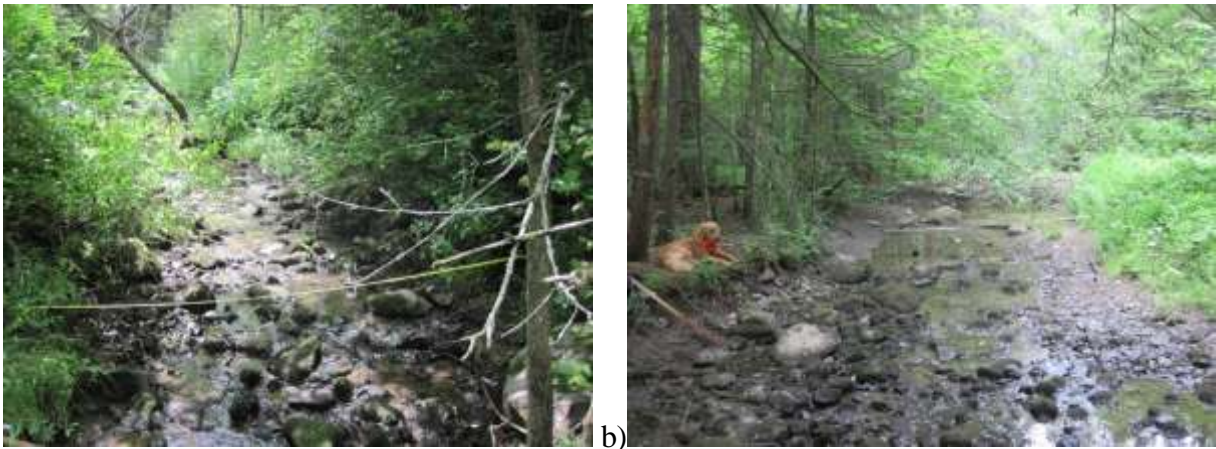
The channel is a Rosgen C-type channel with riffle-pool bedform in good condition. It is in channel evolution stage II of the F-model and has high sensitivity. There is some incision (IR=1.3) that may be due to the breach of the upstream dam. The channel bed is gravel and cobble. There is some minor incision occurring, but the channel has not departed from its reference condition and has clear access to the forested floodplains.

T1.07A has good habitat (RHA score = 78%). The wide forested buffer is in good condition and providing shading, cover, and woody debris to the channel. There is minor fining occurring on the bed. The riffle pool pattern has fewer pools than reference and lacks fast-deep habitat. There is exposed substrate in the channel that may be due to recent lack of rain.

a) b)  
*Photo 3: T1.07A typical channel sections looking a) upstream and b) downstream.*

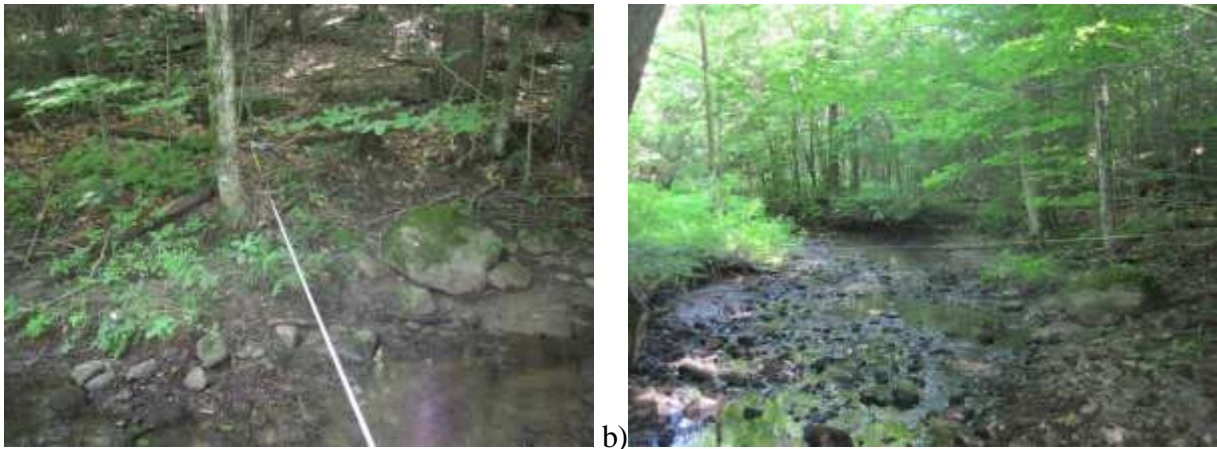
The channel is a Rosgen C-type with a riffle-pool bedform and a gravel bed. The channel is in good condition in channel evolution stage II of the F-model with high sensitivity. There are minor signs of aggradation, widening and change in planform due to exposed substrate and bar formation. There is a large amount of substrate exposed that could be due to the recent dry weather.

T1.06B has good habitat (RHA score = 75). The wide forested riparian area provides LWD to the channel and excellent riparian and bank conditions. Fining and minor embeddedness is occurring, but may be natural due to sand and clay banks.

a) b)  
 Photo 4: T106B typical a) bank and b) channel sections.

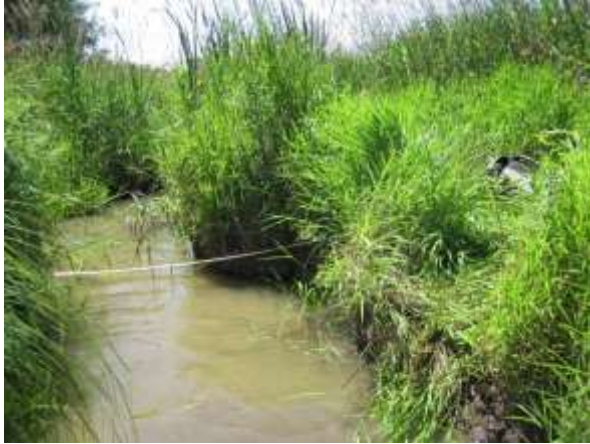
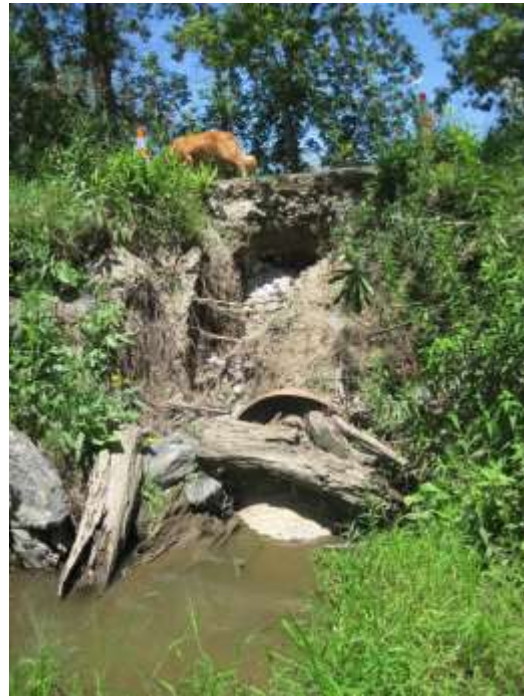
The Lime Kiln Road culvert was failed during the July 15, 2011 site visit. The culvert constricts the channel and floodplain. Sometime after the initial visit the culvert was replaced with a similar 4 foot diameter round culvert. The bank and road was reconstructed and hard armoring was added. The replacement with the same size culvert did not provide additional conveyance.

a) b)  
*Photo 5: T1.06A a) typical section and b) failed Lime Kiln Road culvert viewed from upstream end.*

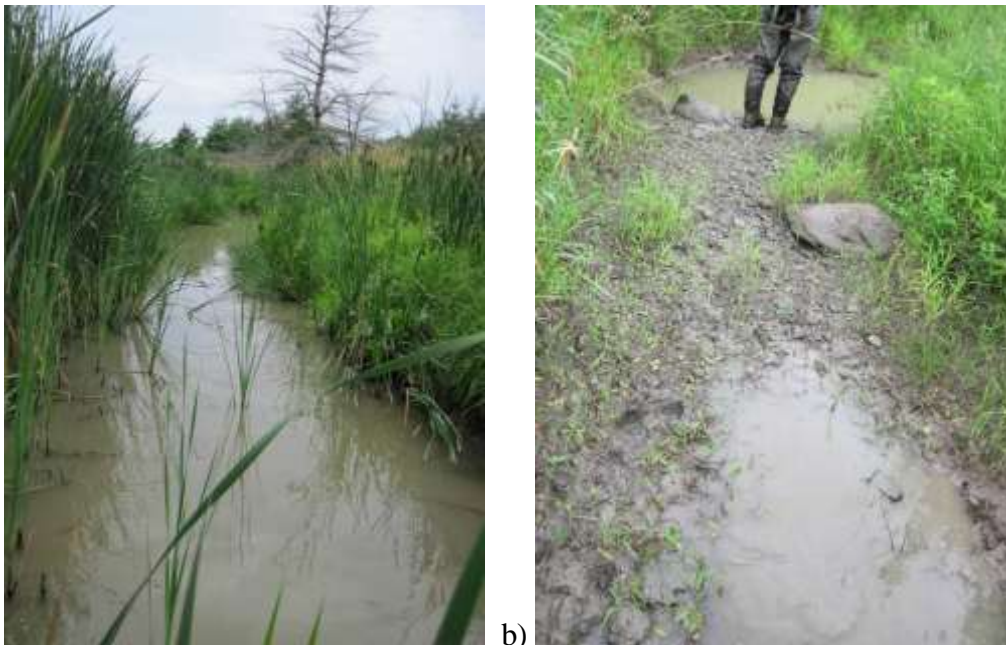
There are multiple existing or damaged partial beaver dams in the segment that influence short sections of the channel both by impounding sediments and causing floodchutes. The downstream segment break is within the impoundment of a large downstream beaver dam and located at the Charlotte-Shelburne town boundary. Some sections of the reach have exposed substrate where the channel does not have above ground flow and water is probably flowing through the gravel on the bed.

a) *Photo 6: T1.05C a) typical section and b) dry section near downstream segment break.*

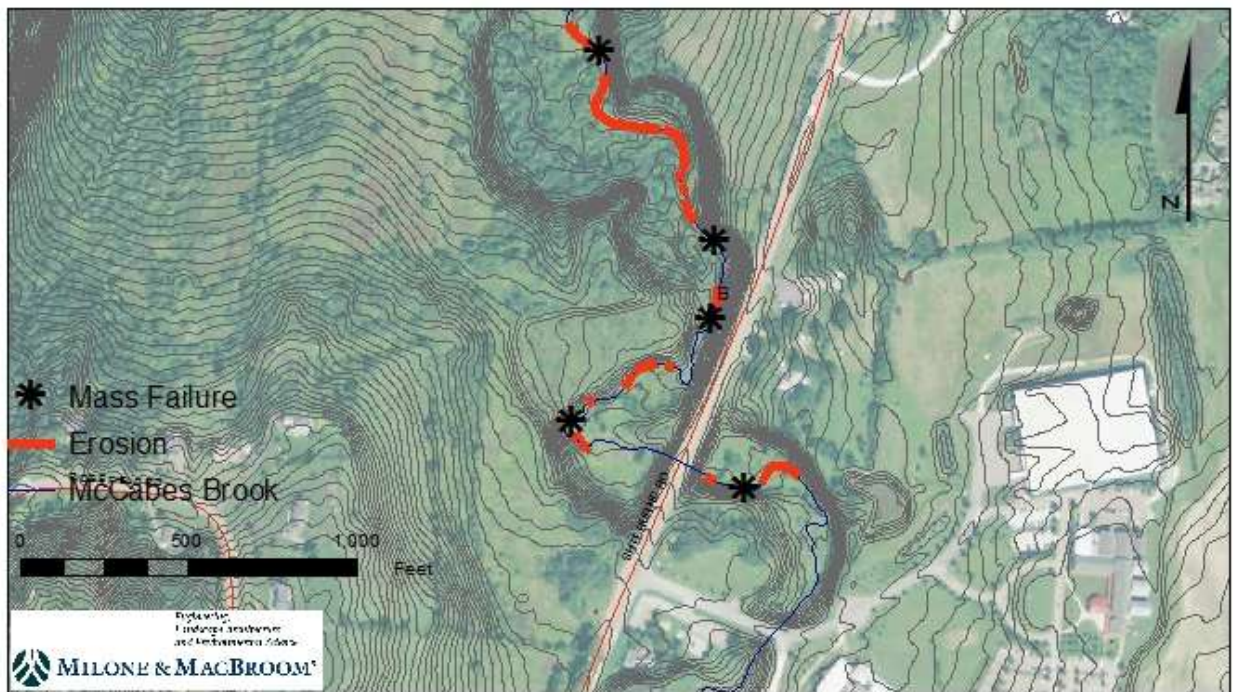
*Figure 3: T1.05A and T1.05B have multiple mass failures and significant bank erosion in the vicinity of the Route 7 crossing, possibly caused by constriction of the floodplain. Two foot contour lines show locations of steep slopes and the edge of the river corridor.*

Priority Rank	River Segment / Condition	Site Description including Stressors and Constraints	Project or Strategy Description	Project Benefits
1	<b>T1.05B/A #1</b>	Route 7: The road embankment completely fills the floodplain at the crossing location. Downstream of the crossing the river turns and flows parallel to the embankment, where it is severely constricted by the embankment fill. Mass failures have resulted upstream and downstream of the constriction. Armor at toe of Route 7 embankment has some damage.	Remove Constriction / Floodplain Restoration: Remove constriction caused by embankment. Route 7 is a major travel corridor and unlikely to be re-routed or accommodate a narrower embankment. Explore creation of a compound channel with floodplain using undeveloped land on the opposite bank.	Improved sediment transport; reduced erosion risk; Improved floodplain attenuation.
2	<b>T1.05A #4</b>	Bostwick Road Culvert: This culvert is undersized and completely filling the floodplain with a tall embankment. The structure is accumulating debris upstream and has a very large cobble and gravel delta extending a few hundred feet upstream. Scour is occurring downstream and an outlet drop of 0.5 ft blocks AOP.	Replace Structures - The Bostwick Road culvert should be replaced with a larger structure than can accommodate sediment and flood water movement along with AOP.	Wildlife habitat connectivity; sediment continuity; reduce erosion risk.

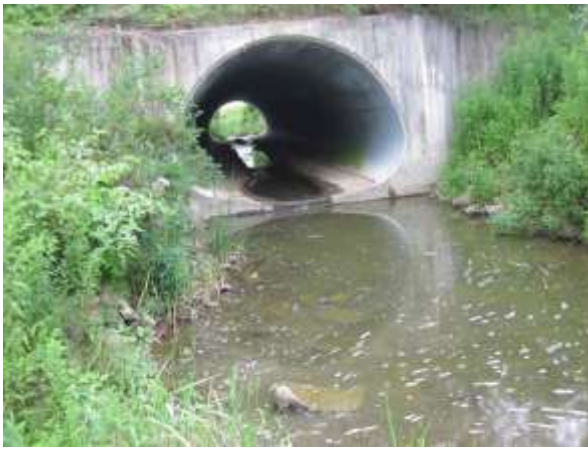
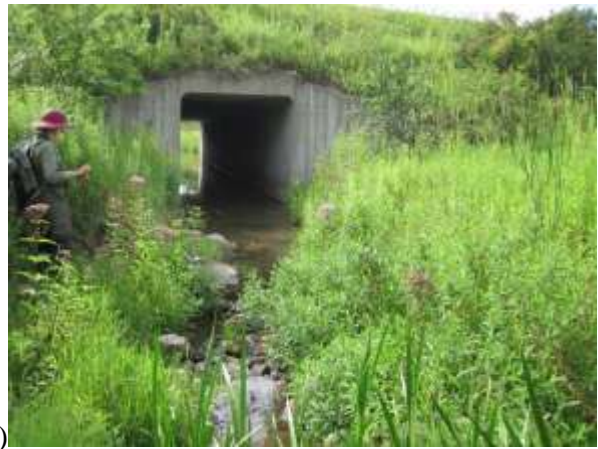
The culvert at the Teddy Bear Factory is large and in good physical condition, but has reduced aquatic organism passage. A long apron with very shallow flows existing upstream creates a fish block. Also, the drop at the downstream outlet also is a fish passage issue. The valley significantly narrows at this culvert and continues to be narrow downstream. The Route 7 culvert is an undersized concrete box culvert that completely fills the floodplain with its tall embankment. Between the Teddy Bear Culvert and Route 7 culvert are two mass failures contributing a large amount of sediment to the river. Downstream of the Route 7 culvert the channel makes a large S-turn back towards the Route 7 embankment. It flows straight towards the embankment and is forced to make a sharp turn and flow against the embankment in a severely constricted straight channel for a few hundred feet. multiple large mass failures also exist. Looking at the topography of this section indicates that the embankment (and terrace on left) is severely constricting the flow (Figure 3). In addition to the mass failures upstream of the culvert there are several more extremely active failures downstream of Route 7, including in Segment T1.05A. The segment ends at this constriction.

*Photo 7: Culverts on T1.05B include a) Teddy Bear Factory Access Road (looking upstream) and b) Route 7 (looking downstream).*

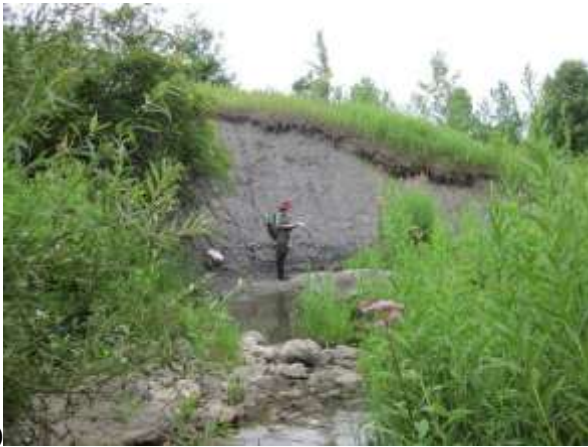
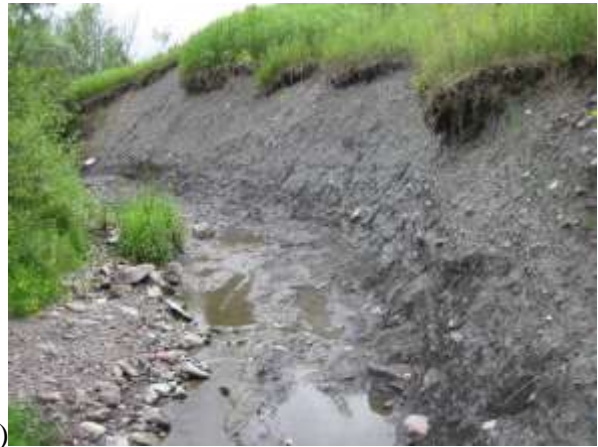
*Photo 8: T1.05B a) large mass failure near downstream end a) looking downstream and b) looking upstream.*

T1.05B has fair habitat (RHA score = 61%). The riparian buffers were narrow with a lack of both trees and shrubs in the buffer and near the river. The lack of trees decreased the bank canopy, and reduced the amount of LWD present in the channel. There was significant fining on the bed possibly produced locally from the clay banks. Both culverts have reduced aquatic organism passage. The banks had few undercuts and although for most of the segment didn't have significant bank erosion, had multiple large mass failures at the lower end.

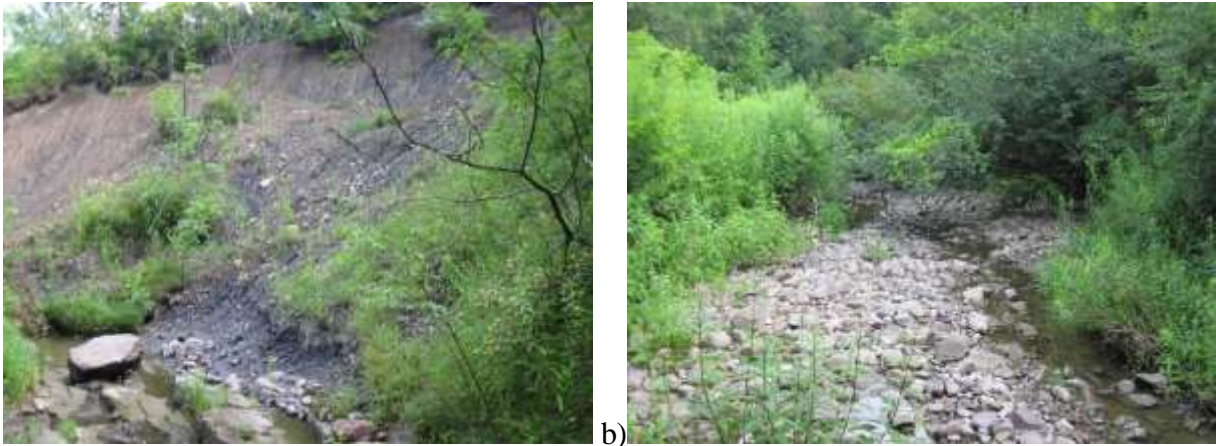
This segment begins just downstream of the Route 7 embankment constriction. At the downstream end of the constriction a large bedrock grade control exists, bordered by a mass failure. There are additional bedrock grade controls and mass failures in this reach. The mass failures in this reach and upstream in T1.05B are till, and contribute a significant amount of mixed sediment to the river. This segment is heavily sedimented with primarily gravels. The majority of the bed substrate is exposed with large gravel bars filling bed features. There are sections of dry bed. Some of the visible gravel may be due to the underlying surficial geology, a band of Champlain Sea Deposit of marine beach gravel that is unlike the upstream and downstream clay and sand.

a) b)  
*Photo 9: a) A large mass failure with bedrock bed near upstream segment break and b) typical sedimented channel section.*

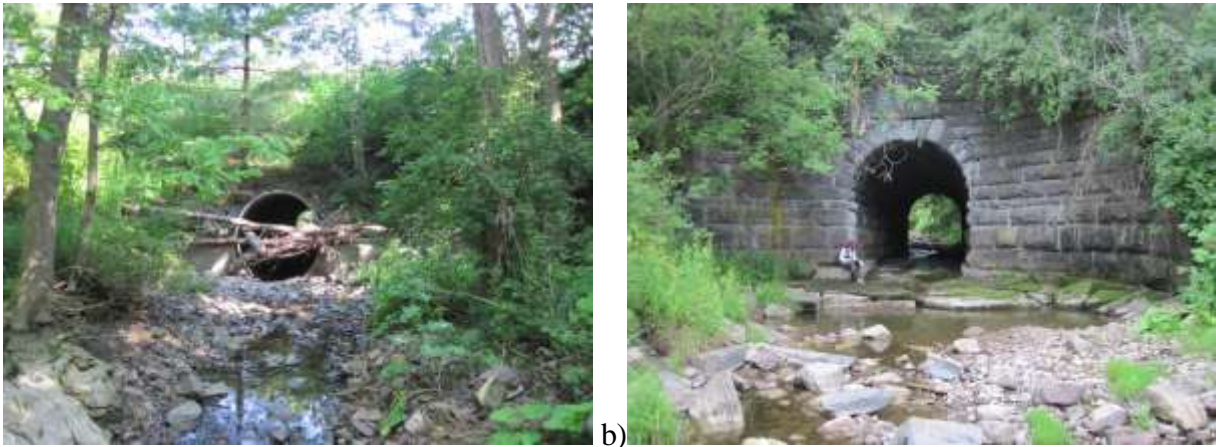
a) b)  
*Photo 10: a) Bostwick Road culvert constricts the channel, accumulating debris and sediment upstream (shown looking downstream) and b) the railroad culvert reduces aquatic organism passage with a drop at the downstream end and flow under the culvert floor (shown looking upstream).*

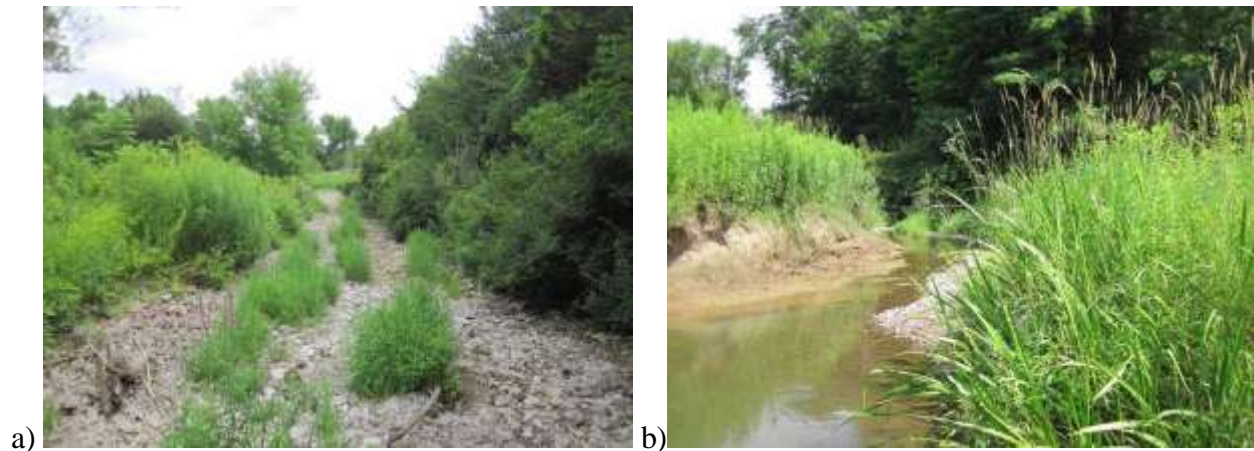
A grass footpath crosses the channel in the middle of the reach over a bridge. The bridge has significant scour along the footings. The flow is not aligned well with the river and is scouring behind one of the abutments.

*Photo 11: a) A dry section along T1.04B downstream of the railroad bridge and b) a typical section.*

Priority Rank	River Segment / Condition	Site Description including Stressors and Constraints	Project or Strategy Description	Project Benefits
7	<b>T1.04B #1</b>	This reach is exhibiting incision and planform change. Erosion is occurring and the channel will continue to meander as it reaches equilibrium. It has reduced floodplain connectivity due to moderate incision. This would be an attenuation asset, located downstream of a reach that is out of its sediment regime.	Protect River Corridors - This reach flows through a primarily undeveloped forested riparian area. Protection of this corridor will allow the river to meander as necessary to reach equilibrium, continue to provide habitat and water quality functions, and prevent unnecessary flood and erosion risks.	Improved habitat; improved water quality.
8	<b>T1.02B #1</b>	This reach is very close to Lake Champlain and therefore management directly impacts the Bay and Lake. The majority of the river corridor and a large amount of the subwatersheds has been conserved, but specific land management should be investigated for compatibility with the river and lake.	Protect River Corridors - Work with landowners to manage inputs of runoff and sediment to river.	Improved water quality.

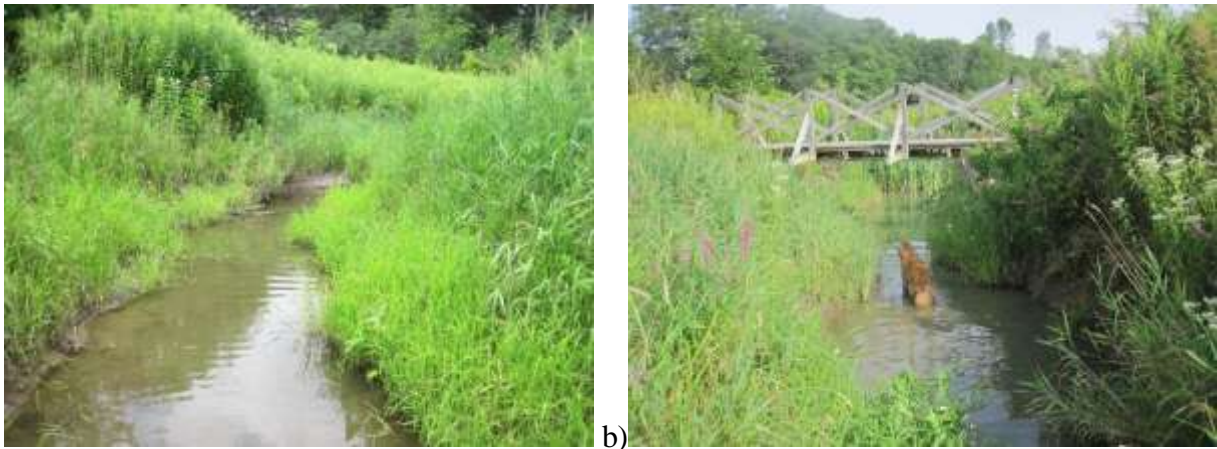
A small footbridge crosses the channel in this reach and does not appear to have significant conflict with river processes.

a) b)  
*Photo 12: a) T1.04A typical section and b) small footbridge.*

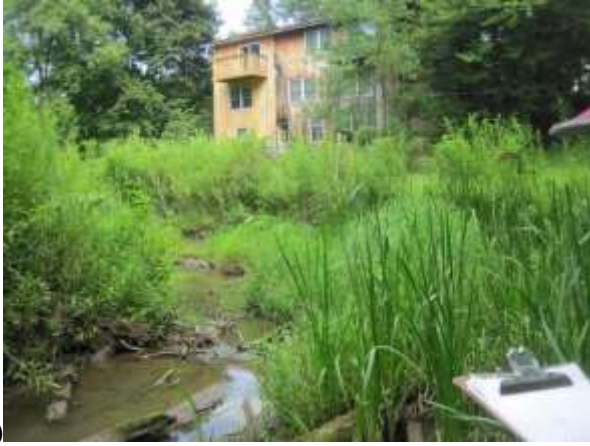
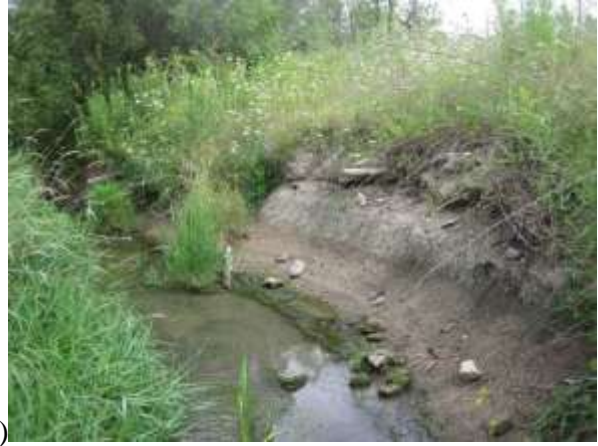
Encroachments exist at a few residential properties in the School Street neighborhood. Most homes sit up on the valley wall, and only one home off of Davis Lane has removed the riparian buffer. The Shelburne Public Works building at the sewer treatment plant has encroached on the channel with some visible fill, no vegetated buffer, and storage of materials adjacent to the channel. Erosion is occurring at this location. Harbor Road crosses McCabe's Brook in this reach. The culvert was recently replaced with a structure that is as wide as bankfull width and is embedded and backwatered. It does not have significant conflict with either channel processes or AOP.

*Photo 13: T1.03 has a) encroachments from a home on Davis Lane and b) possible historic filling at the top of the bank behind the Shelburne Public Works building.*

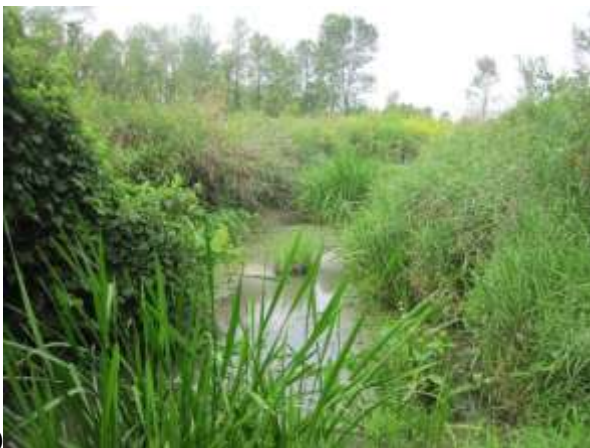
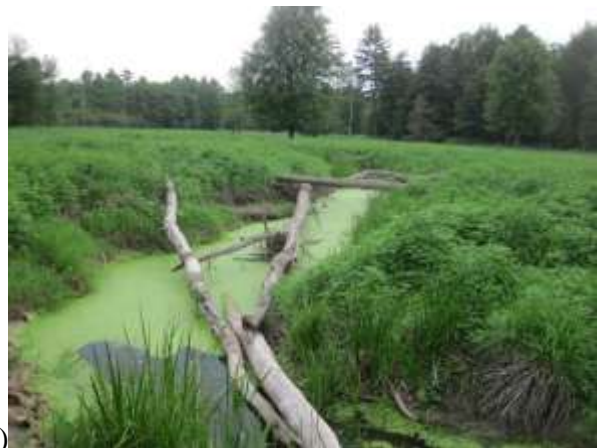
This reach begins downstream of the Shelburne Public Works facilities and extends to the backwater from Lake Champlain. It mainly runs through land conserved by The Nature Conservancy on the right and at the edge of an active farm on the left. The farm does maintain buffers from the mainstem, through which run the Shelburne recreation trail and a utility corridor. Tributary channels to McCabe's Brook run through active areas on the farm and runoff is a concern. The farm has new ownership and has expressed interest in working with the LWP and LCA to improve farm/stream interaction.

*Photo 14: T1.02 typical channel sections a) upstream and b) near downstream end.*
