AHEAD OF THE STORM

Site: Charlotte Park and Wildlife Refuge

Location: U.S. Route 7 and Greenbush Road, Charlotte, Vermont

Existing Conditions Site Summary

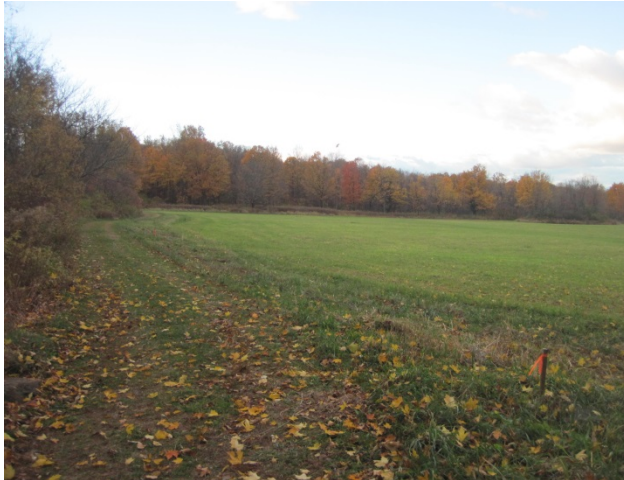
Figure 1: Looking south along the roadway at the east end of the field, two culverts concentrate water (at stakes).

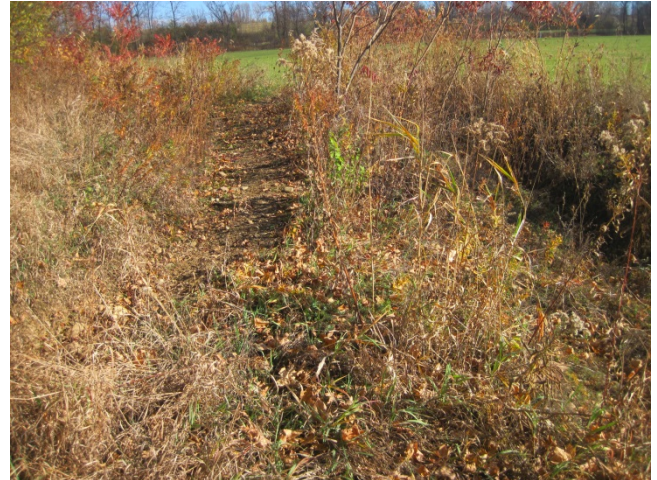
Figure 4: Looking east along a horsepath leading into the field from adjacent property.

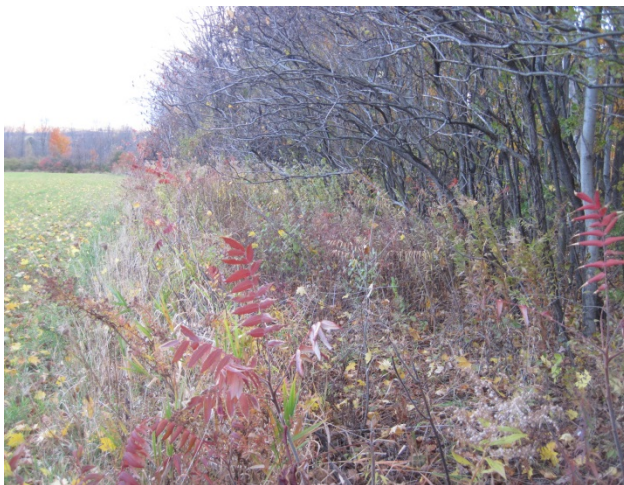
Small sections of rill erosion exist off of the edge of the field in the northern brushline that act as swales. These swales concentrate runoff for a short distance then lose definition allowing runoff to spread and flow into the wooded area to the north as sheet flow. The three sections of erosion are each approximately 70 feet long and vary in depth from 4 inches to 18 inches.

Figure 2: Looking west along the northern edge of the field along the brushline near the east end of field.

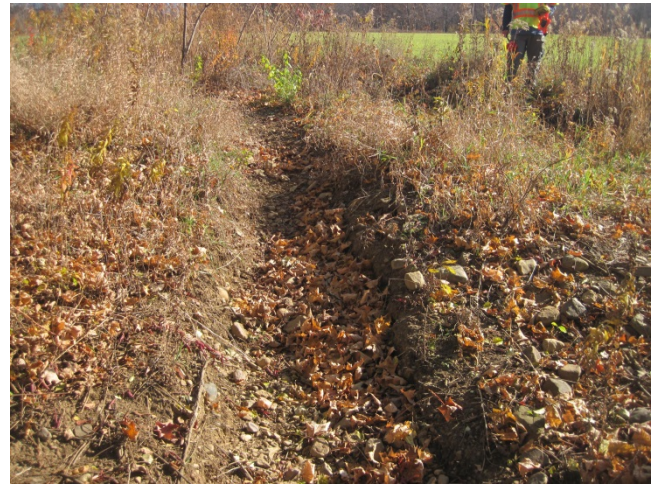
The most severe erosion area near the horsepath has a drainage area of 0.4 acres. The other two locations have varying drainage patterns based on current ruts in the field.

Figure 5: Erosion is actively occurring along the horsepath and in the adjacent swale (hidden in vegetation).

1. Continue to allow water leaving the culverts under Byington Road to flow overland in sheet flow.
2. Improve the horsepath entrance area with buried logs and check dams.
3. Improve rill erosion areas with check dams and increased vegetative buffer to prevent further gully formation.

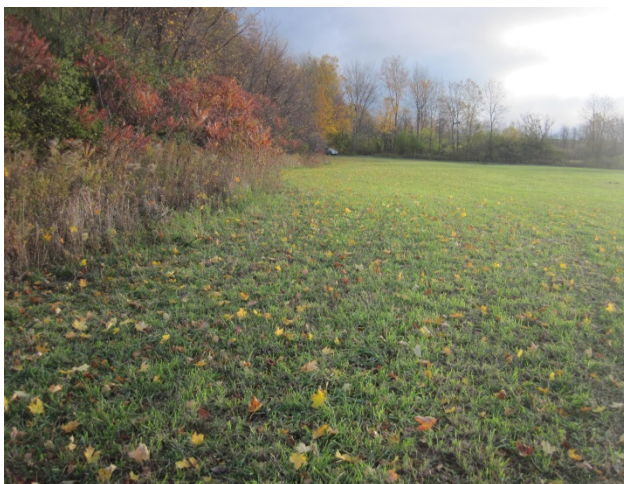
Figure 3: Looking east across the field along the north brushline.

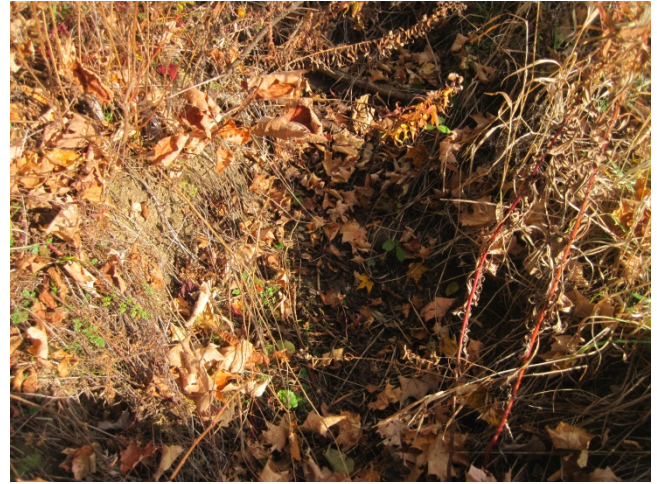
Figure 6: Active erosion in the swale adjacent to the horsepath, partially hidden by vegetation.

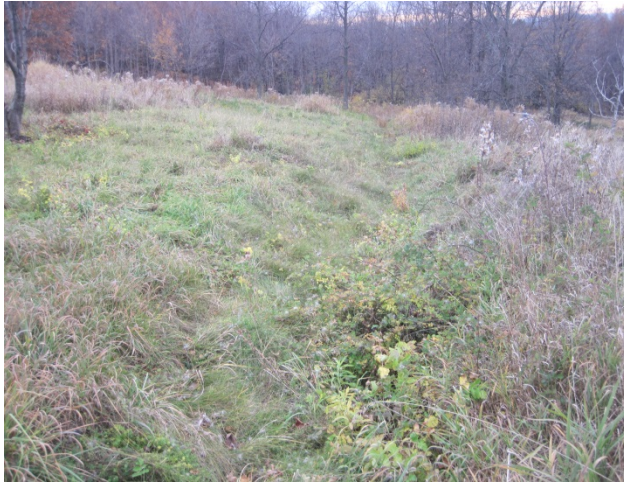
The cross-slope swale parallel to Byington Trail collects runoff from 2.1 acres and is now experiencing erosion. This swale drains to the southwest discharging to a headwater tributary of the Holmes Brook. Just before entering the Holmes Brook tributary, the runoff in the swale runs through a small historic farm junkyard of mostly metal.

Figure 7: Looking northeast along a cross-slope swale running parallel to the Byington Trail.

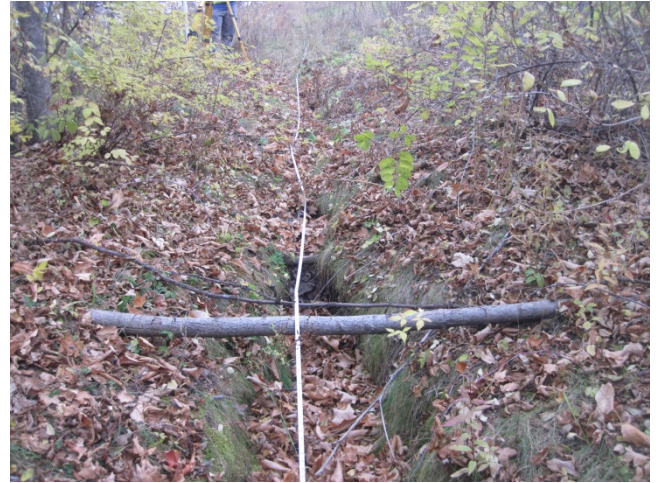
The downstream end of the cross-slope swale has eroded where an active headcut is forming. Active erosion in the swale is approximately 75 feet long, between 8 and 18 inches deep, and up to 1.5 feet wide.

Figure 10: Active gully erosion is occurring near where the cross-slope swale meets the stream.

1. Arrest gully erosion and headcutting before it worsens using applications of log structures and vegetation.

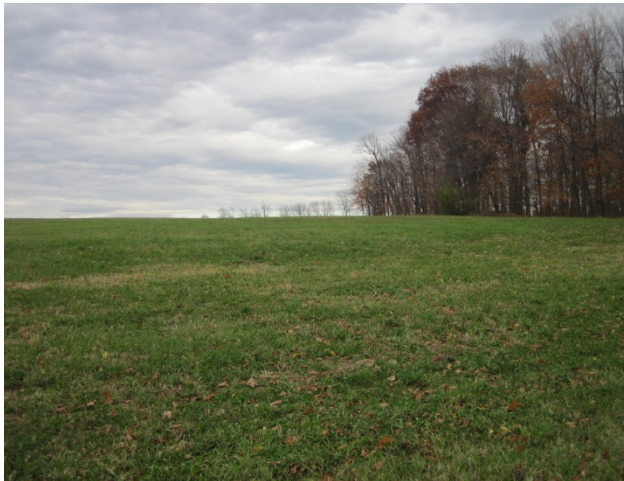
Figure 8: Looking east across the upper field that drains to the cross-slope swale.

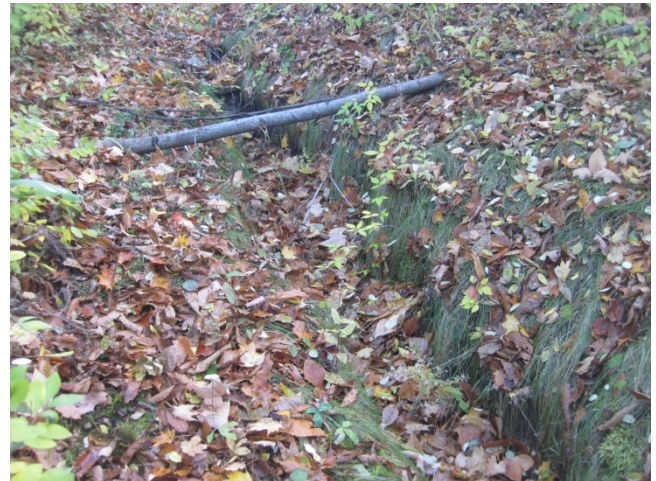
Figure 11: Active gully erosion in the cross-slope swale, partially hidden by vegetation.

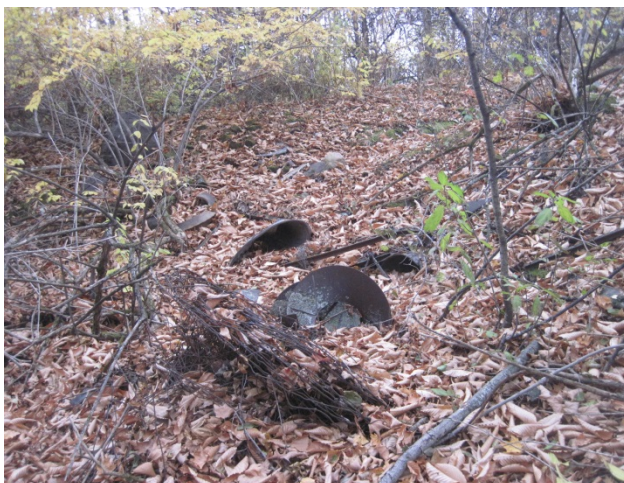
Figure 9: A small farm dump is located where the swale meets the stream.

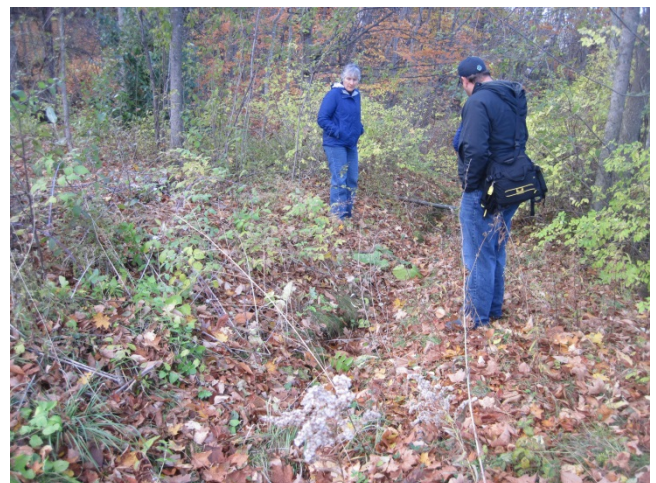
Figure 12: Gully erosion is migrating farther to the northeast along the swale (between the two people).
