**LaPlatte River Phase 2 Stream Geomorphic Assessment:
Hinesburg Reaches**

**Prepared by the LaPlatte Watershed Partnership
February, 2006**

LaPlatte River Phase 2 Stream Geomorphic Assessment: Hinesburg Reaches

Prepared by the LaPlatte Watershed Partnership

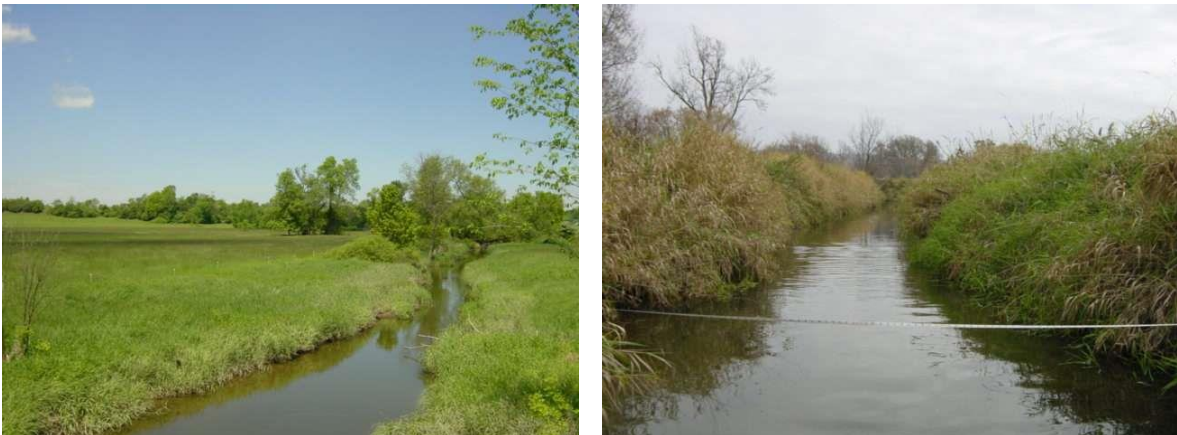
Historical channel alteration appeared to have affected many of the reaches in Hinesburg. Straightening of streams in the valleys and ditching and draining wetlands allowed for increased tillable land for agriculture. Along with this came reduction or elimination of woody riparian vegetation (Figure 3). These activities reduced geomorphic and habitat conditions in many of the valley reaches, and in some cases have led to extreme adjustment or stream type departure (M17, T5.01D). Elsewhere in the valley (M12, M13, M14, and M15a) the channel does not appear to have been straightened, although riparian vegetation is still lacking.

Figure 3. Straightening and lack of woody riparian vegetation affected RGA and RHA condition in Hinesburg.

Eroding banks were common in the valley reaches, as the channel experienced adjustment to regain sinuosity. However, clay soils appeared to be slowing erosion, as little channel migration was observed since channel straightening occurred (est. 1930s).

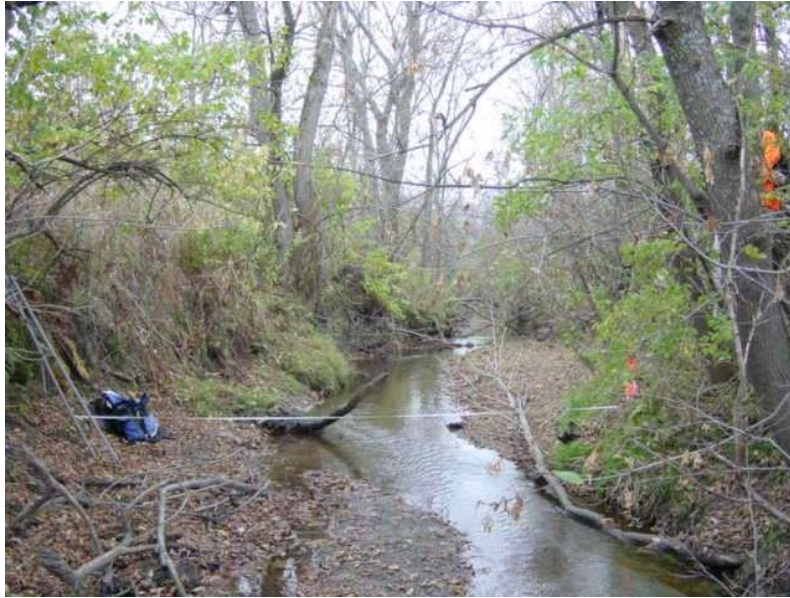
Straightening combined with berming on M17 and T5.01D resulted in severe channel departure from reference. Reach M17 experienced a stream type departure (C to B) and currently appeared to be widening and aggrading, attempting to gain some floodplain and sinuosity in its incised and entrenched position (Figure 4).

Figure 4. Reach M17, entrenched and now widening and aggrading.

Reaches M14, M15, M16 and M17 had degraded and lost floodplain access (stage II of the F process), likely from straightening and berming activities. Now, they appeared to be in stage III of the F-stage process, widening and aggrading and attempting to regain some sinuosity (Figure 4).

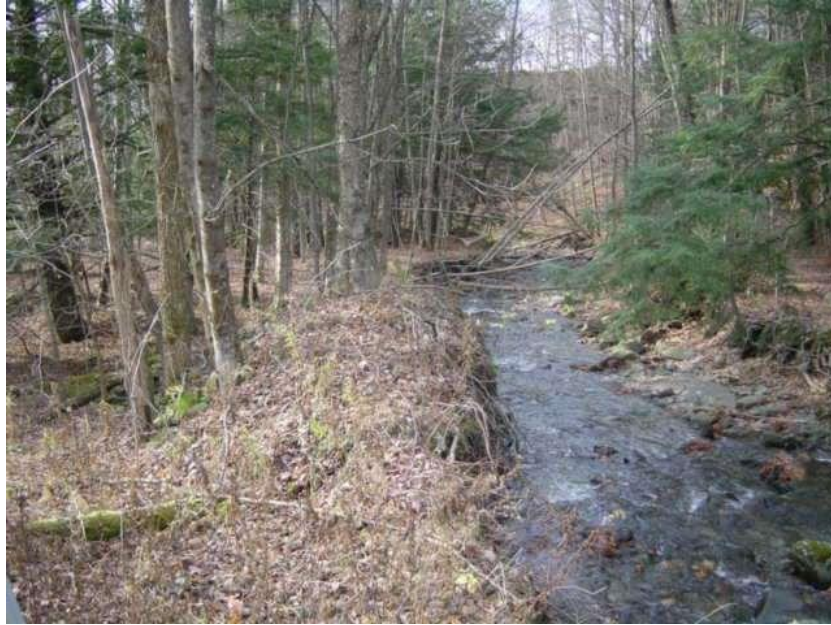
Segment T5.01D had been straightened, moved, and bermed historically, likely in conjunction with construction of North Road. Following the channel alteration, the stream had no access to floodplain and appears to have severely widened and incised. Continued incision and widening (channel enlargement) were evident in headcuts and scoured banks (Figure 5), leaving property at risk. This segment had ledge grade controls at both the upstream and downstream ends, helping confine these adjustments to this area.

Figure 5a. Signs of an old channel were evident to the left of the photo. The channel appeared to have been moved to its current location and held in place by a berm, seen in the center of the photo.

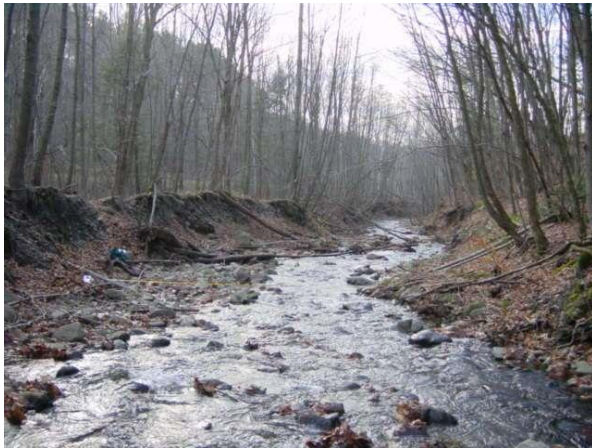
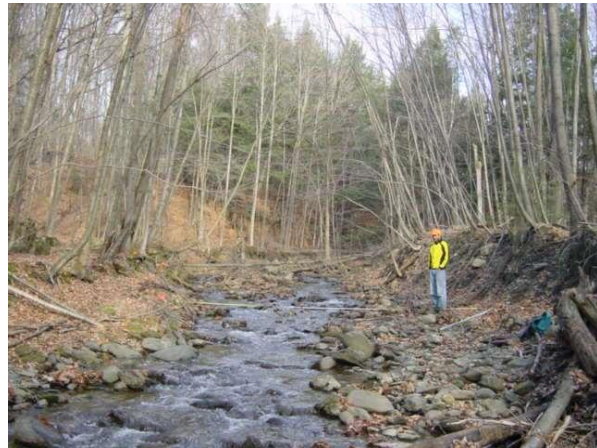
Figure 5b. Significant channel enlargement following straightening and berming.

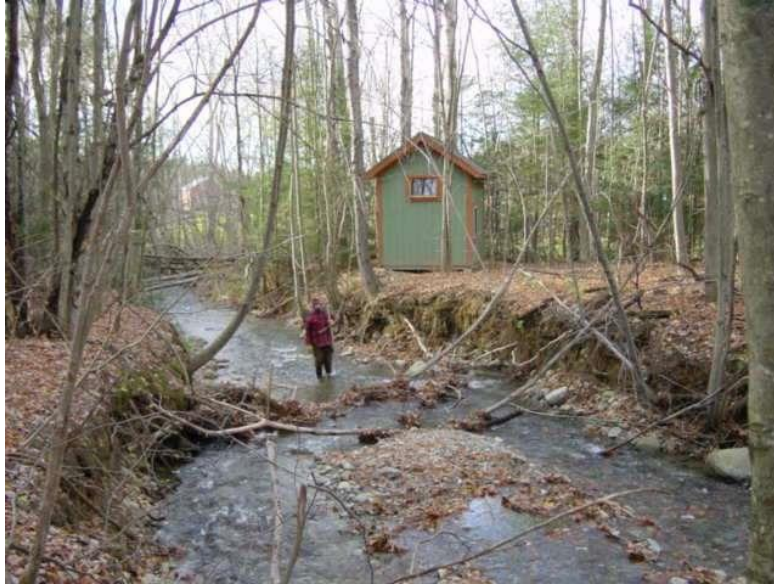
Figure 5c. Channel enlargement leaving investments in danger.

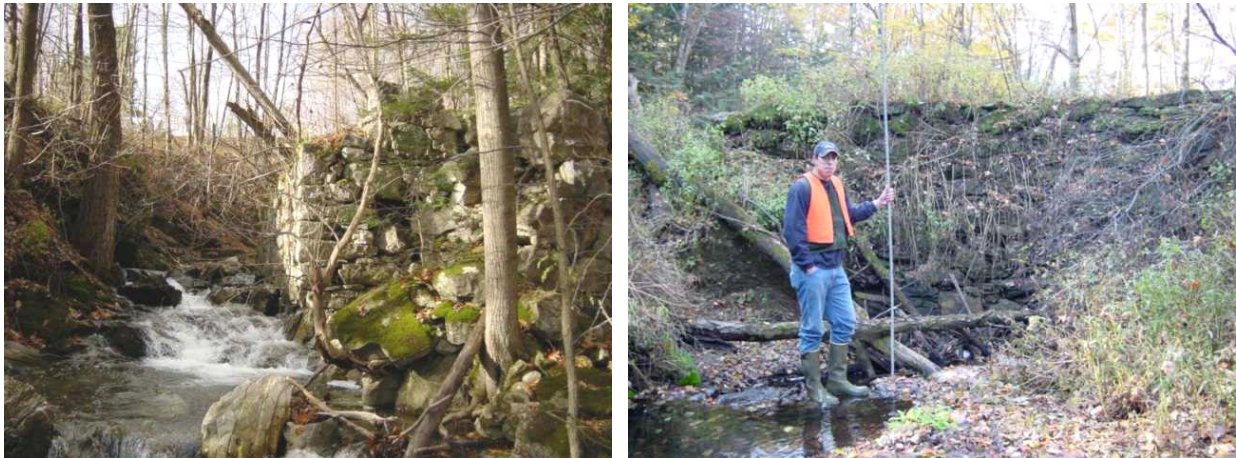
Other factors affecting geomorphic and habitat condition in Hinesburg were structures obstructing or constricting of the channel. Historical structures included milldams and footings on the steeper reaches of Patrick Brook and Beecher Hill Brook. Many of these structures were in part still existing (Figure 6).

Figure 6. Mill footing on Beecher Hill Brook T5.01C (left) and mill dam on Patrick Brook T4.04 (right).

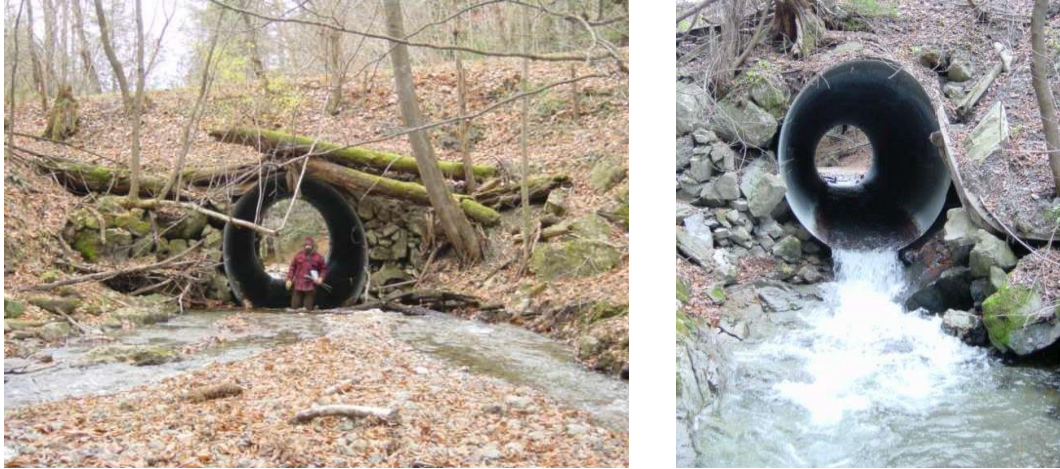
More recent channel constrictions included undersized bridges and culverts. These structures blocked the free passage of water, sediment and organic debris, and resulted in flooding of land,

severe aggradation of the channel and floodplain, and severe degradation downstream. Two examples are the culvert on Beecher Hill Road in segment T5.01B (Figure 7) and the culvert crossing Route 116 in segment M18B (Figure 8).

Figure 7. Beecher Hill Brook (T5.01B) culvert. Note aggradation forming bars and splitting flow upstream. Some erosion was noted downstream, although the downstream end falls onto ledge and boulders.

Undersized bridges and culverts, and those poorly aligned with stream channels, have resulted in erosion, aggradation, outflanking, loss or damage of infrastructure and personal property, reduced wildlife passage, backup of flood waters, reduction of floodplain function, and debris jam catchers. As bridges and culverts require replacement, sizing new structures according to bankfull and floodprone widths and placing them in proper alignment with stream channels could alleviate these problems.

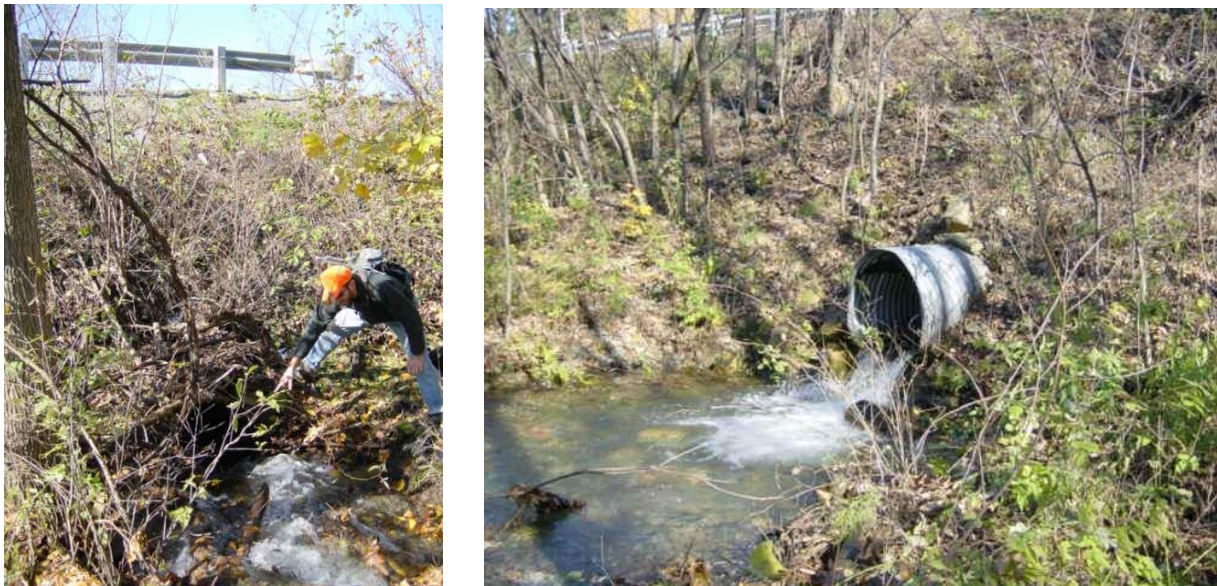
Figure 8a. Culvert on segment M18B. The upstream end of the culvert was blocked by sediment and debris and was hardly visible (left). Extreme scour was apparent at the downstream end and beyond (right).

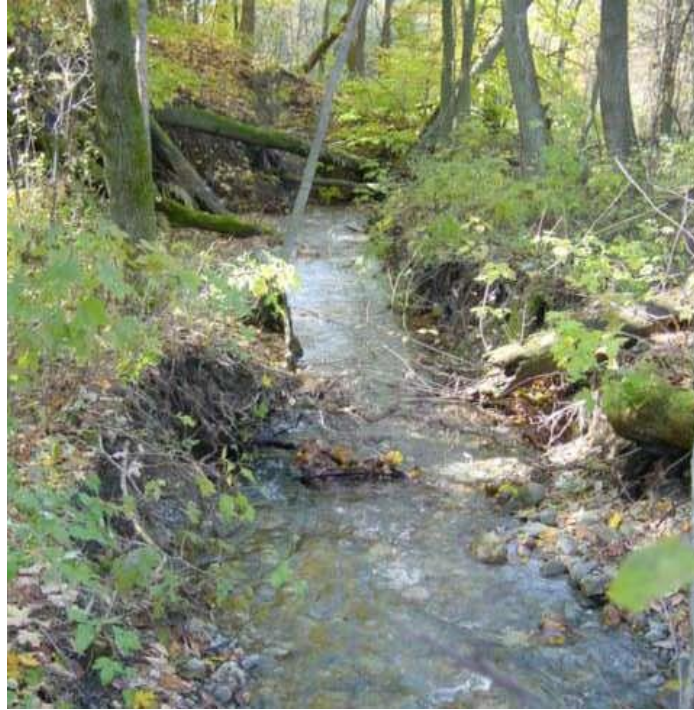
Figure 8b. Extreme effects of constricting the channel and blocking flow of sediment has led to property damage with aggradation upstream and erosion downstream.

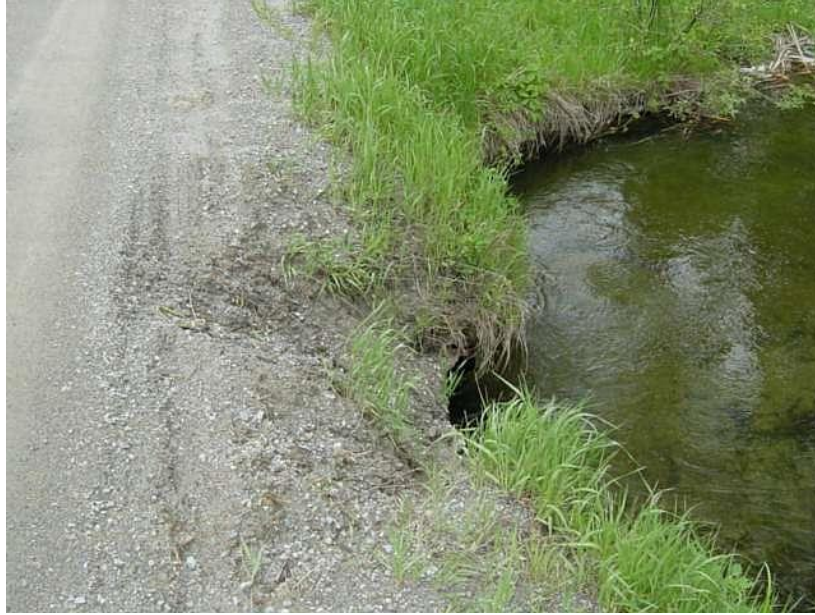
Runoff from roads and road washouts during storms also appeared to be a source of increased sediment in the streams (Figure 9). Driveways and roads had essentially dammed floodplains and channeled runoff directly to streams, which was especially evident in hill reaches. Exposed soil from incremental development in the watershed was another source of sediment to stream channels.

Figure 9. Sand and gravel from roads washing into the channel.

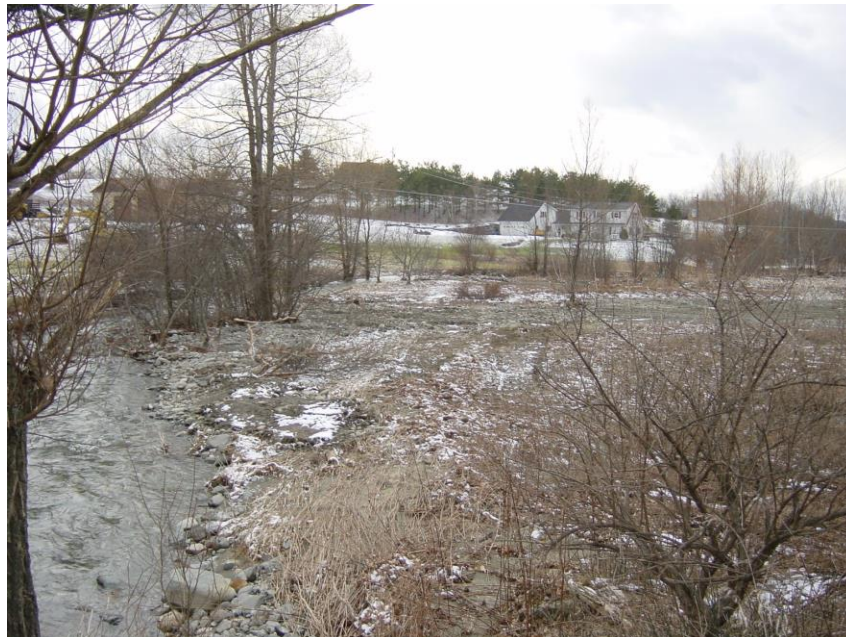
Some vital flow and sediment attenuation zones were being filled and bermed as on T5.01D (Figure 10) and M17.

Figure 10. Floodplain fill replaced after January 18, 2006 storm flows, reducing sediment and flow attenuation in this area, which was between 2 degrading areas.
