**WATER QUALITY PLANNING ON THORP AND KIMBALL BROOKS  
CHARLOTTE AND FERRISBURG, VERMONT**

February 1, 2010

MMI #3542-07

Lewis Creek Association  
Charlotte, Vermont

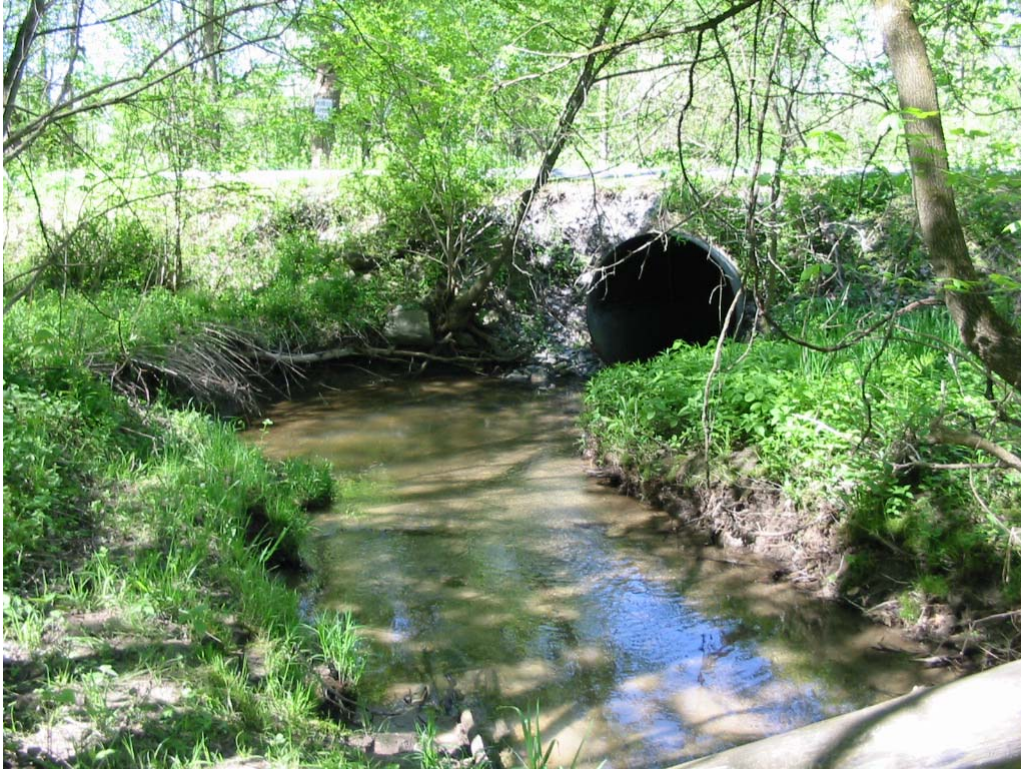
Figure 3a: Kimball Brook upstream of Greenbush Road (Source: MMI, May 7, 2010).

- The small pasture adjacent to the channel upstream of Greenbush Road has disturbed ground, a steep slope, and no buffer.

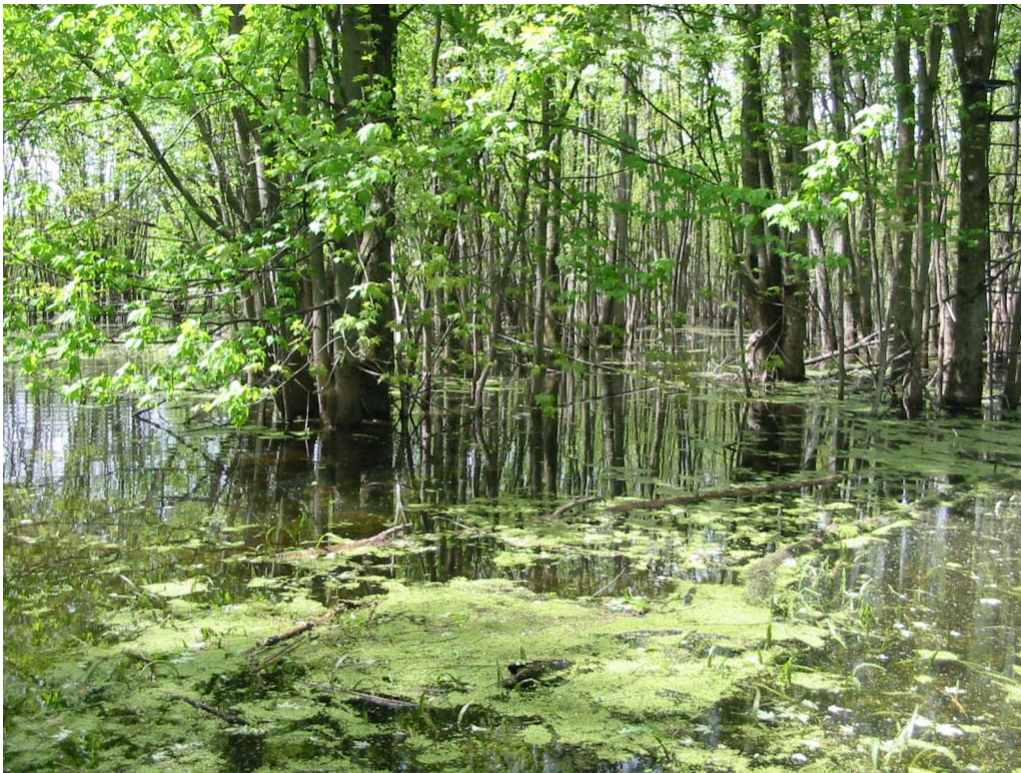
Figure 3b: Kimball Brook at the Lake Champlain floodplain forest (Source: MMI, May 7, 2010).

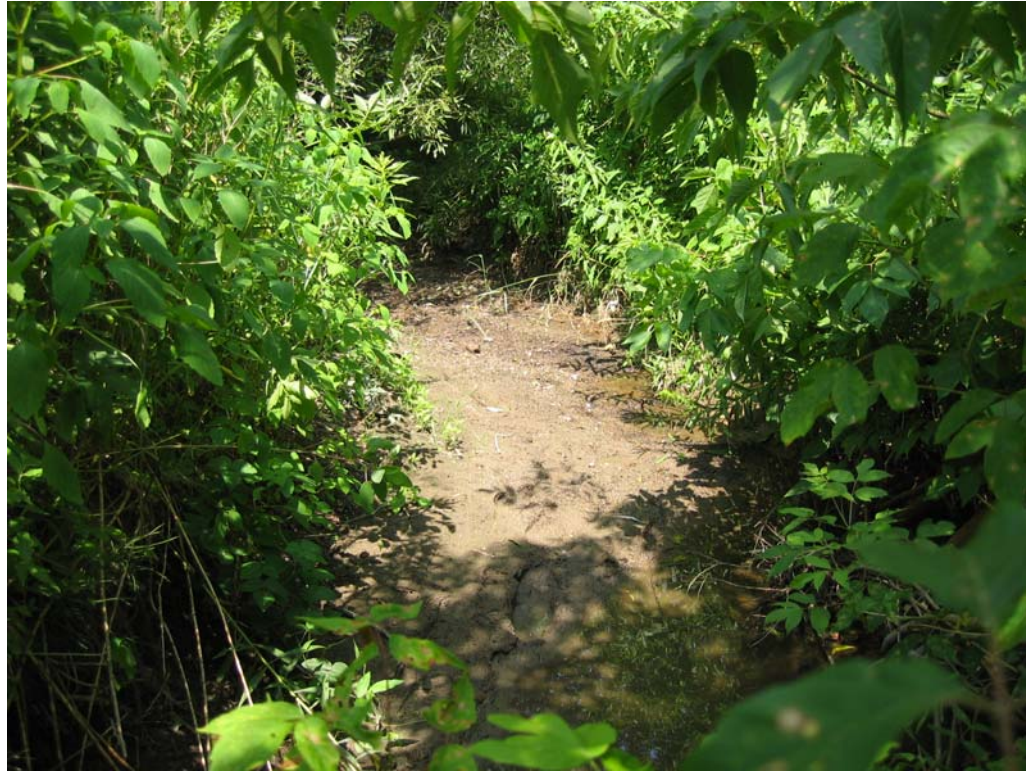
Figure 4: Kimball Brook with mostly dry streambed near Kimball Brook Farm manure pit. (Source: MMI, July 13, 2010).

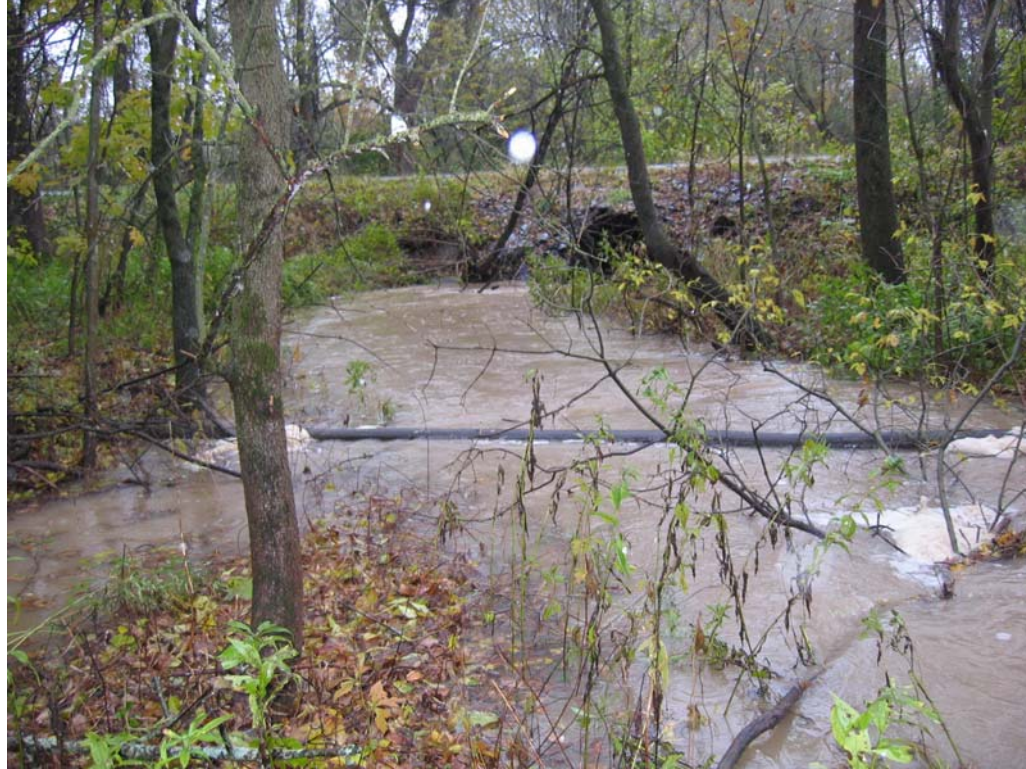
Figure 5: High flows in Kimball Brook upstream of Greenbush Road culvert on (Source: MMI, October 15, 2010).

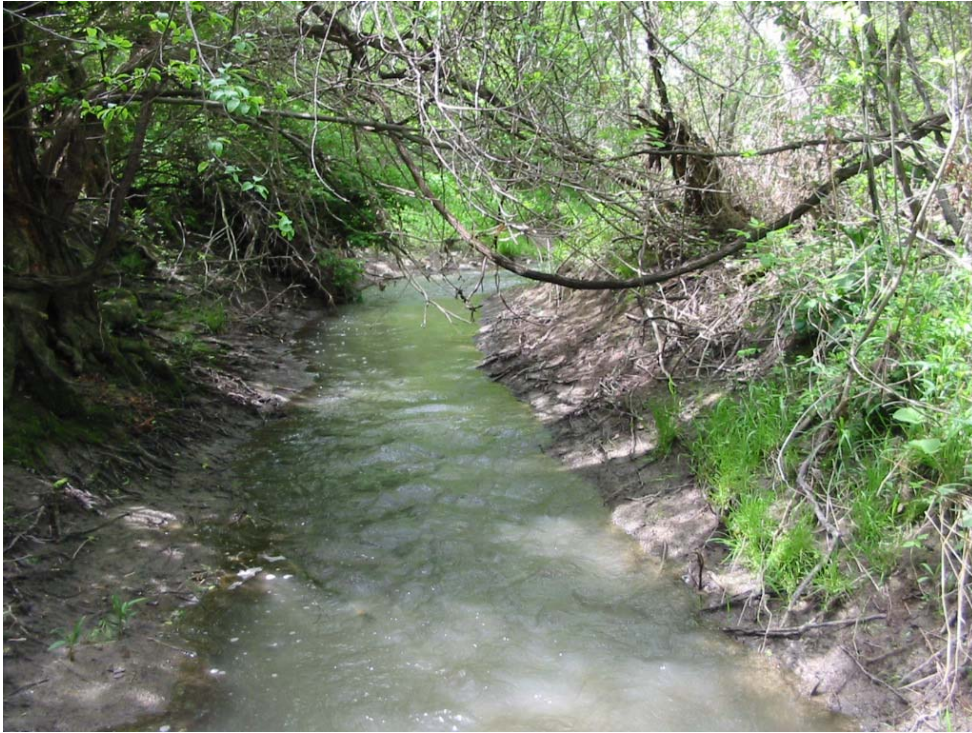
Figure 7a: Thorp Brook just downstream of the Greenbush Road Culvert looking downstream (Source: MMI, May 7, 2010).

Water quality impacts possible on the walked stream segment is the inputs from the mowed lawn upstream of Greenbush Road, drainage along the roadway itself, and the undersized culvert possibly leading to excessive local erosion. A vegetated buffer exists around the brook over much of the observed area. The main sources of nutrient loading to Thorp Brook are located upstream of Greenbush Road.

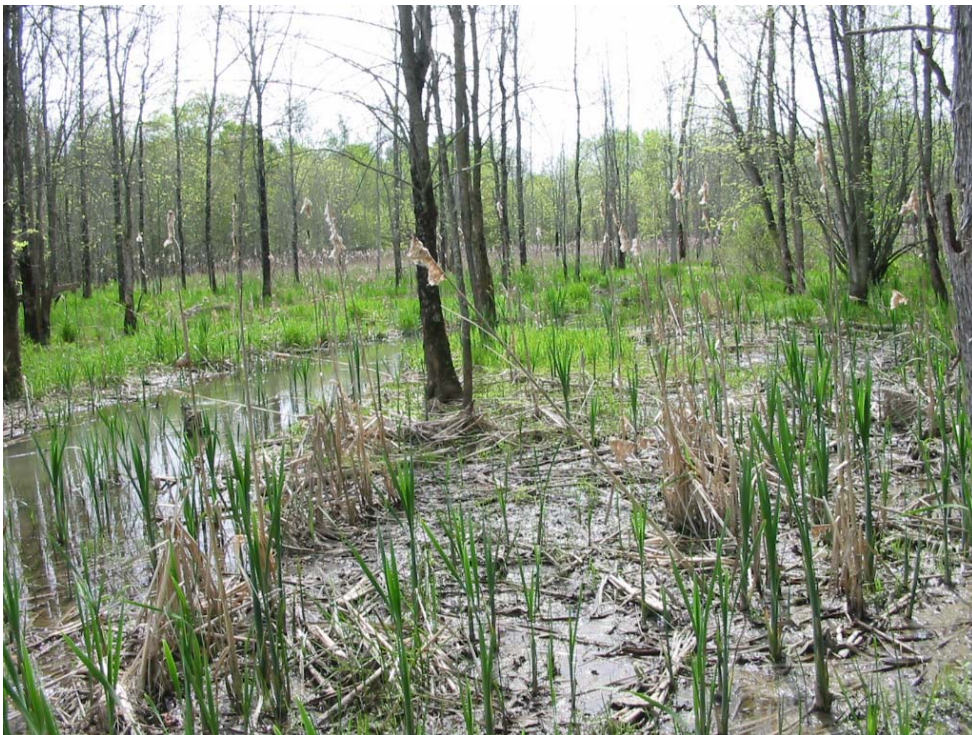
Figure 7b: Thorp Brook at beginning of lake influence downstream of the railroad crossing (Source: MMI, May 7, 2010).

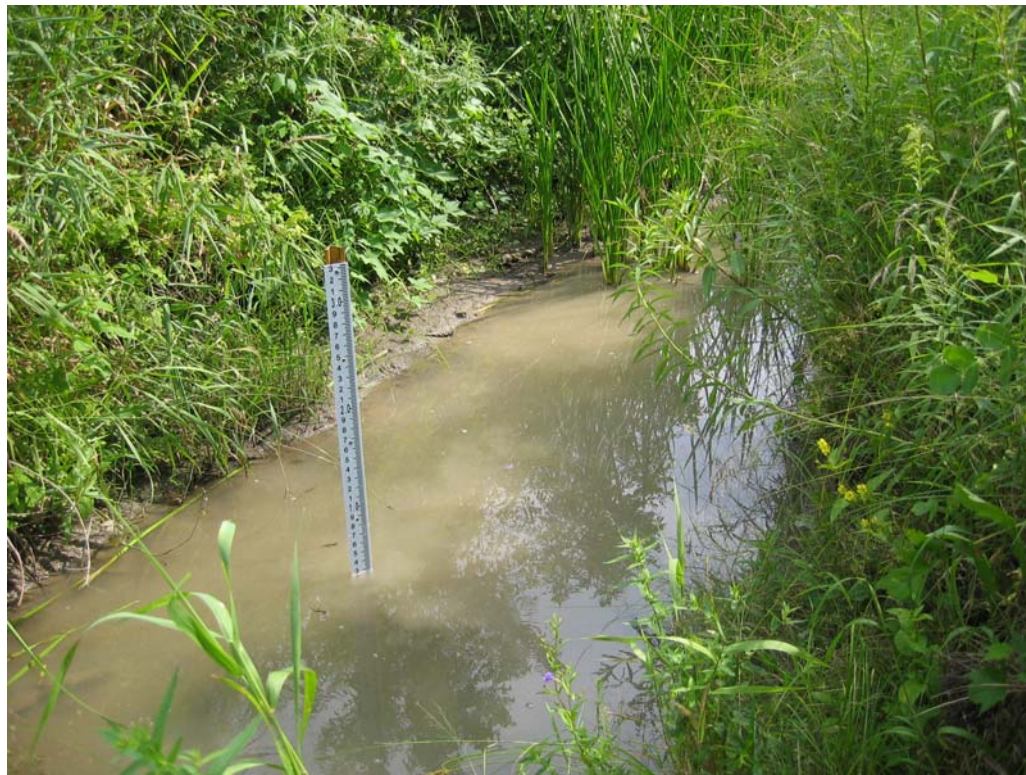
Flow in Thorp Brook was extremely low during the dry summer of 2010 (Figure 8). The brook was observed on July 13 and August 10 at select locations. Flow was very low, almost non-existent.

Figure 8: Thorp Brook at low flow on (Source: MMI, July 13, 2010).

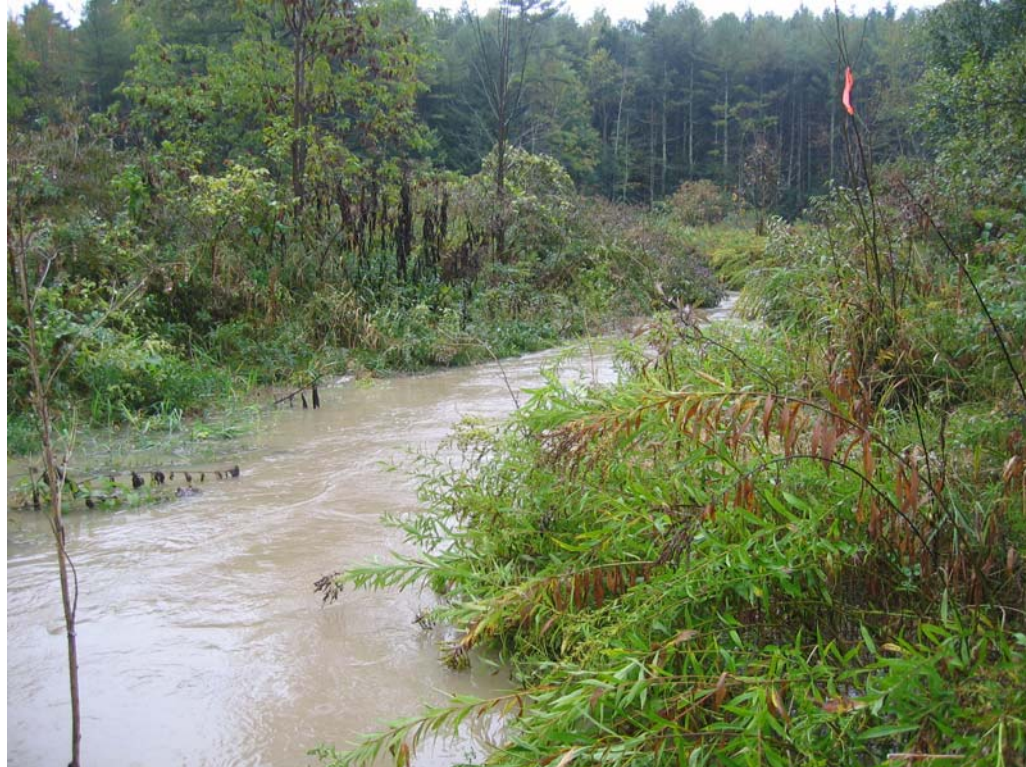
Figure 9: High flows at the Thorp Brook staff gauge location, looking downstream (Source: MMI, October 1, 2010).
