AHEAD OF THE STORM

Site: Charlotte Library

Location: Ferry Road, Charlotte, Vermont

Ahead of the Storm
Existing Conditions Photo Documentation Summary
Charlotte Library

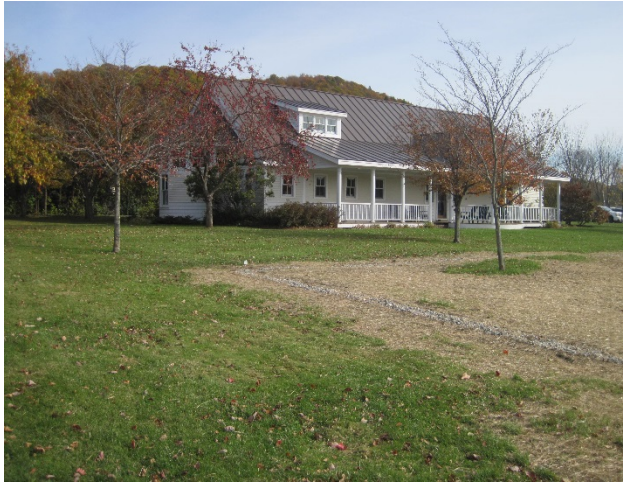
Currently runoff from the existing library building, parking lot, driveway, and sidewalk flows overland off site to either a swale across the driveway or a newly installed trench drain on the Village Green (Figure 1). This project will increase treatment of stormwater runoff leaving the site via overland flow. There are no reported stormwater related issues at the site.

Figure 1: Library existing building, looking across Green. Newly installed gravel perimeter trench drain visible.

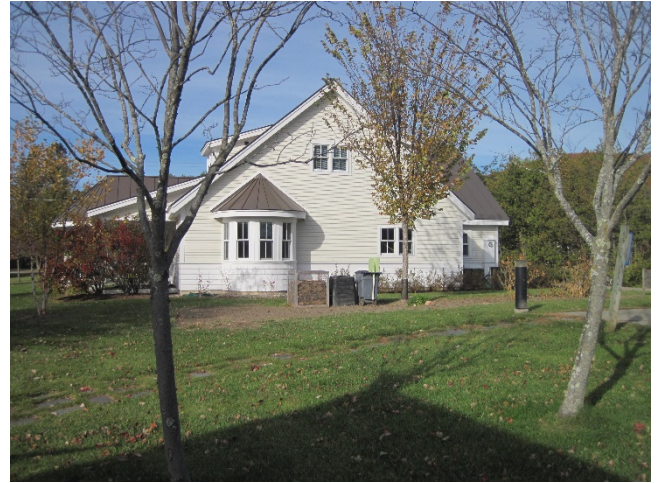
Figure 3: South end of library building. Existing gardens in foreground could be watered using collected rainwater.

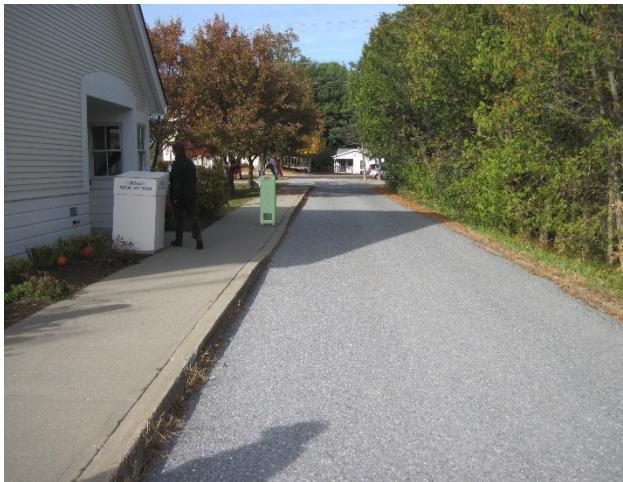
A vegetated swale runs along the east side of the property, carrying water south. Runoff from the east half of the property drains across the driveway to this swale. This swale has thick vegetation. The swale discharges to the south and eventually water enters the Thorp Brook headwater reach (Vermont Geomorphic Assessment Reach T8.05).

Figure 2: Library entrance driveway. Existing site runoff sheet flows across driveway to swale on other side in bushes.

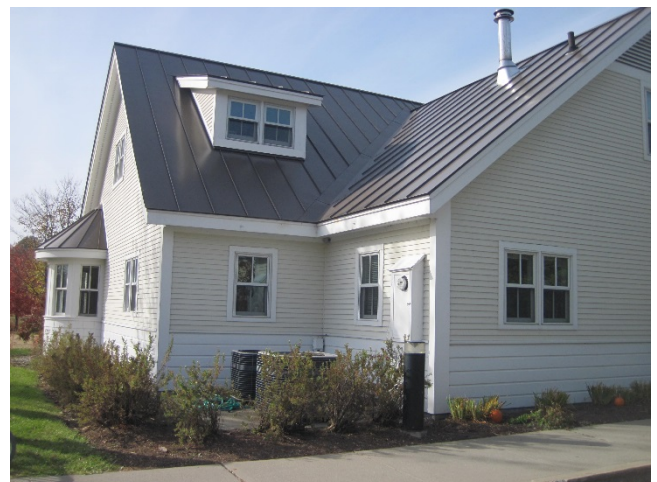
Figure 4: Potential location of new gutter, downspout, and rainbarrel to be used for garden watering.

INSTALL ~20 FEET GUTTER, DOWNSPOUT, AND ICE BARS

INSTALL 360 GALLON RAIN BARREL, SEE DETAIL

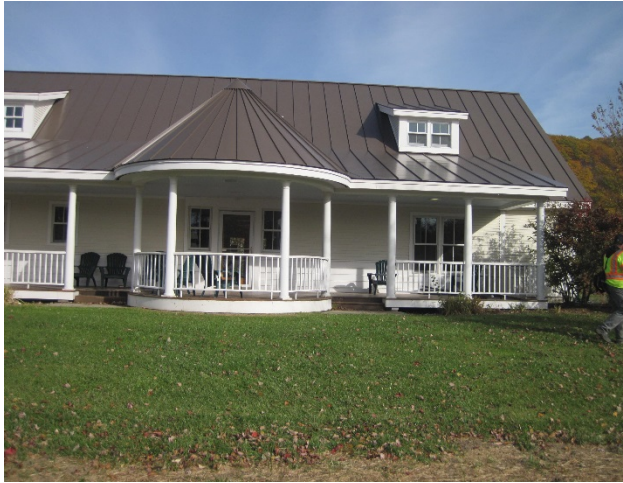
Figure 5: West side of the library. Roof runoff currently falls off roof and travels overland into the Green.

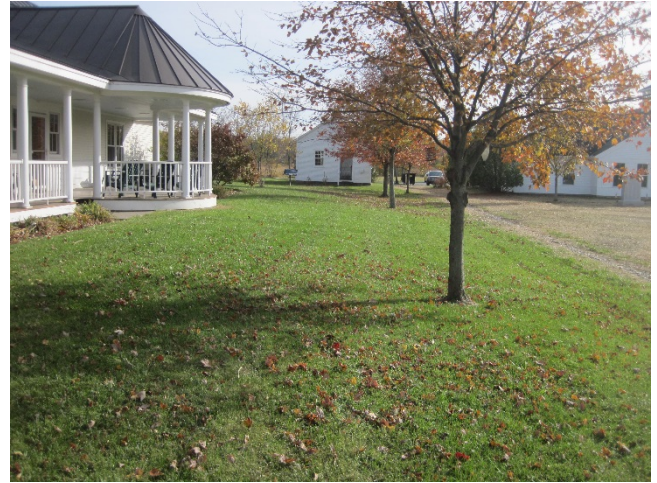
Figure 7: Possible location of bio-retention area between two trees in existing lawn area.

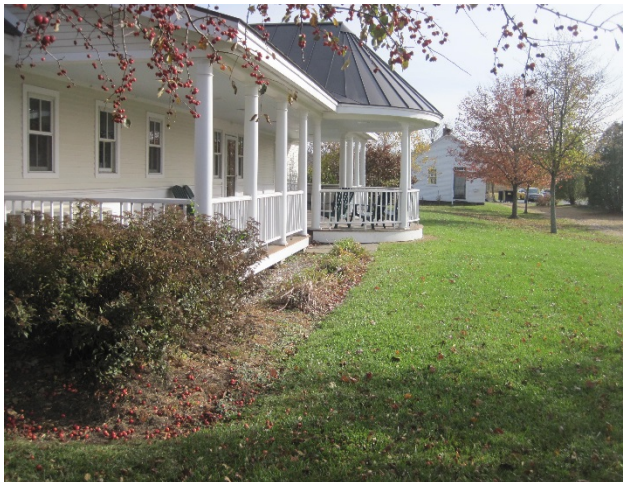
Figure 6: Possible location of bio-retention area to west of building, at location of existing planted bed.

CREATE BIO-RETENTION AREAS ALONG EXISTING FLOWER BEDS (SEE DETAIL)
 DEPTH ~ 6 INCHES
 AREA ~ 136 SQUARE FEET
 VOLUME ~ 129 CUBIC FEET

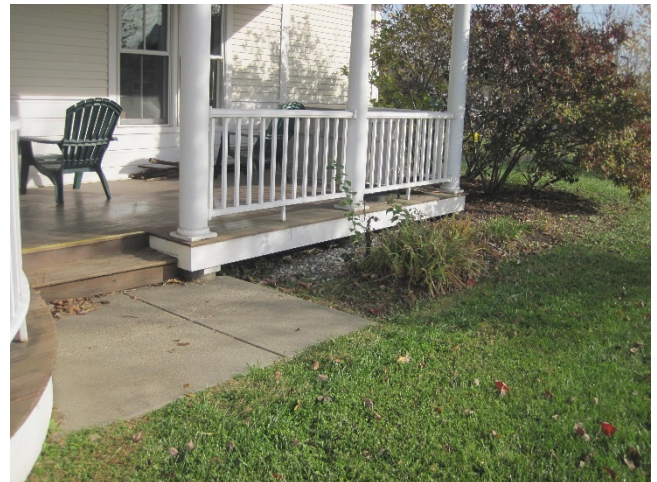
Figure 8: Possible location of bio-retention area to west of building, at location of existing planted bed.
