AHEAD OF THE STORM

Site: Charlotte Senior Center

Location: 212 Ferry Road, Charlotte, Vermont

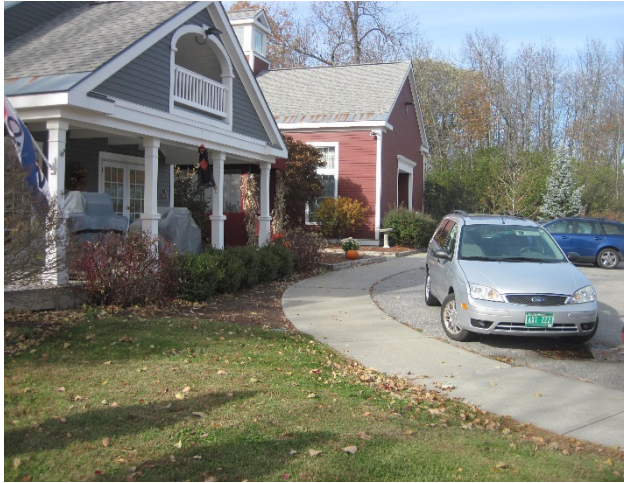
Figure 1: Senior Center existing building and front driveway area.

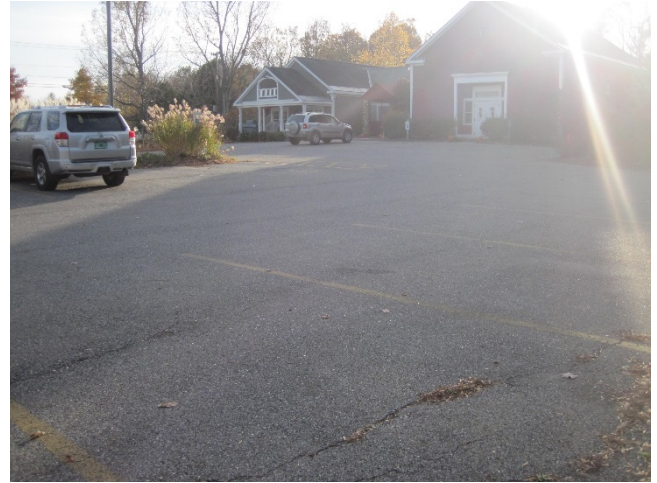
Runoff from most of the entrance drive, parking lot, sidewalks, and front lawn area drain to stormwater catchbasins and is piped to the swale along the north edge of the property. This collection system consolidates runoff from most of the impervious surface, except the building. Drainage area to the pipe system includes 0.8 acres, 61% of which is impervious surface. This drainage system receives a large amount of salt and sand runoff from the parking area in the winter time due to extra heavy application.

Figure 3: Parking lot draining to catch basins at the east side of the property.

1. Install a hydrodynamic separator at the end of the pipe collection system to treat parking lot runoff by removing sediment and pollutants.
2. Create a bio-retention area between the driveway and fire department to slow runoff and increase storage capacity. This will provide pre-treatment to the hydrodynamic separator.
3. Improve the swale by increasing vegetation and provide inline detention using check dams in order to reduce erosion, filter runoff, and retain sediment entering the site from upstream.

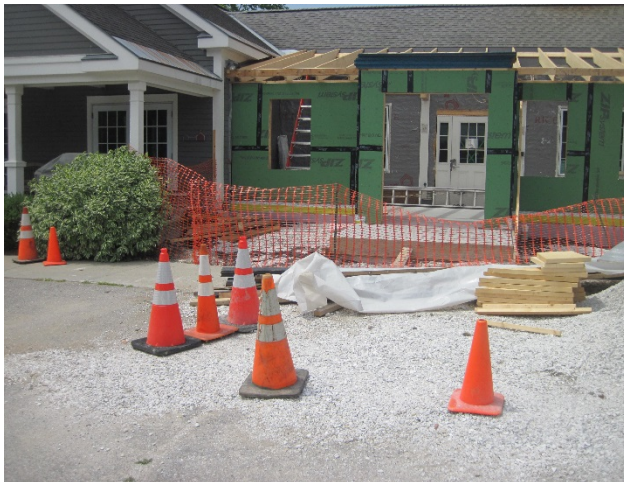
Figure 2: Senior Center existing entryway, in process of being expanded.

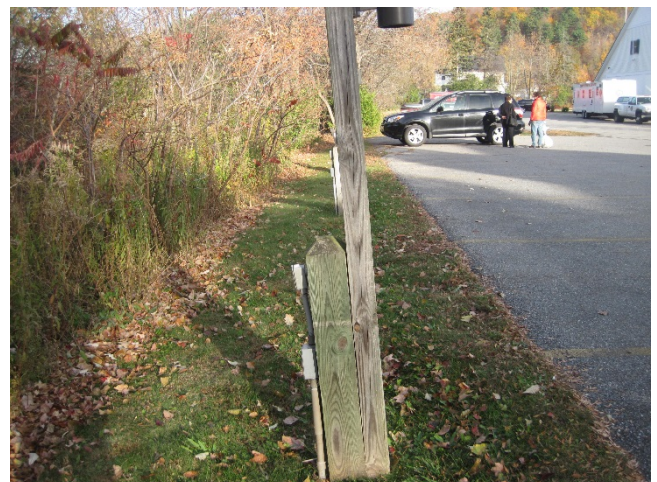
Figure 4: Looking along the swale at the northern edge of the property and parking.

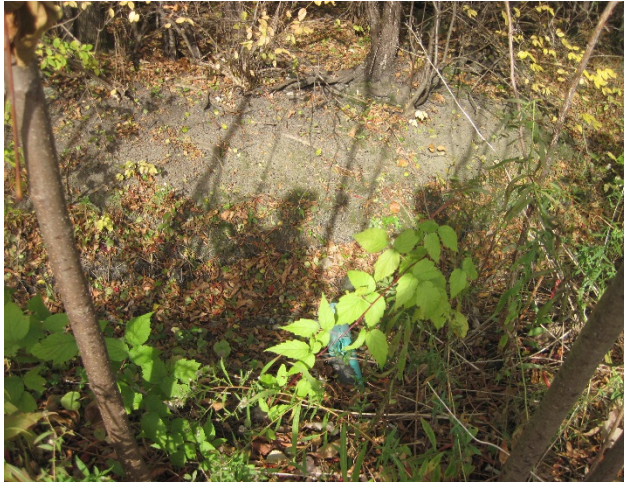
The swale along the north side of the property drains east to the adjacent parcel. This swale is partially vegetated with steep banks with active erosion. There is a narrow natural vegetated buffer along this swale between the adjacent lawn or parking lot. This swale also collects runoff from the adjacent properties to the west on Greenbush Road, for a total drainage area of 2.6 acres at the east end of the property. This swale travels east to a pond behind the Fire Station and then flows north to Pringle Brook, a tributary of Holmes Creek.

Figure 5: Swale at the north side of the property with some erosion visible.

REVEGETATE SWALE AND APPLY EROSION CONTROL BLANKET (SEE DETAIL)

INSTALL STONE CHECK DAMS ALONG ERODING SWALE (SEE DETAIL)

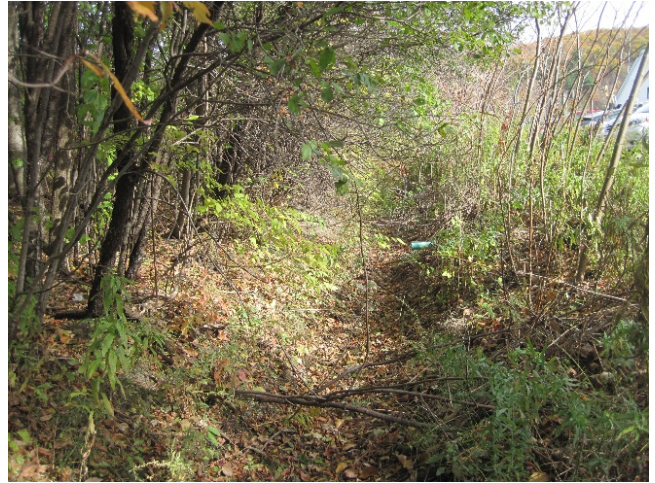
Figure 7: Swale at the north side of property, with some erosion visible.

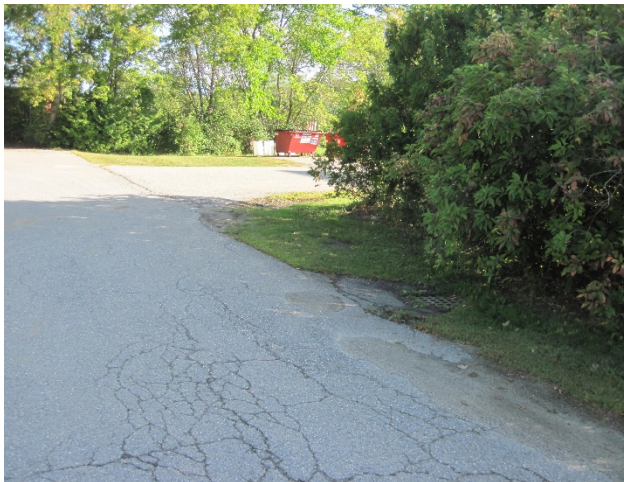
Figure 6: Possible location of bio-retention area between the driveway and fire department.

CREATE BIO-RETENTION AREA AROUND EXISTING CATCH BASIN (SEE DETAIL)
DA = 0.4 ACRES
DEPTH ~ 1 FOOT
AREA ~ 650 SQUARE FEET
VOLUME ~ 510 CUBIC FEET

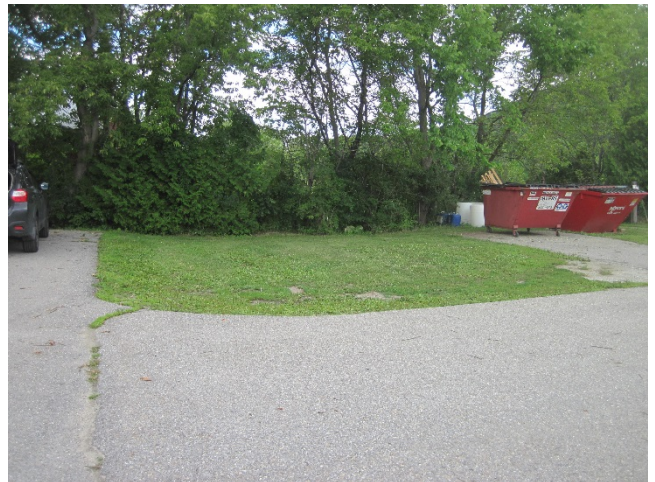
Figure 8: Possible location of hydrodynamic separator (underground) at north-east side of property.

INSTALL HYDRODYNAMIC SEPARATOR ALONG EXISTING PIPE (SEE DETAIL)
DA = 0.8 ACRES
IMPERVIOUS COVER = 94%
WQ FLOW = 0.4 CFS
10-YEAR FLOW = 2.9 CFS
