AHEAD OF THE STORM Site: Du Brul Residence Location: 845 Greenbush Road, Charlotte, Vermont

AHEAD OF THE STORM Existing Conditions Site Summary Site: Du Brul Residence

Ahead of the Storm Existing Conditions Photo Documentation Summary Du Brul Residence

BALLPARK OPINION OF PROBABLE COST DU BRUL RESIDENCE - 845 GREENBUSH ROAD <u>AHEAD OF THE STORM</u> Charlotte, Vermont

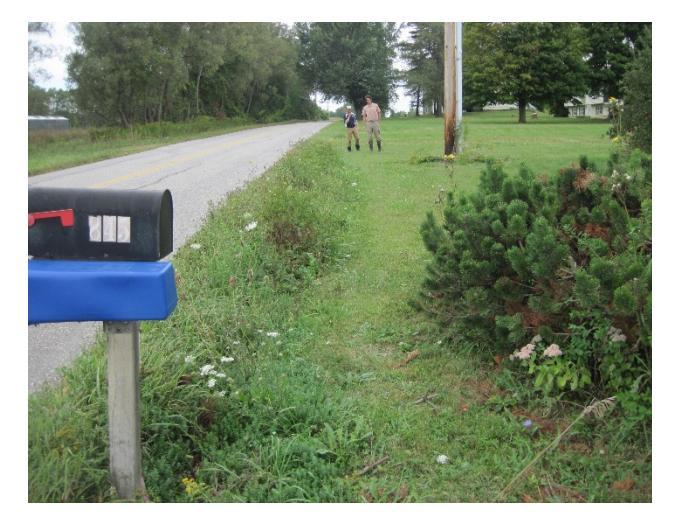
Figure 1: Runoff from road and adjacent property flows toward the Du Brul property along the road.

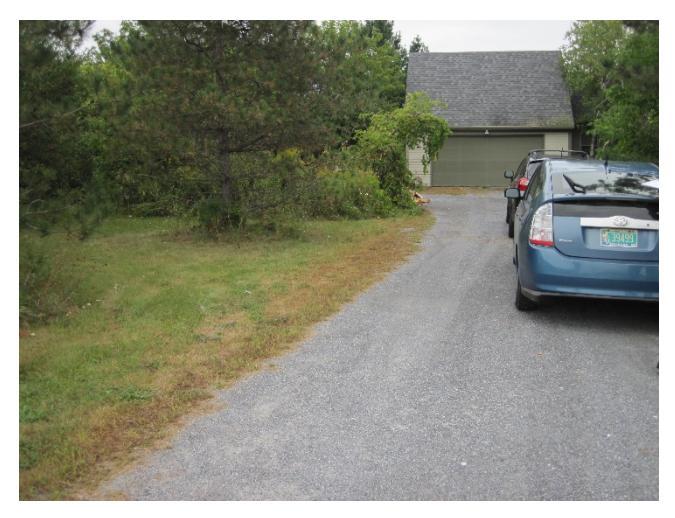
Figure 3: The driveway is low and sloped toward the house, so some water flows towards the house and garage.

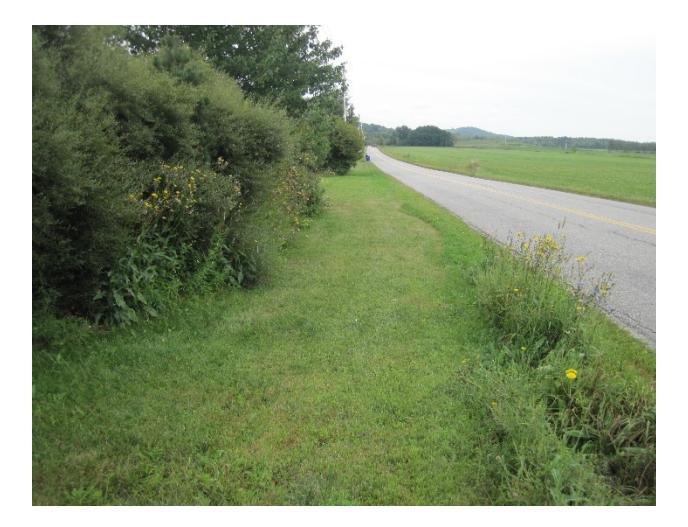
Figure 2: In front of the Du Brul residence, some water continues down swale along the road.

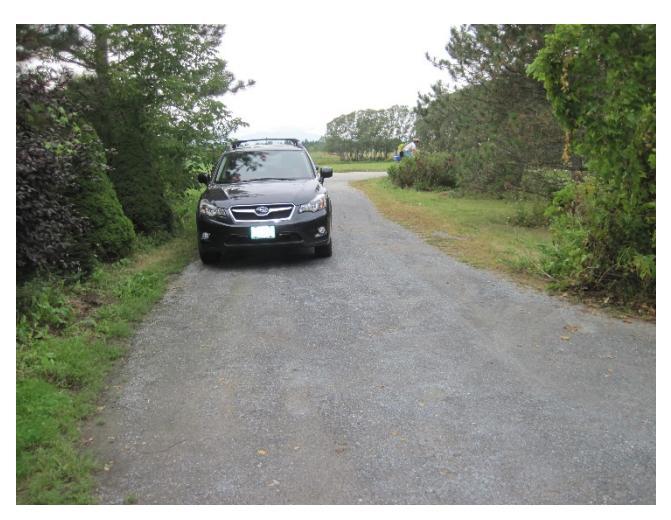
Figure 4: The driveway slopes toward the house.

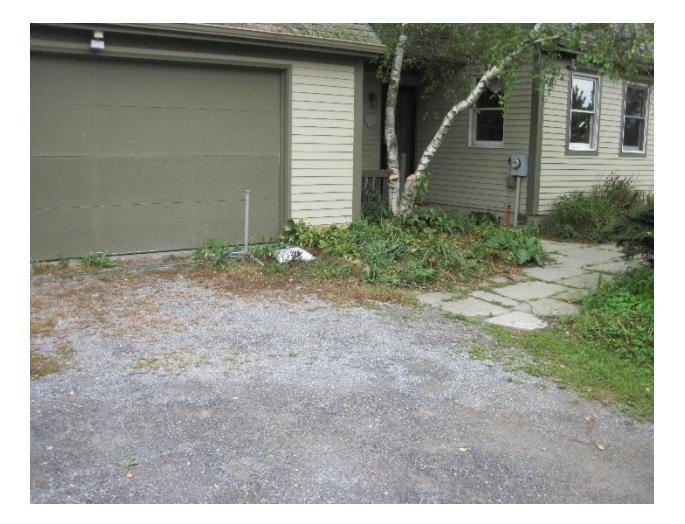
Figure 5: A low spot is located in front of the house and garage.

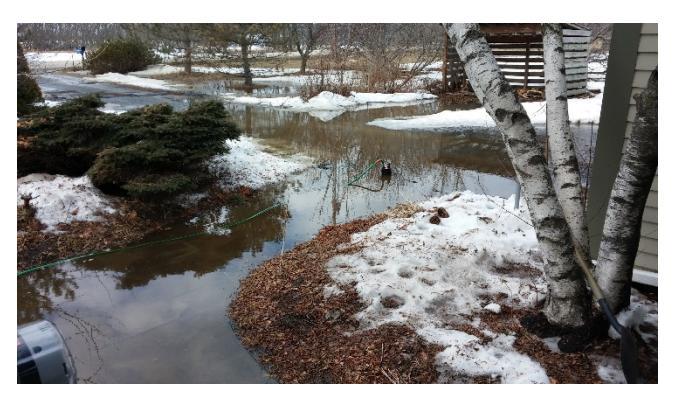
Figure 7: Water puddles in front of the home.

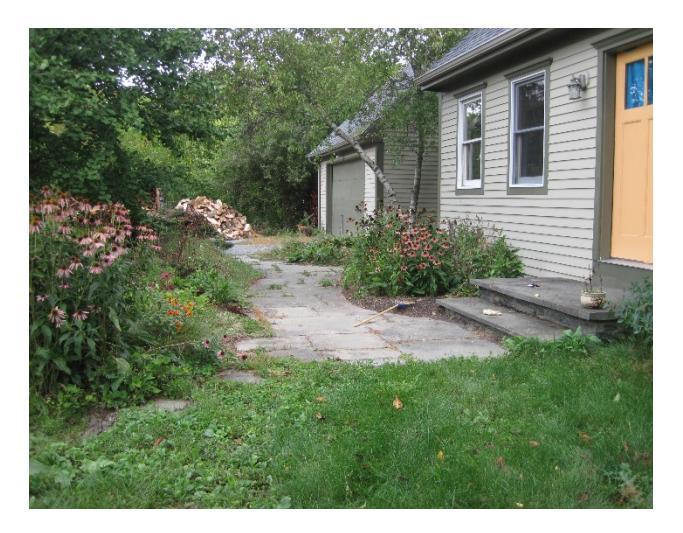
Figure 6: The ground in front of the entryway is low.

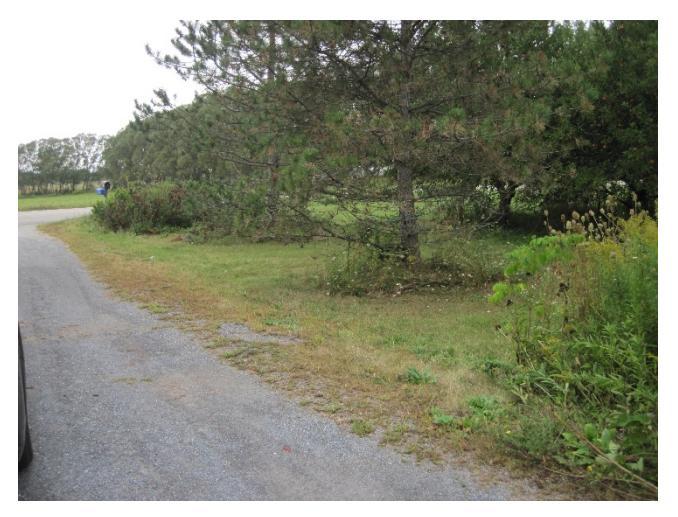
Figure 8: A possible bio-retention area has been identified for the area adjacent to the driveway.

- 1. Create a bio-retention area on the north side of the driveway to capture runoff and direct the overflow due east into the backyard, away from the house and garage. Complete stormwater calculations to complete the concept design by others.
- 2. Elevate and grade the driveway to drain into the new bio-retention area and away from the house.
