AHEAD OF THE STORM

Site: Horsford Gardens & Nursery

Location: Greenbush Road, Charlotte, Vermont

Ahead of the Storm
Existing Conditions Photo Documentation Summary
Horsford Gardens & Nursery

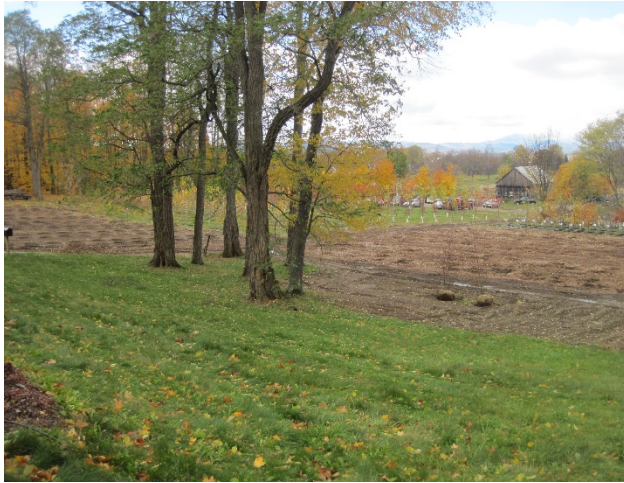
Figure 1: Runoff travels from the east side of the property near the Route 7 entrance across the site to the west.

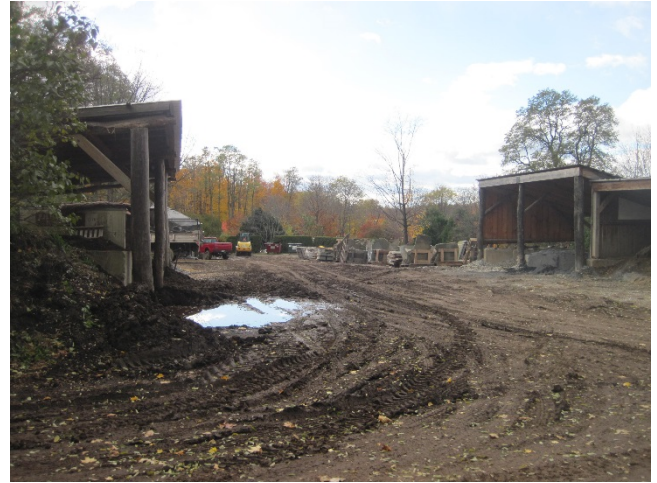
Figure 3: The loading area has high traffic from machinery and the surface is often muddy.

1. Create forebay for existing raingarden to capture sediment from loading area and grade loading area driveway to slope away from barn entrance.
2. Create bio-retention area to capture runoff from the central portion of site now draining south to Pringle Brook. Redirect overflow from this bio-retention area to the middle irrigation pond near the perennials.

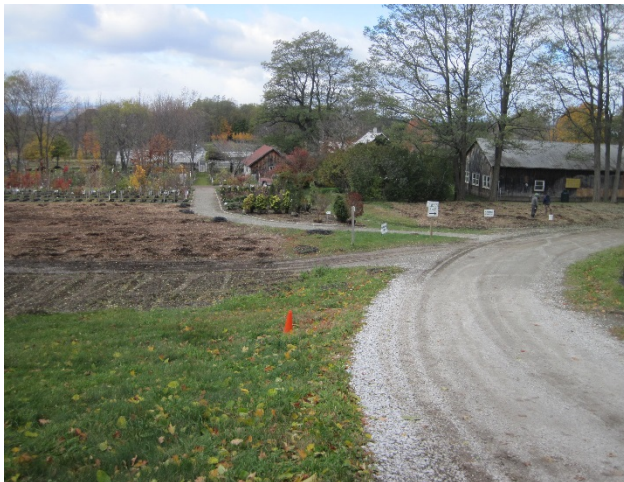
Figure 2: Runoff travels down the Route 7 entrance driveway and meets a swale that carries it to the southwest.

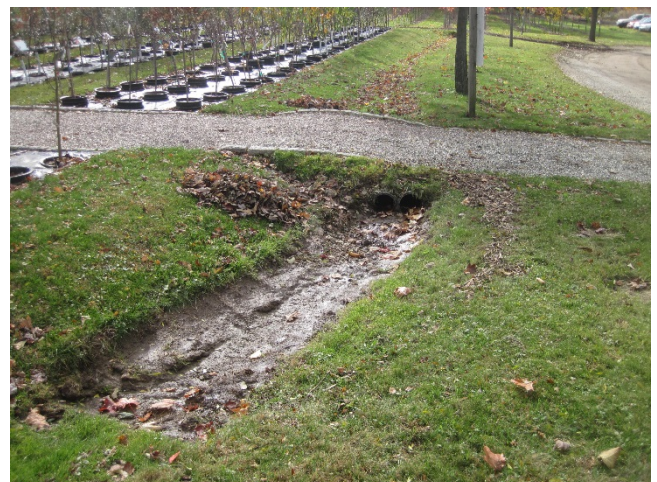
The central portion of the site does not drain to one of the existing ponds. In this area, runoff generally flows from an existing ridgeline located in the eastern portion of the property to the west towards the wholesale loading area, employee building and workshop, and upper nursery fields. This 5.3 acre area drains through a series of grass swales and undersized culverts under several nursery access drives towards the south into the headwater reach of Pringle Brook. The small culverts at the drive crossings are providing in-line detention in the swales during small rain events, however reportedly overtop often. Accumulated sediment is removed from the existing drainage swales on a regular basis.

Figure 4: A swale system with small culverts carries water around the site, but requires frequent maintenance.

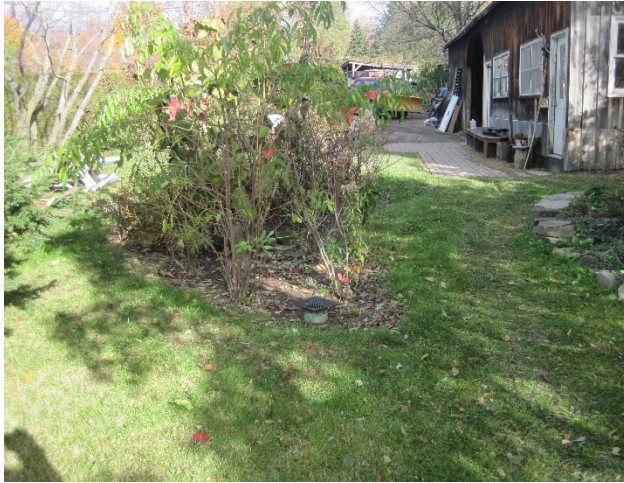
A small raingarden was installed a few years ago to capture runoff from the loading area, just outside the employee building entrance. This raingarden is undersized and requires significant maintenance. The raingarden receives heavy sediment load from the gravel parking lot and washoff from trucks in the loading area. The raingarden is reportedly cleaned out once a year, with the small ditch leading to it being cleaned out 3 times a year. This raingarden does not have a forebay.

Figure 5: A small raingarden was installed to catch sediment leaving the loading area.

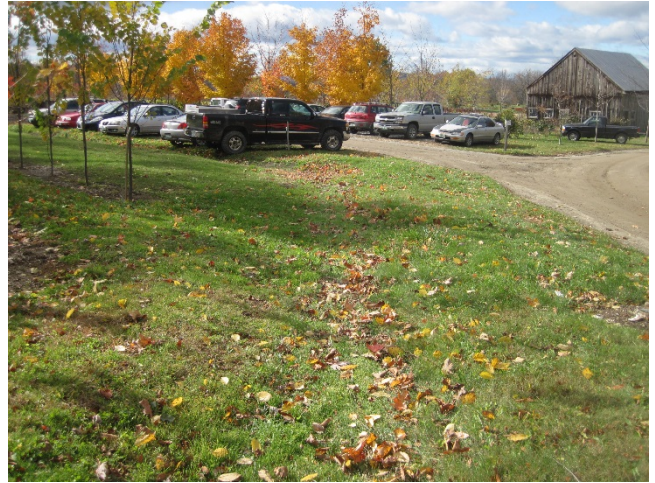
Figure 7: A possible bio-retention area has been identified along the swale system near the employee parking.

1. Create a bio-retention area downstream of existing impervious surfaces and growing areas to slow runoff and retain water on-site. A riser structure will serve as the outlet directing normal overflow to an existing irrigation pond to increase retention time and storage, as well as recycle runoff for irrigation.
2. Create a bio-infiltration swale with tree check dam to pre-treat stormwater prior to entering the bio-retention area, slow runoff, improve vegetation, and increase available storage.

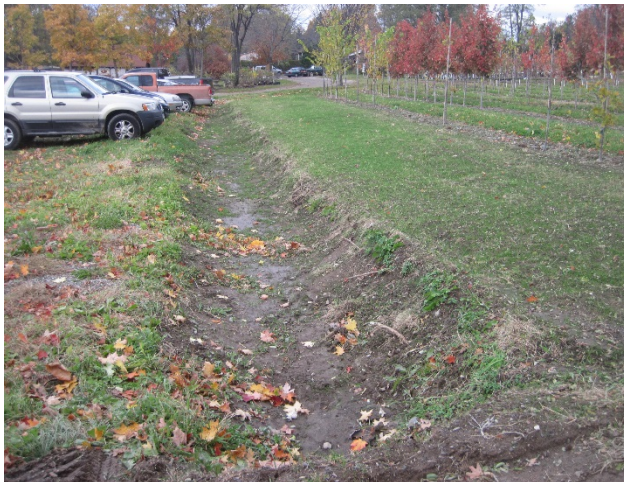
Figure 6: A swale carries water from the entrance area and many of the planted nursery fields to the south off of the site.

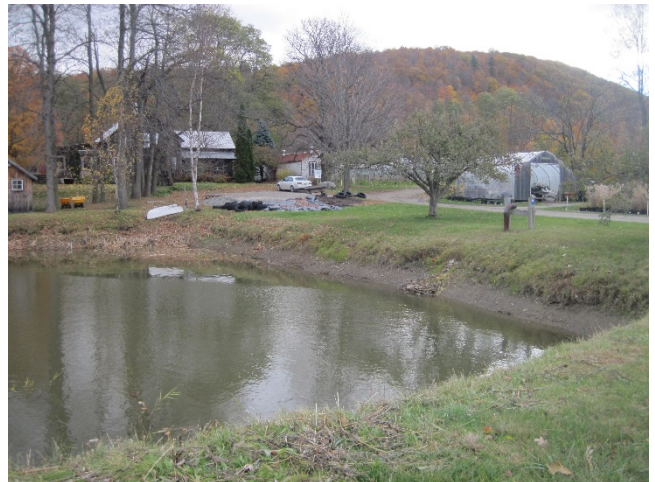
Figure 8: Water collected in the bio-retention area could overflow to an existing pond used to supply irrigation to the site.
