Management Alternatives

Hinesburg Village, Vermont (MMI# 3452-03)

August 24, 2010

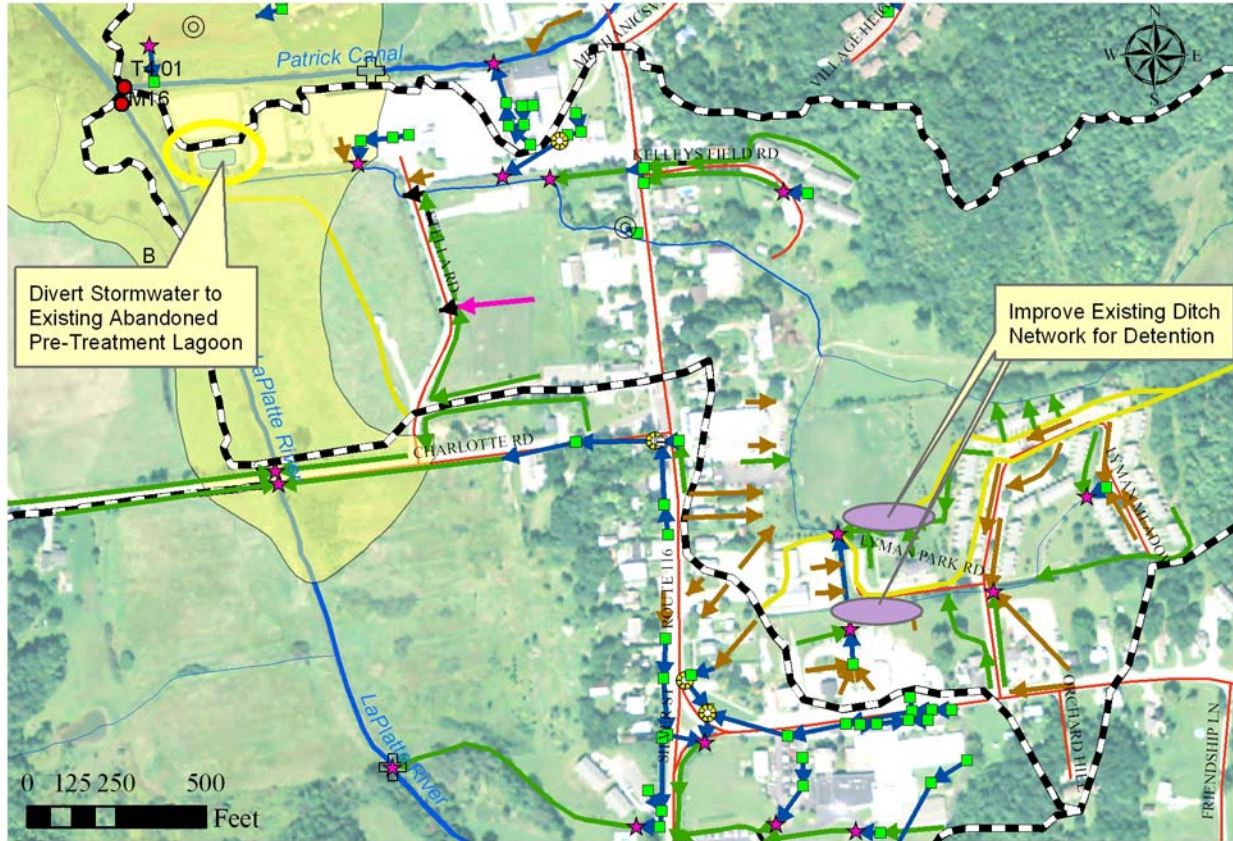
Figure 2: Potential Stormwater Treatment Options in Hinesburg Village Lower M16

The lower two subwatersheds associated with reach M16 have been targeted for stormwater improvement. A majority of village drains to the tributary in the downstream section of this reach, including most of the eastern half of Route 116 through the village. Treatment potential exists in this area. Stormwater could be diverted from the ditched tributary into the existing treatment pond that was formerly used by the Saputo factory (Figure 2). If this pond will not be used for future plant operations it would serve as potential stormwater detention location. Space for other detention areas exists around the factory site that could be reserved for planned future uses in the area and village expansion. Permeable soils are mapped in the LaPlatte River corridor in this area including the western half of the factory site and portions of the fields both to the north and south of the site which could present opportunities for infiltration based mitigation. Permeable soils are rare in the watershed and thus these locations should be protected for stormwater treatment.

wider detention areas. Stormwater enters the ditch systems behind the gas station, church, and the grocery store at multiple locations and thus small decentralized treatment methods such as rain gardens or infiltration practices may be appropriate. Minimal, if any, mowing should be performed in the swales so thicker vegetation increases hydraulic resistance slowing flow rate and increasing retention times.

Additional opportunities for stormwater interception are possible in the collection system upstream including expanding the current ditch in Lyman Park to enhance stormwater treatment by establishing

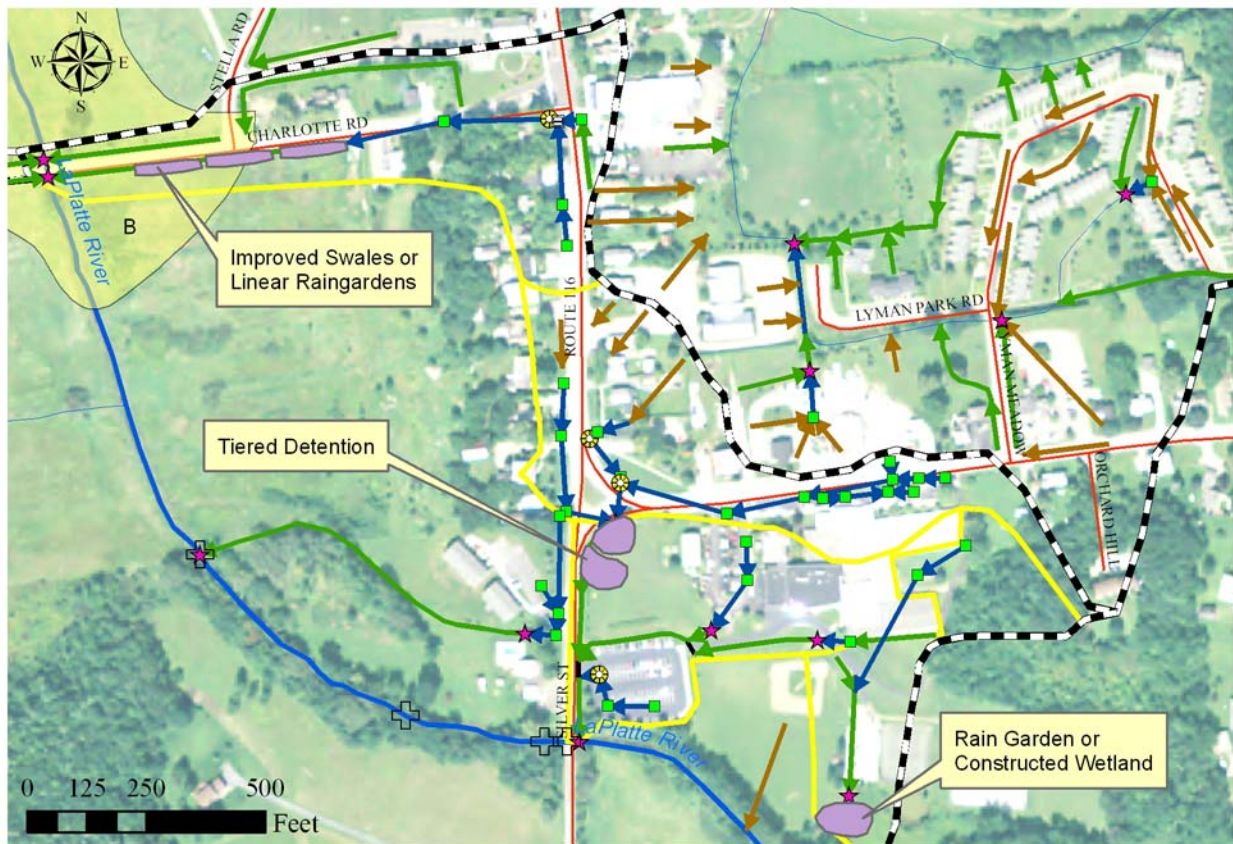
Figure 3: Potential Stormwater Treatment Options in Hinesburg Village Middle M16

The middle section of M16 includes runoff from the remaining section of Hinesburg village, from Charlotte Road upstream past Hinesburg Community School. This subwatershed was targeted for treatment due to high percentage of impervious surface, water quality problems downstream, and local erosion. A multi-celled, terraced detention system is recommended where the piped system meets the ditch at the corner of Silver Street (Figure 3). Multiple detention cells would allow for increased retention times on the sloping corner of land. Water currently rushes out of the pipe and down the existing steep ditch to the LaPlatte River.

Ditches along Charlotte Road collect water from a section of Route 116 with catch basins and stormwater pipes. The ditch that this system discharges to is a grass swale along the road that could be improved into a higher functioning linear rain garden system. Soils located in the area indicate that infiltration could be possible in this location.

Another series of catch basins along the southwest part of the village collects runoff along Route 116 in front of the Hinesburg Elementary school and discharges near the corner of Silver Street and Route 116. Erosion is taking place at this outfall indicating high stormwater flows. Runoff eventually flows through the ditches along Silver Street. The terraced rain garden recommended in this area will thus need to be size for the volume of runoff coming from this and the previously mentioned pipe systems.

Hinesburg Community School has two discharge points behind the school. Multiple opportunities exist for stormwater treatment such as rain gardens or constructed wetlands at the school site (Figure 3). These projects could benefit local stream health and present a hands-on educational opportunity for the students at the Hinesburg Community School to learn about stormwater. The targeted outfall collects runoff from compacted areas of the lawn and discharges behind the play area. Roof runoff should be diverted to the recommended treatment area. Other smaller stormwater projects could be implemented around the school such as inclusion of rain water collection barrels at the roof downspouts and building of small rain gardens in the median strip in front of the school that are now drained by catch basins. Disconnection of impervious surfaces or install of infiltration methods are recommended for the parking areas and the roof that are now discharging to the LaPlatte River near the Silver Street Bridge without treatment. Installation of stormwater treatments may be pursued as part of the reconstruction of the Silver Street Bridge, scheduled for 2011-2012.

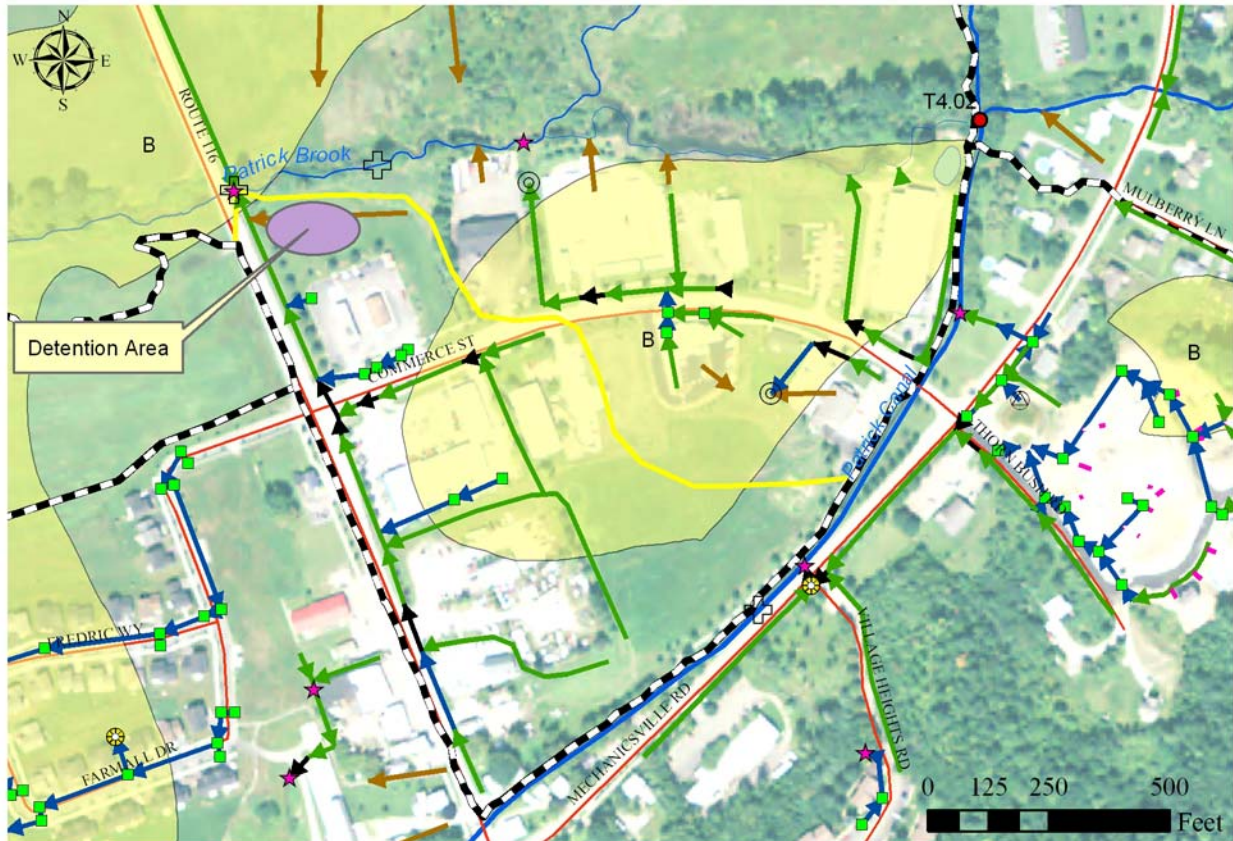
Figure 4: Potential Stormwater Treatment Option in Hinesburg Village Patrick Brook

Patrick Brook (M15.S02.1) was identified as a priority watershed for stormwater treatment based on the ranking analysis and specifically percent impervious surface (Schiff and Clark, 2010b). Between the local gas station and Patrick Brook is a piece of open space that could serve as a location for a stormwater detention pond (Figure 4). A constructed wetland or traditional pond could be built and directly draining runoff from the area could be diverted to the pond via swales or curbing along the back of the parking areas.

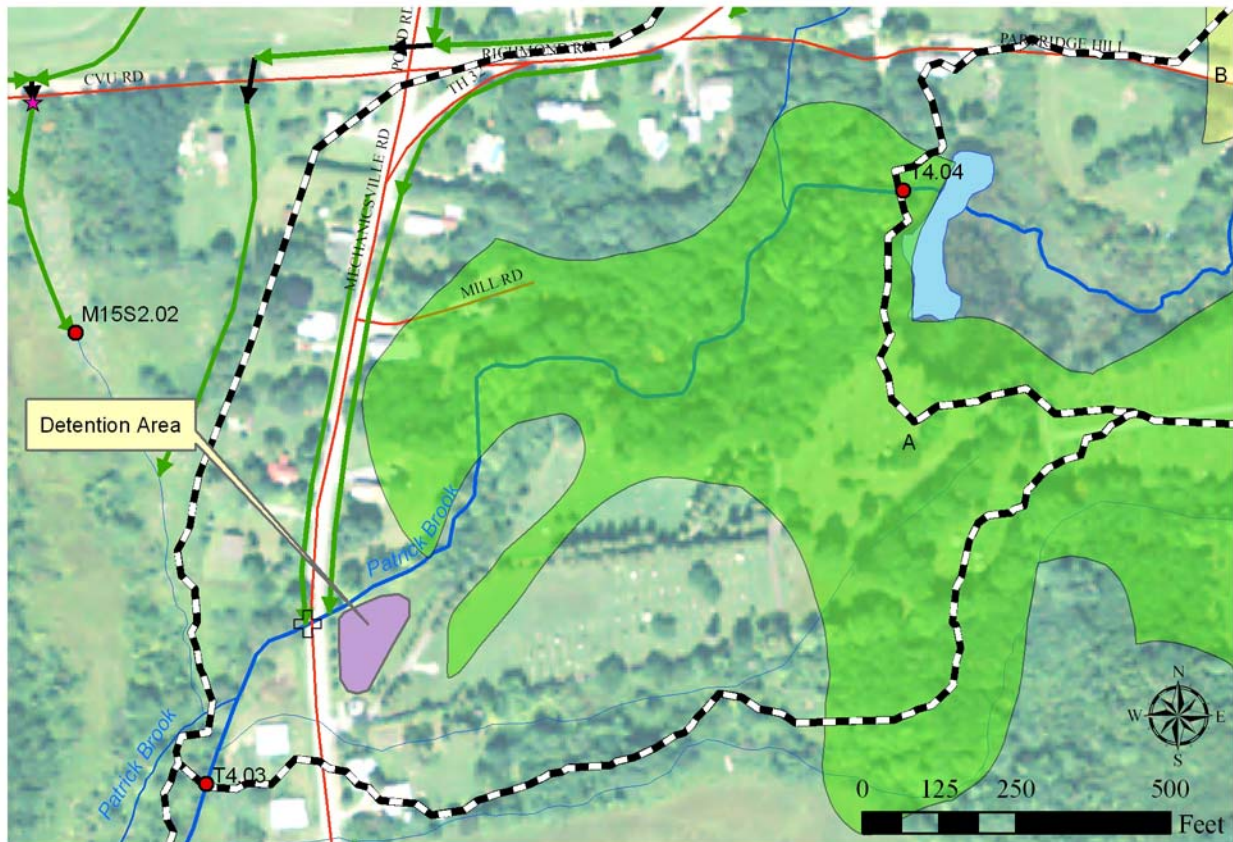
Figure 5: Potential Stormwater Treatment Option in Hinesburg Patrick Canal

Several of the Patrick Canal subwatersheds have been identified as having degraded geomorphic condition and are high priority for stormwater mitigation. Much of the development in the lower reach (T4.01) is new and has adequate stormwater treatment. The close proximity of the canal to Mechanicsville Road limits opportunity for detention along this degraded reach (T4.02). The upper watersheds have some in-line detention in the form of ponds and dams. Residential development in the upper reaches is dispersed and does not have stormwater treatment. One potential treatment location was identified next to Mechanicsville Road at the base of the cemetery (Figure 5). A detention area at this location could serve as channel overflow during storm events and detain runoff from the cemetery

hillside. The location of this detention area is upstream of T4.02 that has poor geomorphic condition and T4.01 which has significant impervious surface and is therefore vulnerable to stormwater runoff. This site was visited in the field and appears to be a good location for a constructed wetland.

As part of the management plan it should be considered that the Canal is essentially a stormwater drainage conveyance. The possibility for increased in-canal stormwater storage and treatment should be explored.
