Ahead of the Storm

Charlotte Congregational Church

Church Hill Road, Charlotte

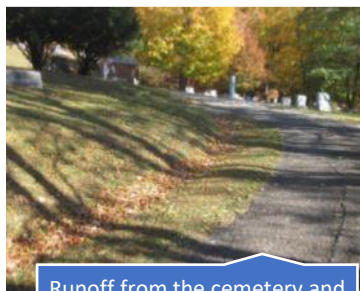
Runoff from the cemetery and hillside flows through the church property

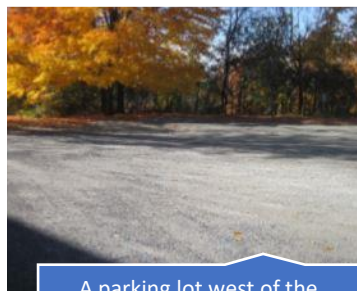
A parking lot west of the church has erosion of the gravel surface during rain

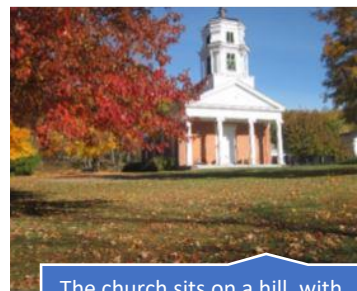
The church sits on a hill, with runoff flowing south towards Church Hill Road

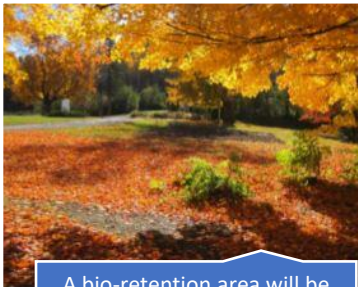
A bio-retention area will be installed in the lawn adjacent to the gravel parking lot

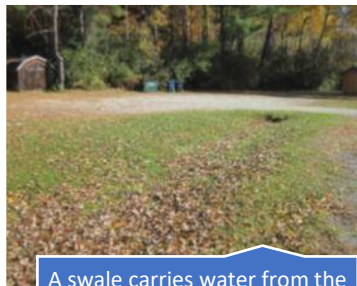
A swale carries water from the parking lot and cemetery to the east into the wetland

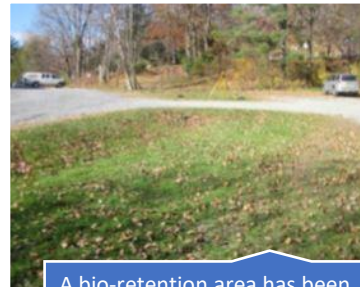
A bio-retention area has been identified between the driveway and parking area
