Ahead of the Storm

East Thompson's Point Road / Thorp Brook

East Thompson's Point Road, Charlotte

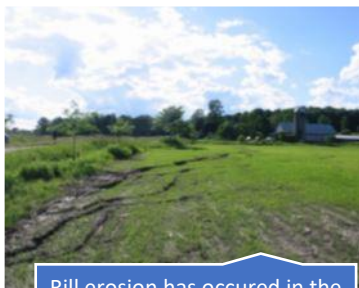
Rill erosion has occurred in the Mack farm field when water cuts across the field

To reduce the erosion and transport of sediment occurring, along with a high level of pollutants entering Thorp Brook, the water traveling through this site needed to be slowed down. Rather than just improving water quality and flood resiliency for today, this design was created to account for more frequent and larger storms expected in the future from climate change. Engineers created a three-cell bio-retention area by installing stone filter berms to slow water and capture sediment and nutrients. Swales leading to the bio-retention area were designed to be larger, with a “U” shape instead of a “V” shape to reduce erosion. Swales are vegetated where the slope allows, so plants can help soak up water and nutrients. Where steeper, the swale is rock-lined with check dams to eliminate erosion and trap sediment. The undersized culvert was replaced with a large culvert to accommodate high water events.

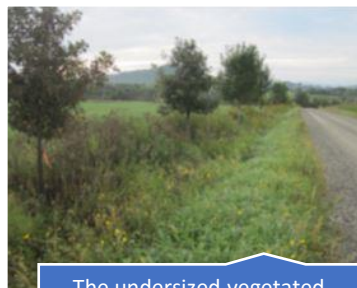
The undersized vegetated swale along E. Thompson's Point Road

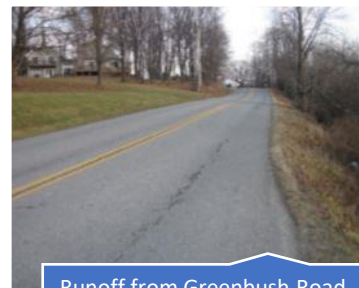
Runoff from Greenbush Road and homes travels through this site to Thorp Brook
