Ahead of the Storm Charlotte Bike Tour

Ahead of the Storm (AOTS) grew out of a group of citizens from Charlotte, Hinesburg, and Shelburne who were concerned about the serious decline of Lake Champlain's health and water quality. Stormwater runoff from driveways, fields, parking areas, and lawns is a major factor in the deterioration of our water quality. Most impervious surfaces were created before regulations requiring water quality treatments were in place or fall below regulatory thresholds. Therefore, runoff is not managed to remove pollutants or slow flows and soils and phosphorus are mobilized and end up in Lake Champlain. AOTS helps communities change the way stormwater is managed on properties to reduce water pollution and be more prepared for extreme weather events and impacts of climate change. Fifteen municipal, educational, and private properties have been selected to become demonstration sites to showcase more optimal conservation practices in a variety of landscape settings. Monitoring and stewardship over time is crucial to successfully addressing water quality issues.

DuBrul Residence Rain Garden

East Thompson's Point Road / Thorp Brook

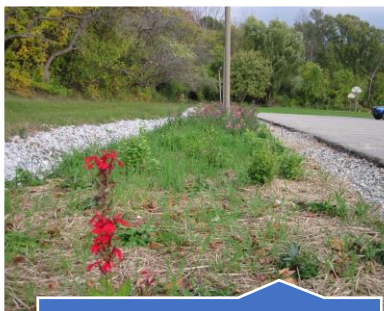
Filter strip off Shelburne Community School parking lot slows down and filters water before it reaches the swale and McCabe's Brook

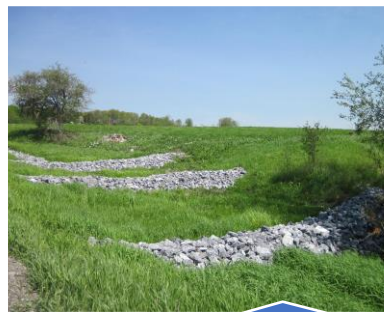
Check dams along a roadside swale slow down water before it reaches Thorp Brook

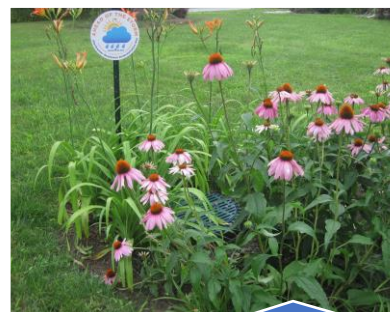
Rain garden alongside a residential road helps clean stormwater before it drains to Munroe Brook

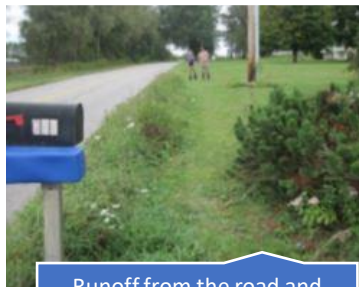
Runoff from the road and adjacent property flows toward DuBrul property

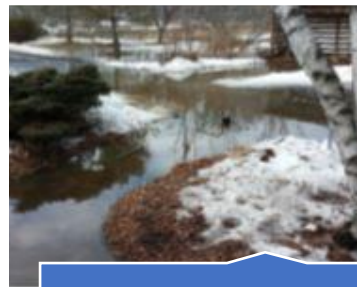
Water puddled in front of home

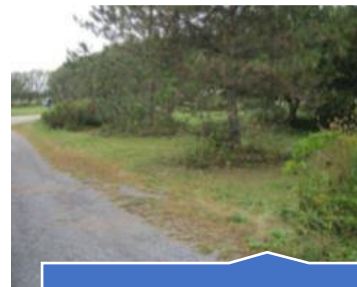
Bio-retention area identified adjacent to driveway

This design creates a bio-retention area (or rain garden) in the front lawn to treat runoff from existing impervious surfaces; it slows runoff, increases water storage, retains sediment, promotes infiltration, and redirects flow away from the house and garage. Runoff calculations indicate that the rain garden treats the runoff from the 1-inch rain storm that occurs during 90% of all rain events.

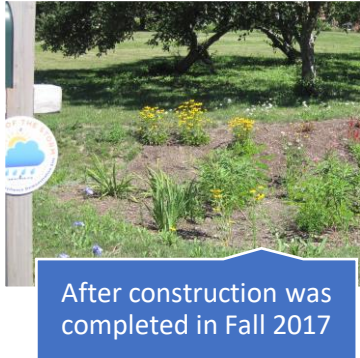
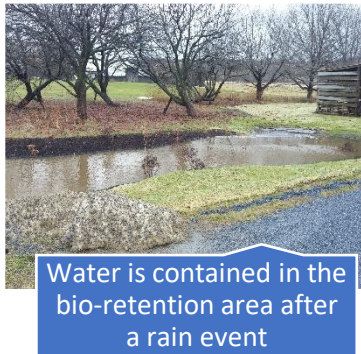
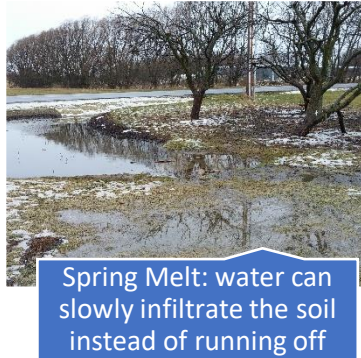
After construction photos:

Implementation occurred in Fall 2017 by Junior Lewis Excavating. Several trees and hedges were removed and an attractive depression was dug to create the bio-retention area north of the driveway to store water. Flowering native perennials were planted and stones were placed at the rain garden outlet to control the ponding level.

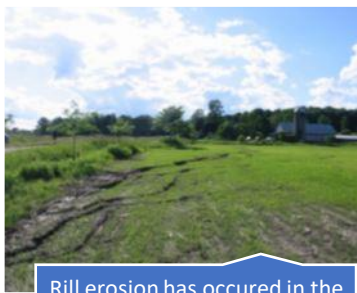
Rill erosion has occurred in the Mack farm field when water cuts across the field

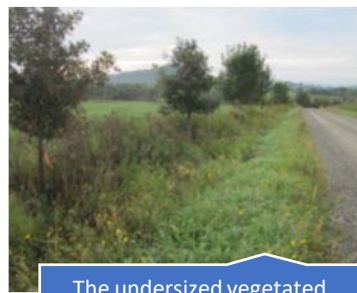
The undersized vegetated swale along E. Thompson's Point Road

Water traveling through this site needed to be slowed down to reduce erosion, sediment, and high levels of pollutants entering Thorp Brook. Rather than just improving water quality and flood resiliency for today, this design was created to account for more frequent and larger storms expected in the future due to climate change. Engineers created a three-cell bio-retention area by installing stone filter berms to slow water and capture sediment and nutrients. Swales leading to the bio-retention area were designed to be larger, with a "U" shape instead of a "V" shape to reduce erosion. Swales are vegetated where the slope allows, so plants can help soak up water and nutrients. Where steeper, the swale is rock-lined with check dams to eliminate erosion and trap sediment. The undersized culvert was replaced with a large culvert to accommodate high water events.

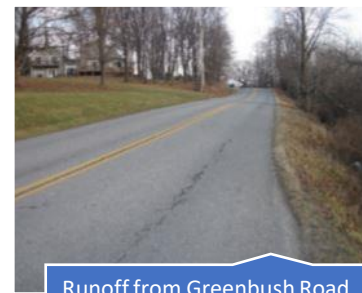
Runoff from Greenbush Road and homes travels through this site to Thorp Brook

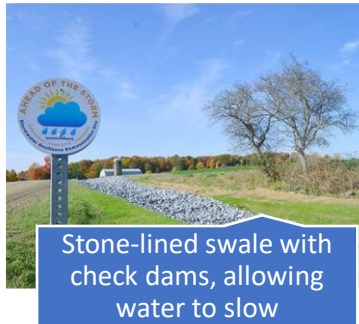
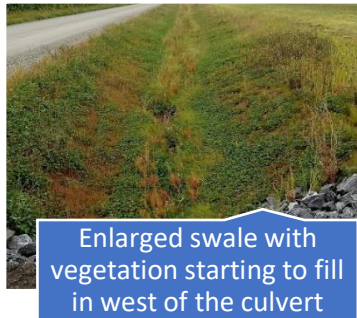
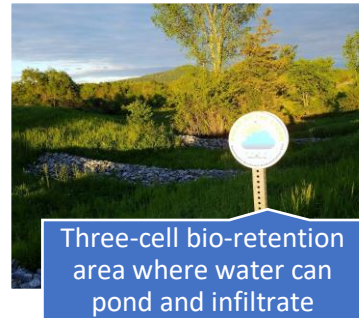
After construction photos:

Implementation occurred in Summer 2016 by Junior Lewis Excavating. The site was excavated to increase the swale (to the west/left when looking at the sign from the road) and create bio-retention areas (directly in front of and down the hill to the right of the sign). The culvert at the crest of the hill (west of the sign) was upsized, and the adjacent part of the swale was stone lined. Stone filter berms and check dams were installed and erosion matting and seeding were put in place.

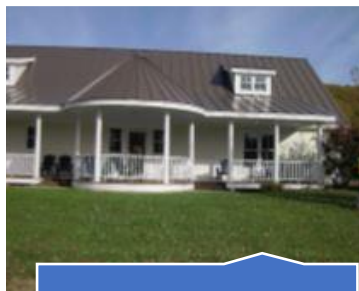
West side of the library

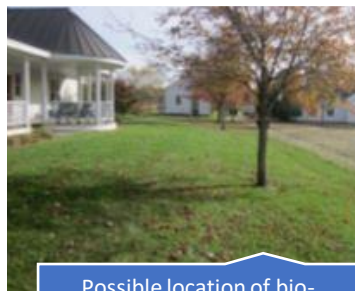
Possible location of bio-retention area between 2 trees in lawn area

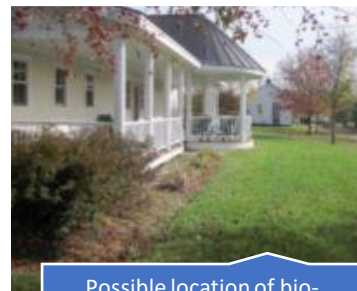
Possible location of bio-retention area to west of building, using existing bed

In order to improve water quality, engineers at Milone & MacBroom created designs to slow runoff, increase infiltration, and enhance vegetation on the half-acre property. The designs included bio-retention areas in existing landscaped beds on the west side of the building to slow runoff and increase storage capacity, and a rain barrel to water the gardens and flower beds from the untreated water coming off the roof. Since soils are tight and the water table is high at this site, infiltration or underground treatment practices would not be effective.

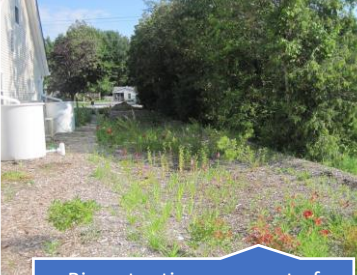
Bio-retention area east of building with rain barrels (where former entrance driveway was)

The library addition (constructed in 2020) somewhat altered the original designs, and included removing the library entrance driveway, replacing soil in the area, and installing gutters, rainbarrels, pipes, and a bio-retention area east of the building. This removed a net 0.06 acres of impervious and provided treatment for 0.14 acres of runoff from the roof. Additional bio-retention areas are planned for the west roof runoff.

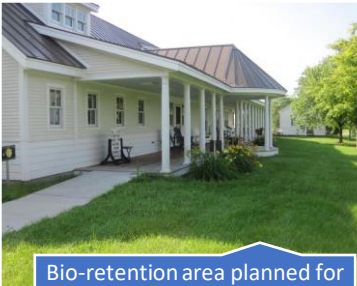
Bio-retention area planned for this west side of building; runoff from sidewalk sheet flows into vegetation

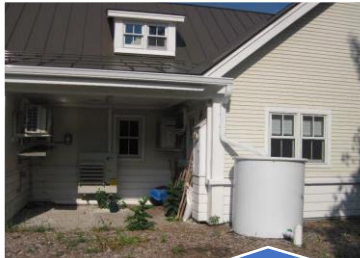
Gutter, downspout, and installed rain barrel for garden watering
