## AHEAD OF THE STORM

Site: Hollow Brook Refugia Design

Location: Hollow Brook, Sugarhouse Lane, Starksboro, Vermont

## EXISTING CONDITIONS SUMMARY

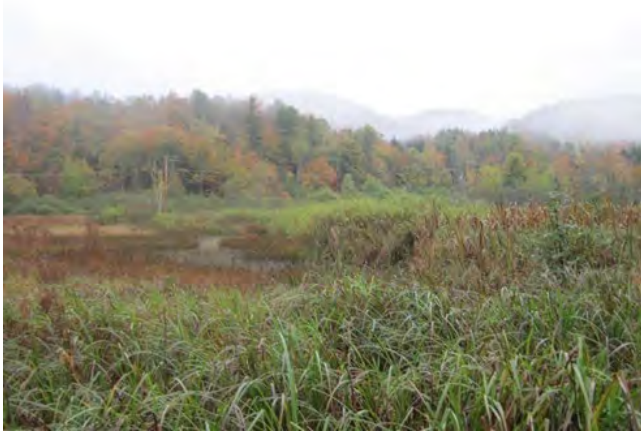
*Figure 1: A former agricultural field is located to the east of Hollow Brook. It is often wet and likely used to be wetland before it was cleared for farmland (October 2, 2020).*

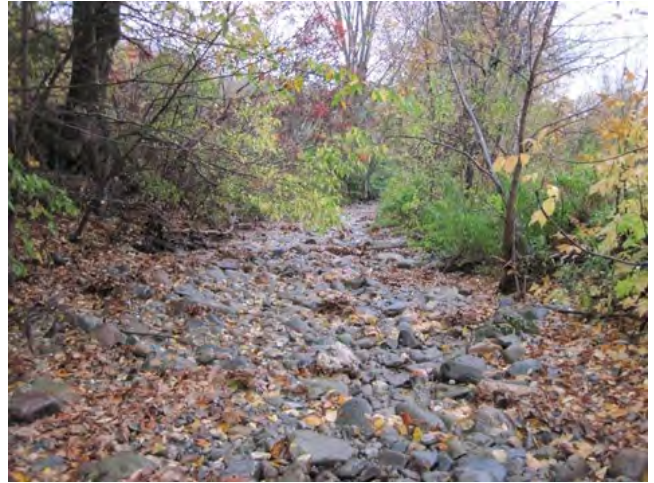
*Figure 3: Hollow Brook has been straightened and is dry portions of the year downstream from the culverts where deposited sediment has filled in the channel bed (October 2, 2020). The channel was observed flowing October 28, 2019 and December 6, 2020 and observed dry August 3, 2020, October 2 and 9, 2020.*

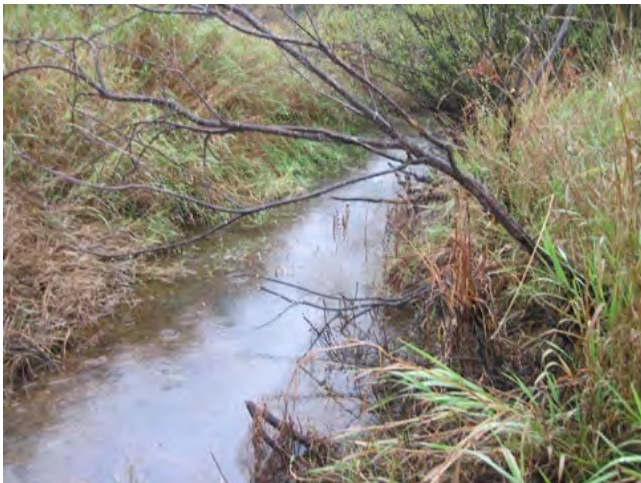
*Figure 2: Small channels wind throughout the field shown in Figure 1. These are potentially the historic flow path (October 2, 2020).*

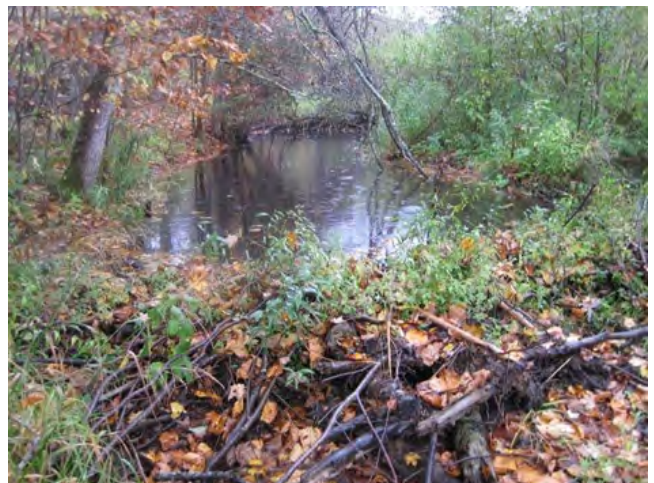
*Figure 4: Several beaver dams have been built in Hollow Brook near the southern end of the field (October 2, 2020). The beaver dams are collecting sediment upstream, which is now filling the channel up to the culverts, causing subsurface flow during dry periods, and depositing sediment into the field. These low velocity areas combined with large sediment inputs are combining to fill the channel with sediment.*

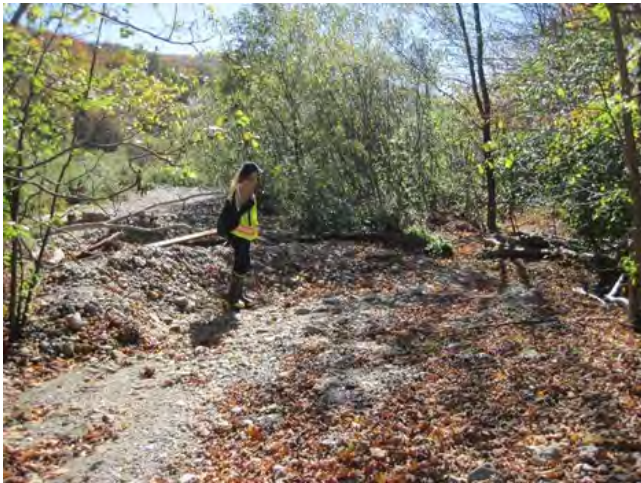
*Figure 5: Flows left Hollow Brook in several spots and carried materials into the field, as shown on the left side of this photo (October 9, 2020).*

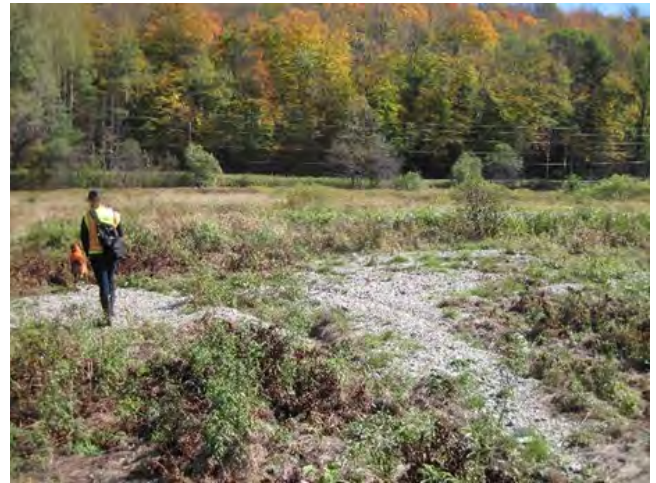
*Figure 7: Some of these deposits are very large. This one is about 30-40 ft wide (October 9, 2020).*

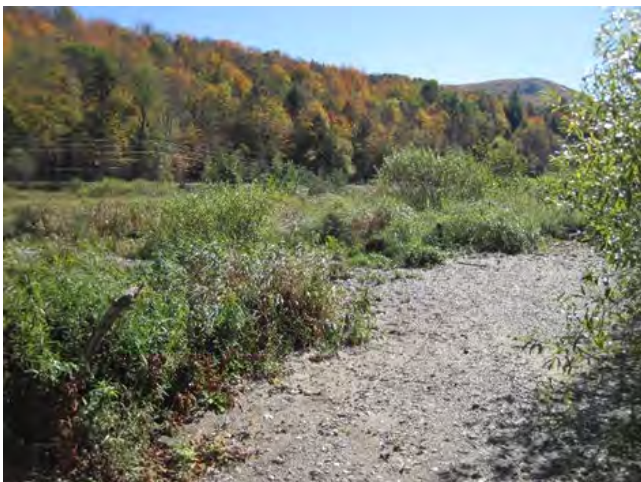
*Figure 6: Gravel deposits have been left by these flows far outside the main channel (October 9, 2020).*

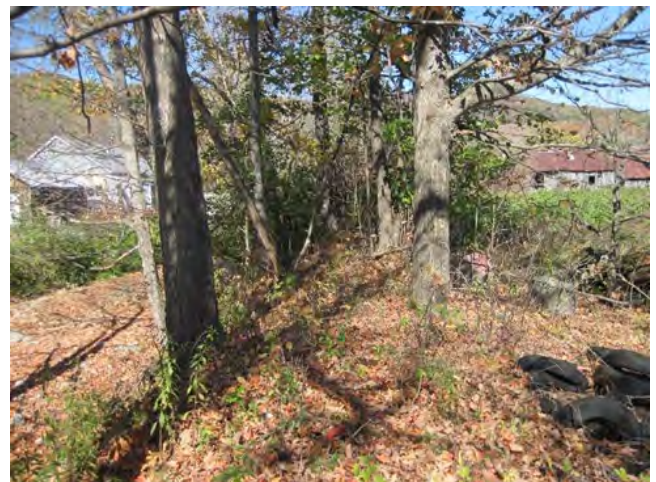
*Figure 8: A berm (image center) runs along the channel bank (image left) downstream of the culverts. It extends approximately 240 ft (October 9, 2020).*

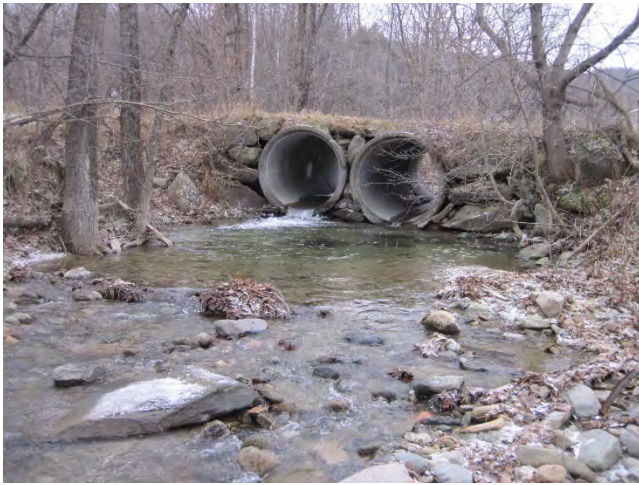
The double culvert passing under Sugarhouse Lane is perched – trapping sediment upstream and blocking fish passage. The landowner reports that they regularly remove wood caught at the culvert and that the culvert has been overtopped by flood waters. This is the only access over the river to private land. A home is located immediately upstream of the culvert and is at risk of flooding and erosion damage if the culvert is clogged.

Figure 9: The driveway culverts are perched with a scoured pool at the downstream end of the culverts (December 6, 2020).

REPLACE EXISTING 6FT DIAMETER CULVERTS WITH 1.2 TIMES BANKFULL WIDTH OPEN BOTTOM STRUCTURE, 24 FEET WIDE

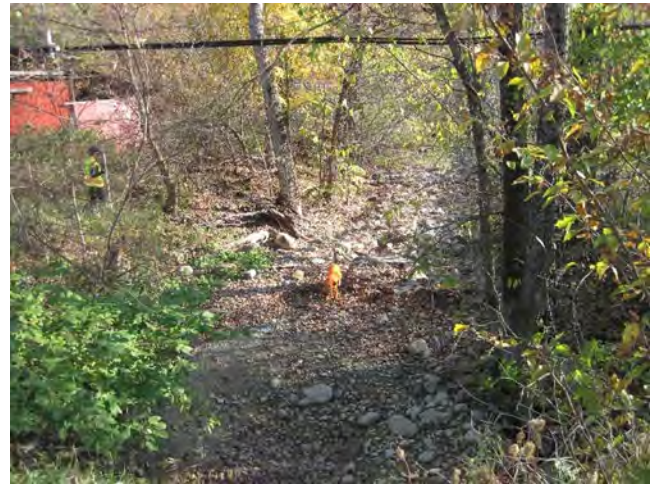
Figure 11: A view of the channel looking downstream from on top of the culverts (October 9, 2020).

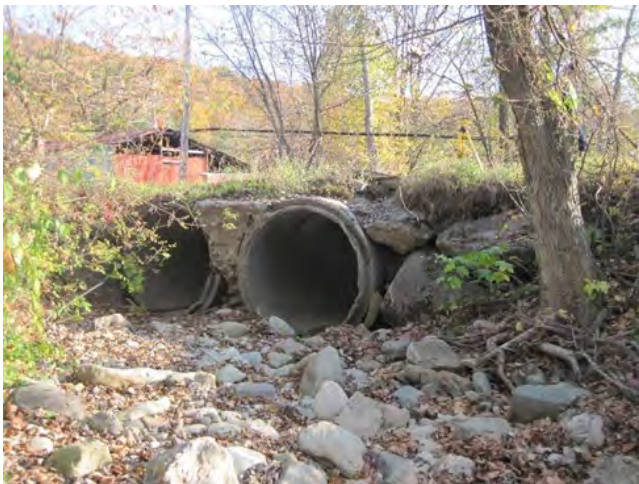
Figure 10: The channel begins to go dry at the culverts (October 9, 2020). A view of the culverts from upstream.

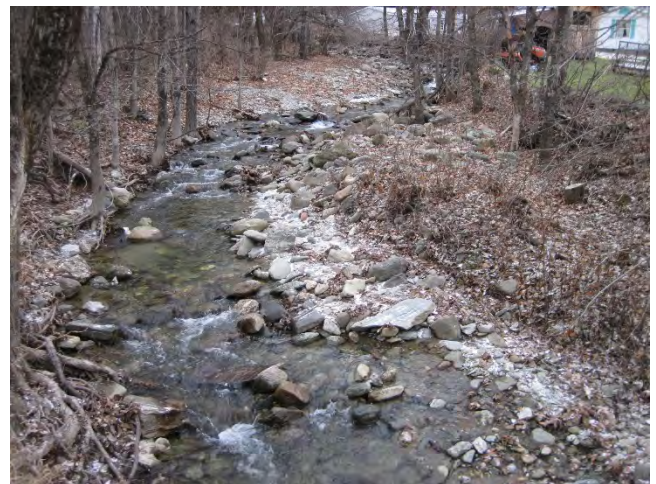
Figure 12: A view of the channel looking upstream from on top of the culverts (December 6, 2020). Large sediment deposits fill the channel, covering tree bases.

REMOVE SEDIMENT DEPOSITION

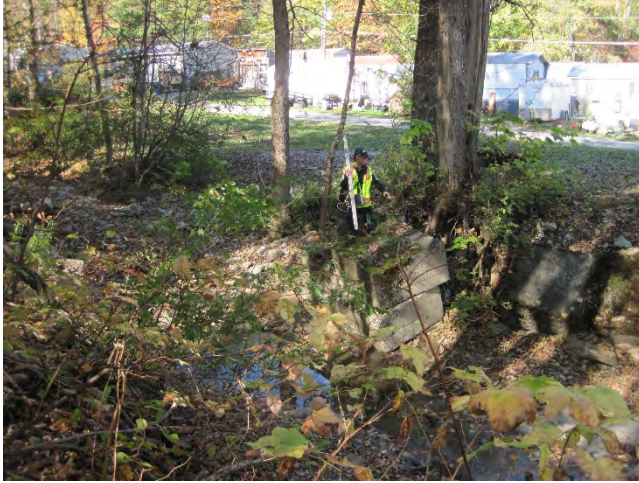
Figure 13: When flow backs up at the old abutment constriction, the water flows out onto nearby Elm Lane, damaging homes, and carrying sediment (October 9, 2020).

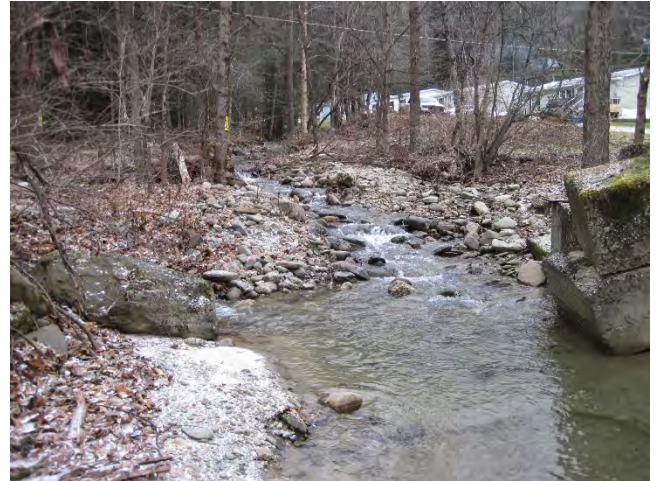
Figure 15: View of old bridge abutments looking upstream. There is a steep riffle and sediment deposit filling the river channel and contributing to flows leaving the channel (December 12, 2020).

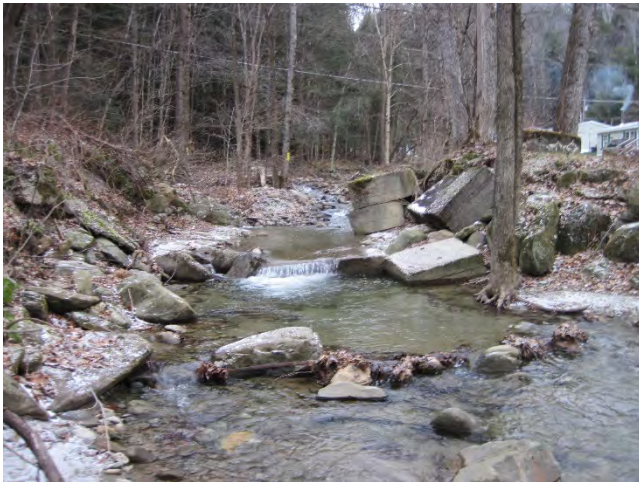
Lazy Brook Mobile Home Park has encroached on the channel with development, roads, homes, and an informal rock berm on the east side of the channel (river left looking downstream). Abandoned bridge abutments are constricting the river and causing floodwaters to leave the channel and flow into the neighborhood. This area is the former location of an alluvial fan where the channel slope decreases and sediment deposits. Flow from the fan spilled into the downstream wetland complex before the river was channelized.

Figure 14: A concrete sill crosses the river at an abandoned crossing. Abutments constrict channel to 12.5' wide. View of old bridge abutments looking upstream (December 6, 2020).

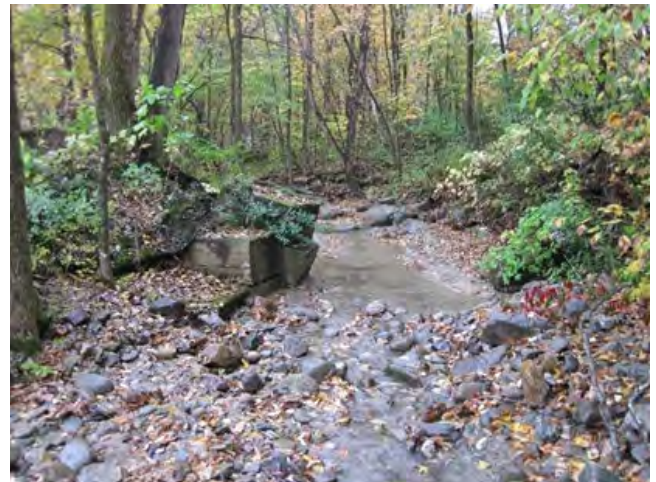
Figure 16: View of old bridge abutments looking downstream (October 2, 2020).

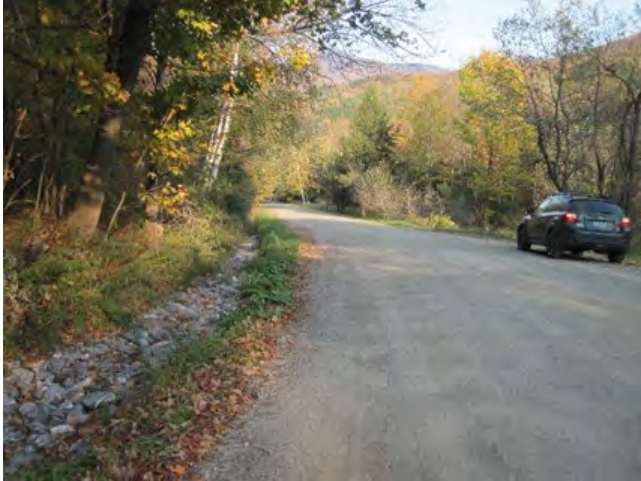
Figure 17: Stormwater from Lincoln Hill Road is collected in road ditches and directed to a Hollow Brook tributary (October 9, 2020).

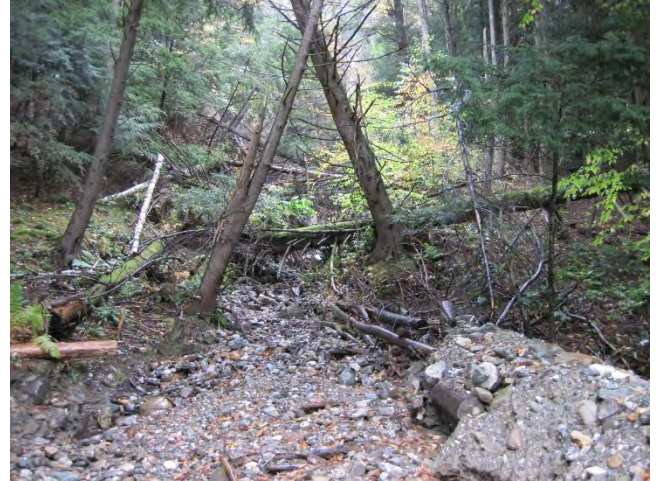
Figure 19: Gully erosion is causing large amounts of sediment to move down the very steep Hollow Brook tributary and into Hollow Brook (October 2, 2020).

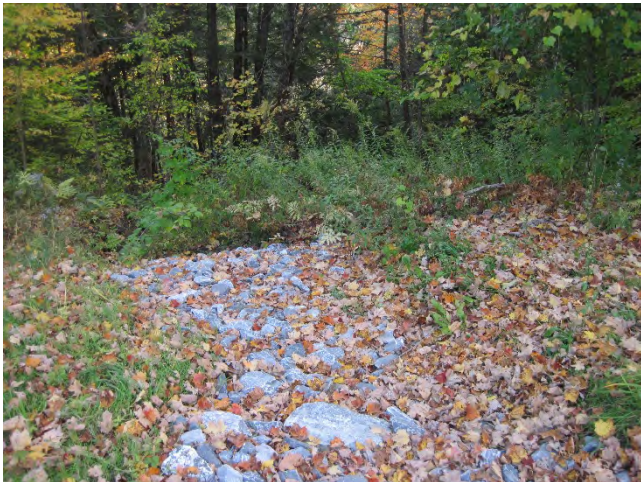
Figure 18: Stormwater from Lincoln Hill Road flows over erosion stone and then enters to top of the steep gully channel (October 9, 2020).

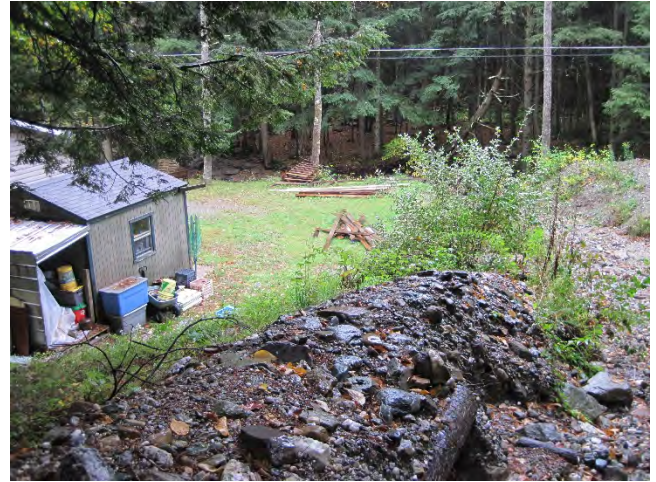
Figure 20: Runoff from uphill along Lincoln Hill Road flows down this steep tributary, contributing large amounts of sediment which have been cleaned out often and now bermed up to protect nearby home (October 2, 2020).

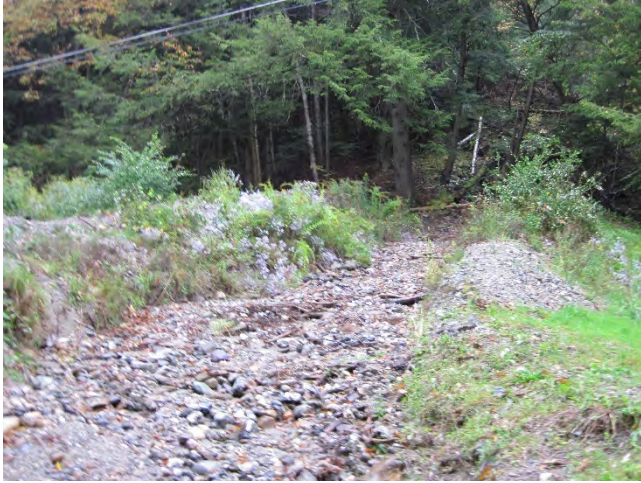
*Figure 21: Sediment has washed down into the Hollow Brook channel and has been bermed up on both sides to recreate the path to the river where sediment has deposited (October 2, 2020).*

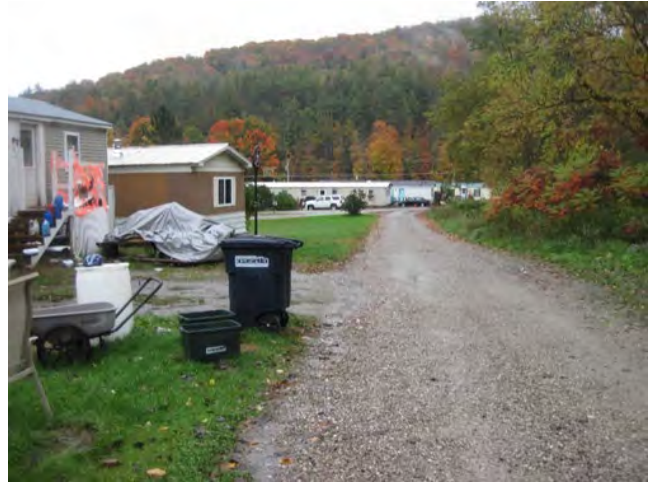
*Figure 23: Many homes along Elm Lane and Lazy Brook Drive are vulnerable to damages from inundation or sediment deposition. Several have already experienced damages (October 2, 2020).*

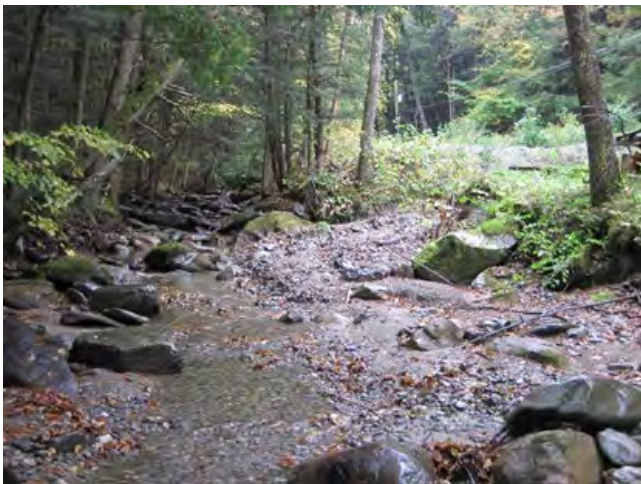
*Figure 22: Sediment has washed down into the Hollow Brook channel (October 2, 2020).*

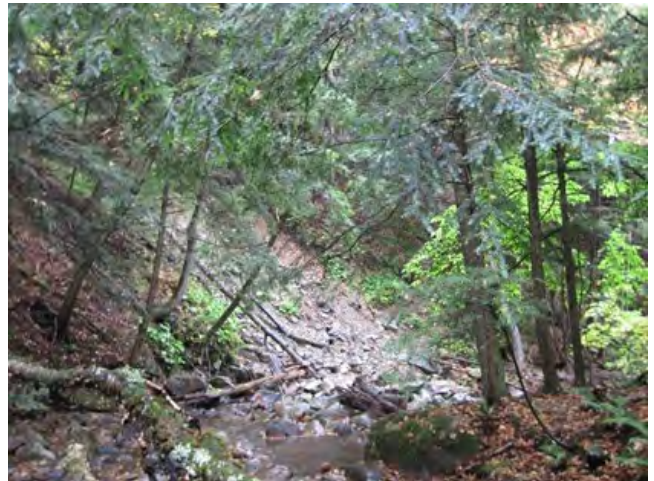
*Figure 24: Upstream mass failures were investigated and found to be naturally healing and not contributing large amounts of sediment to the channel (October 2, 2020).*

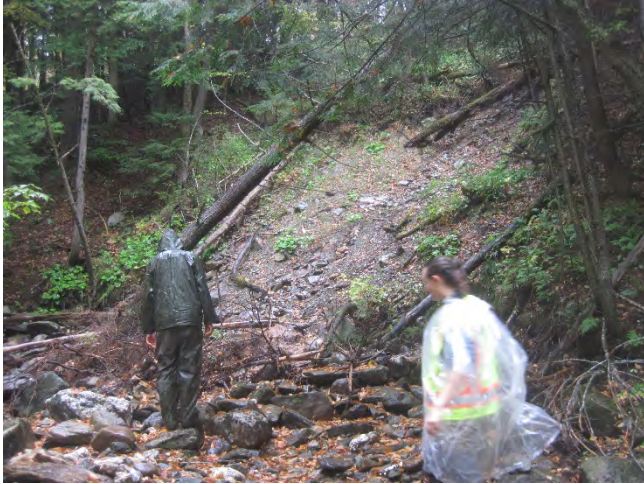
*Figure 25: Upstream mass failures naturally healing with vegetation (October 2, 2020).*

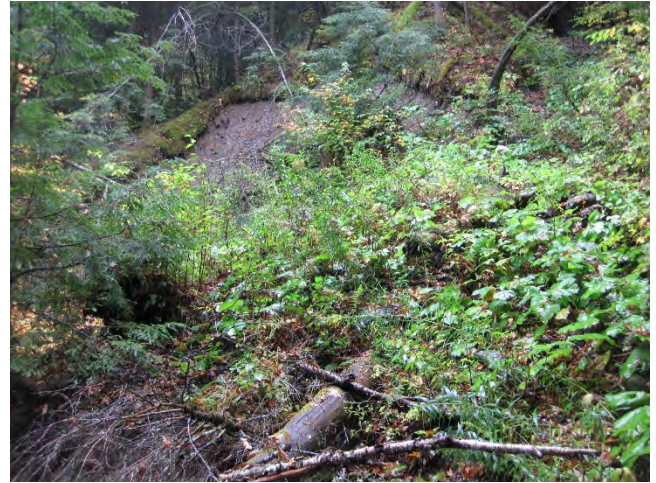
*Figure 26: Upstream mass failures naturally healing with vegetation (October 2, 2020).*

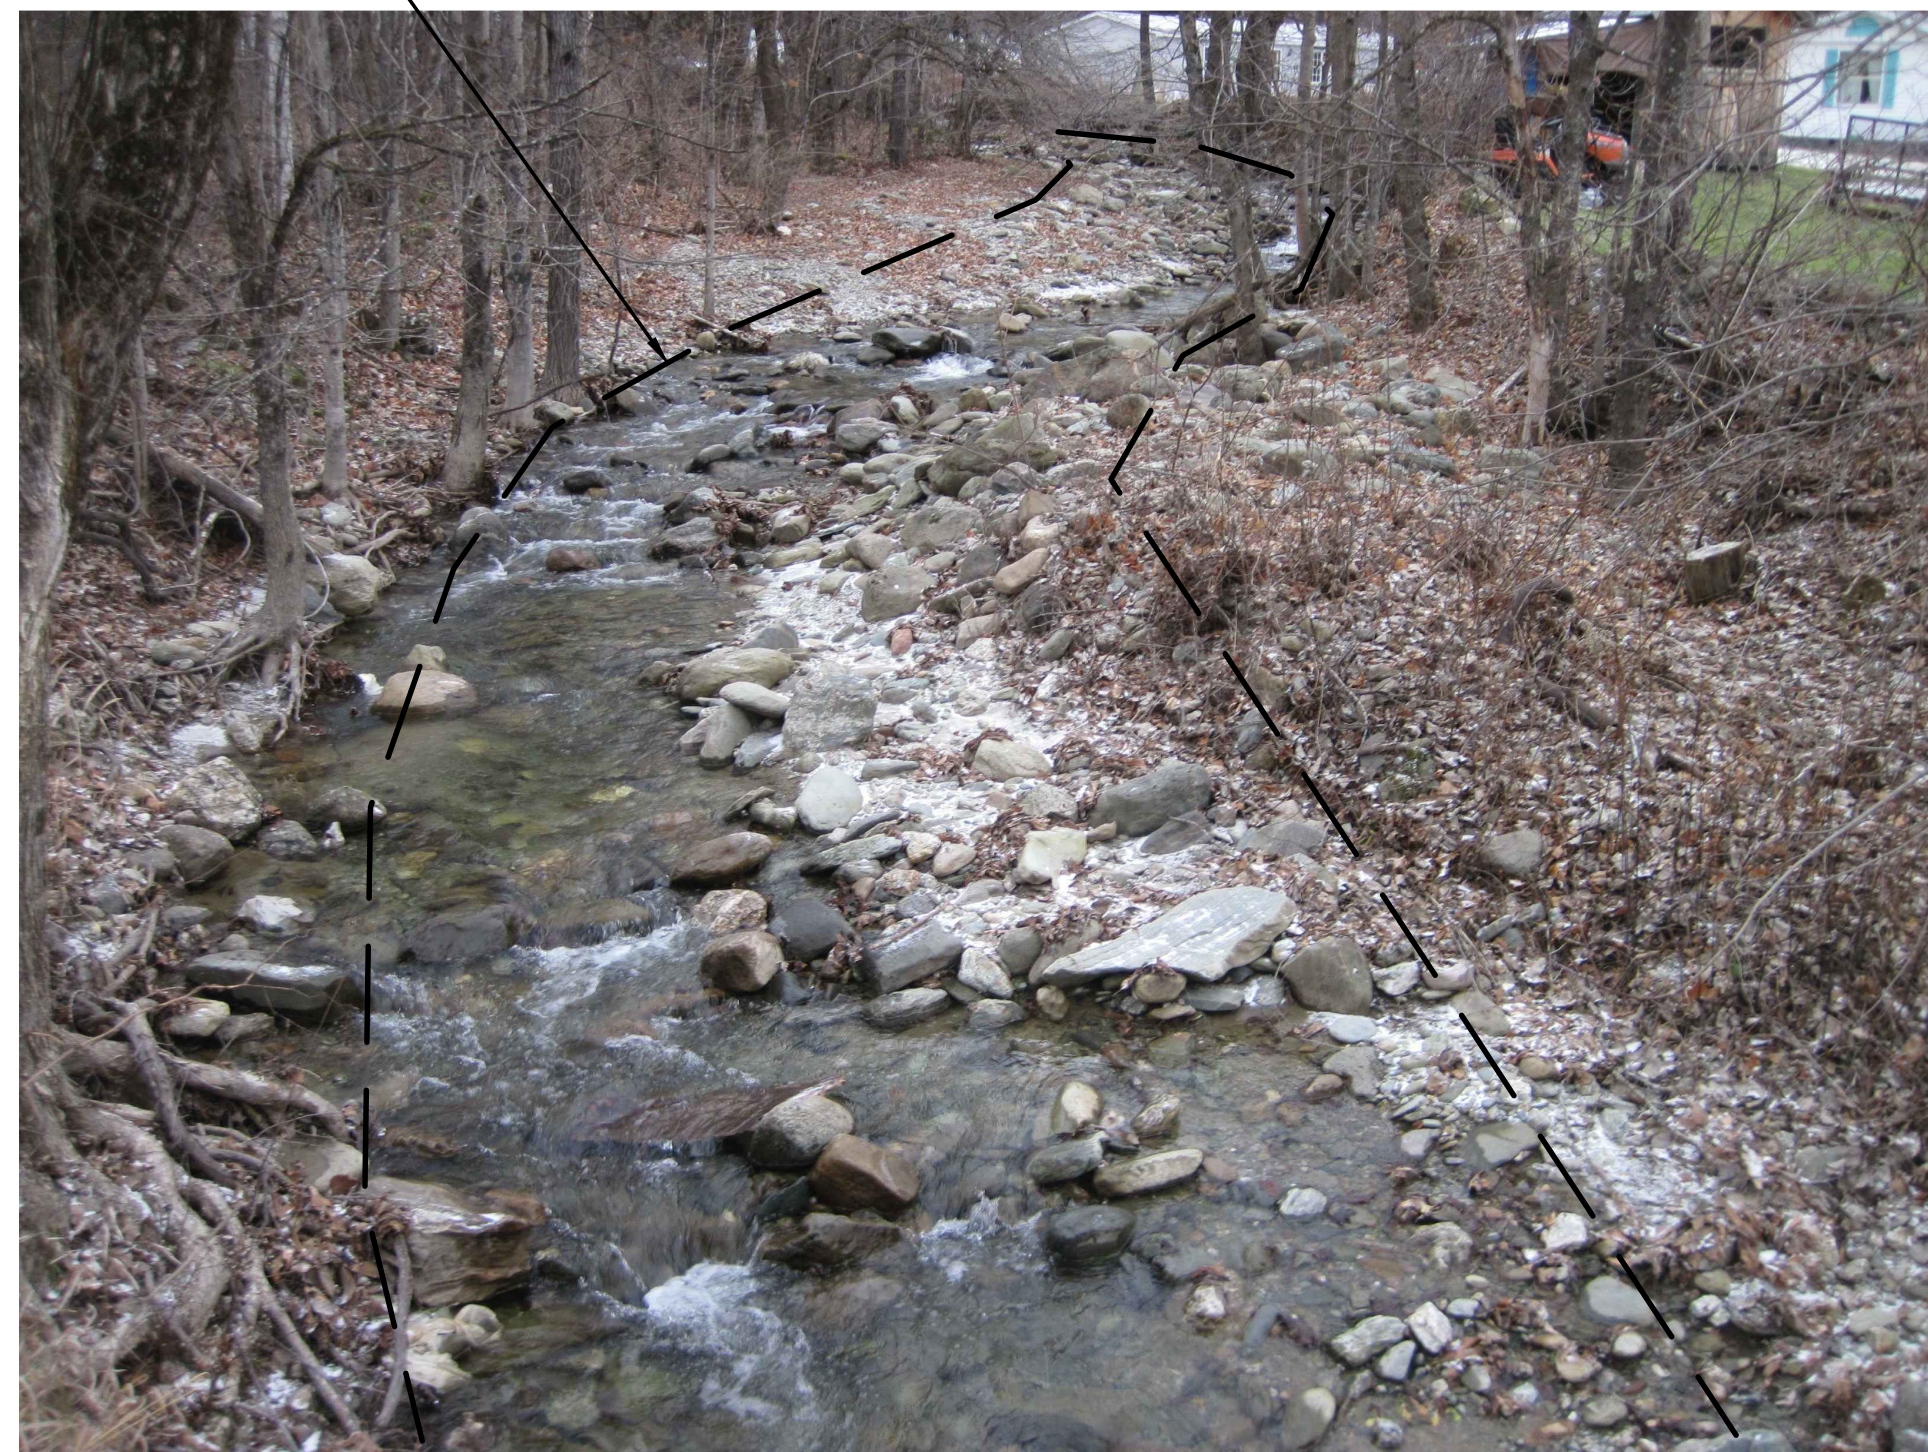
SEDIMENT REMOVAL IMMEDIATELY UPSTREAM OF CULVERTS

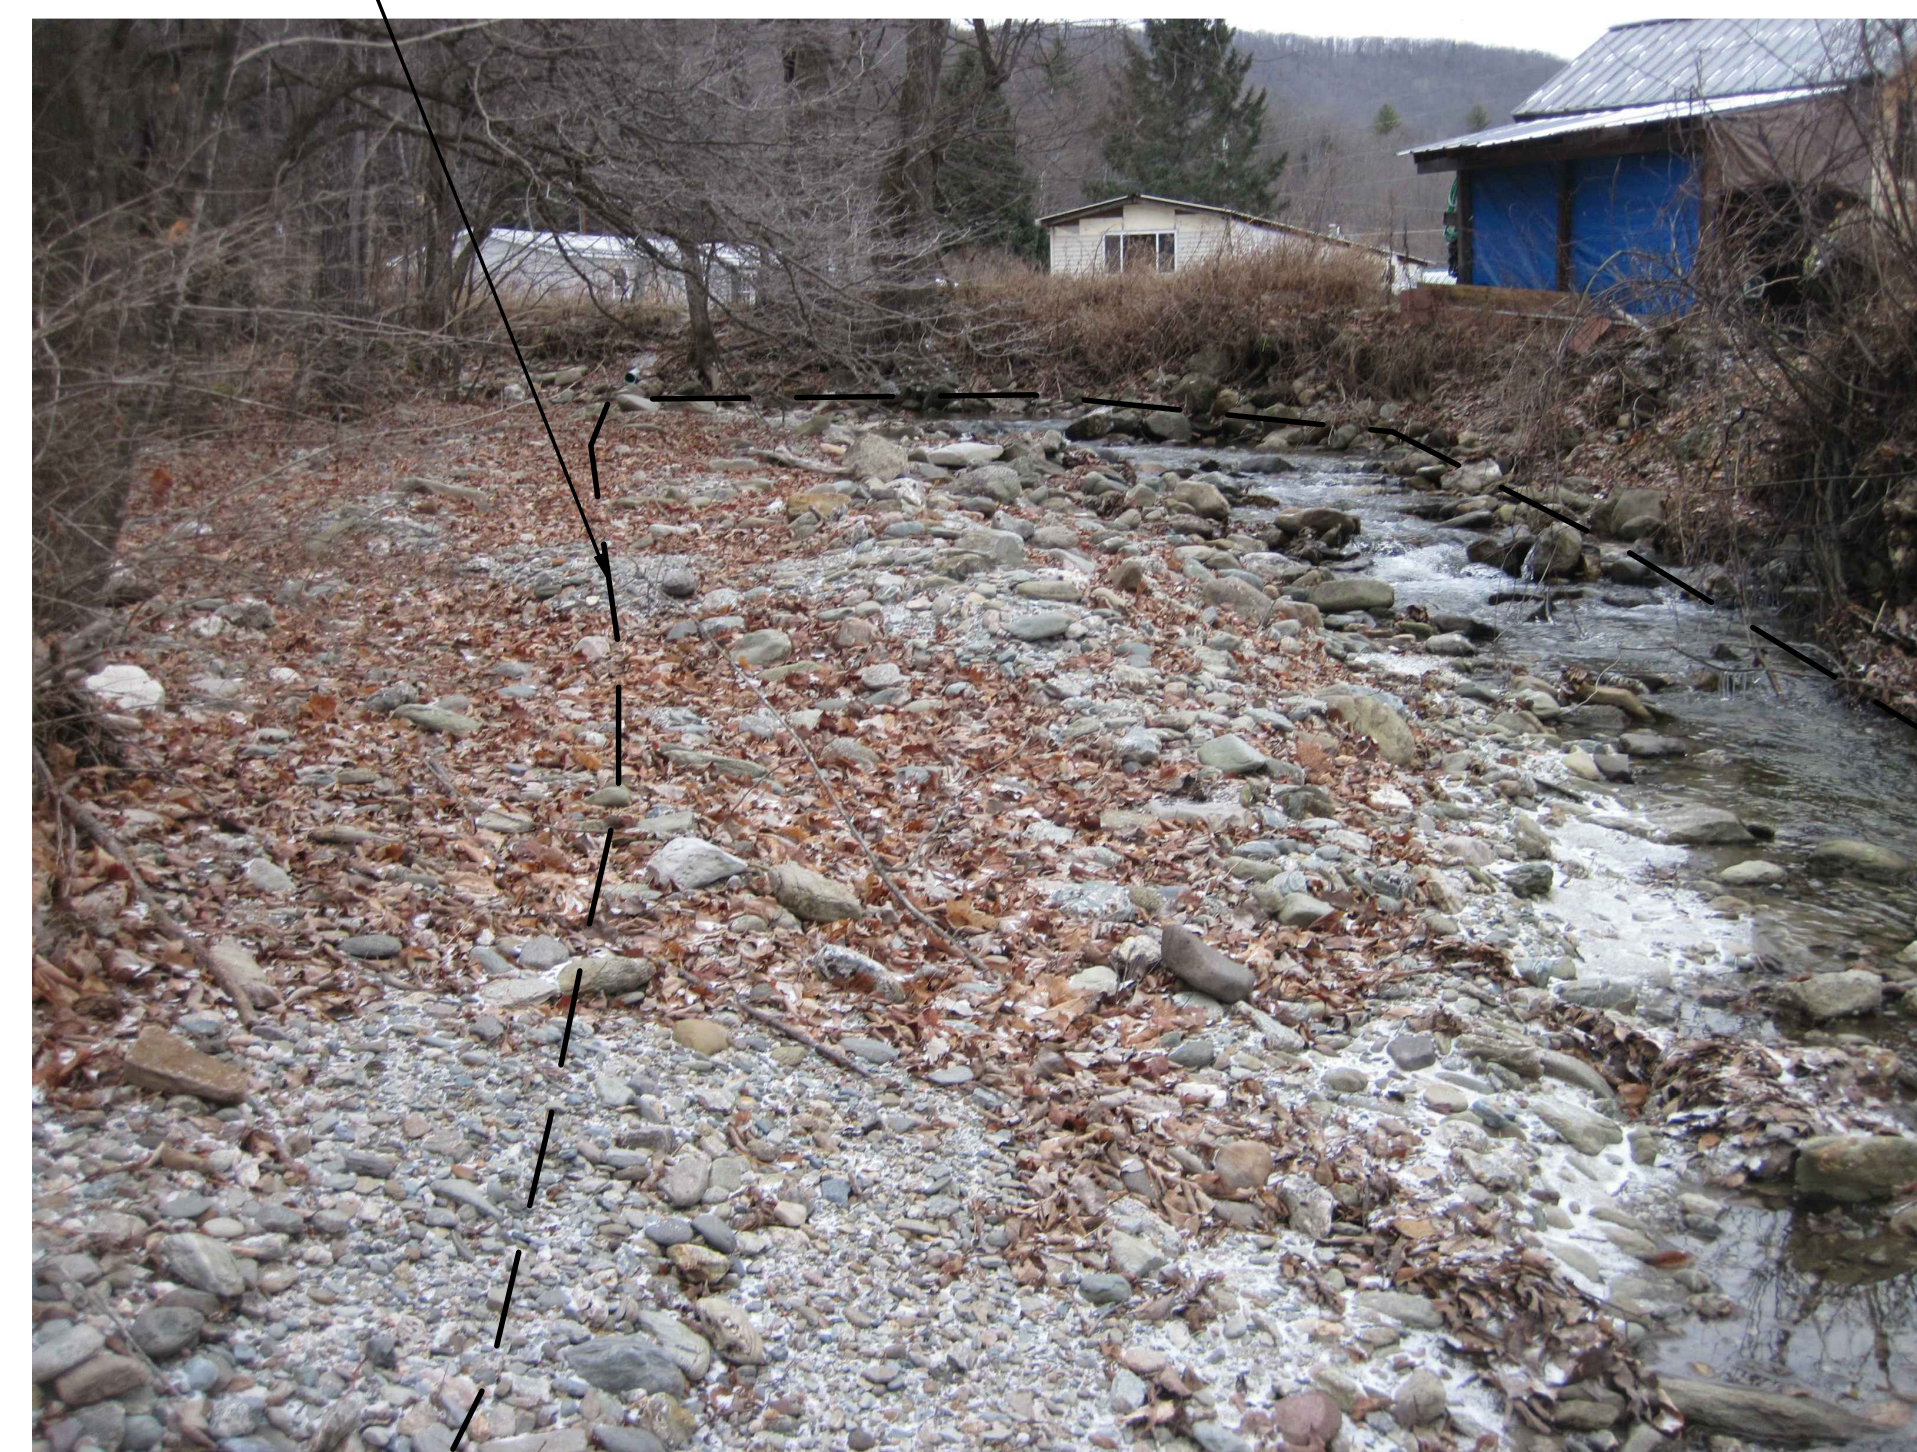
SEDIMENT REMOVAL AT UPSTREAM END OF CULVERT AREA

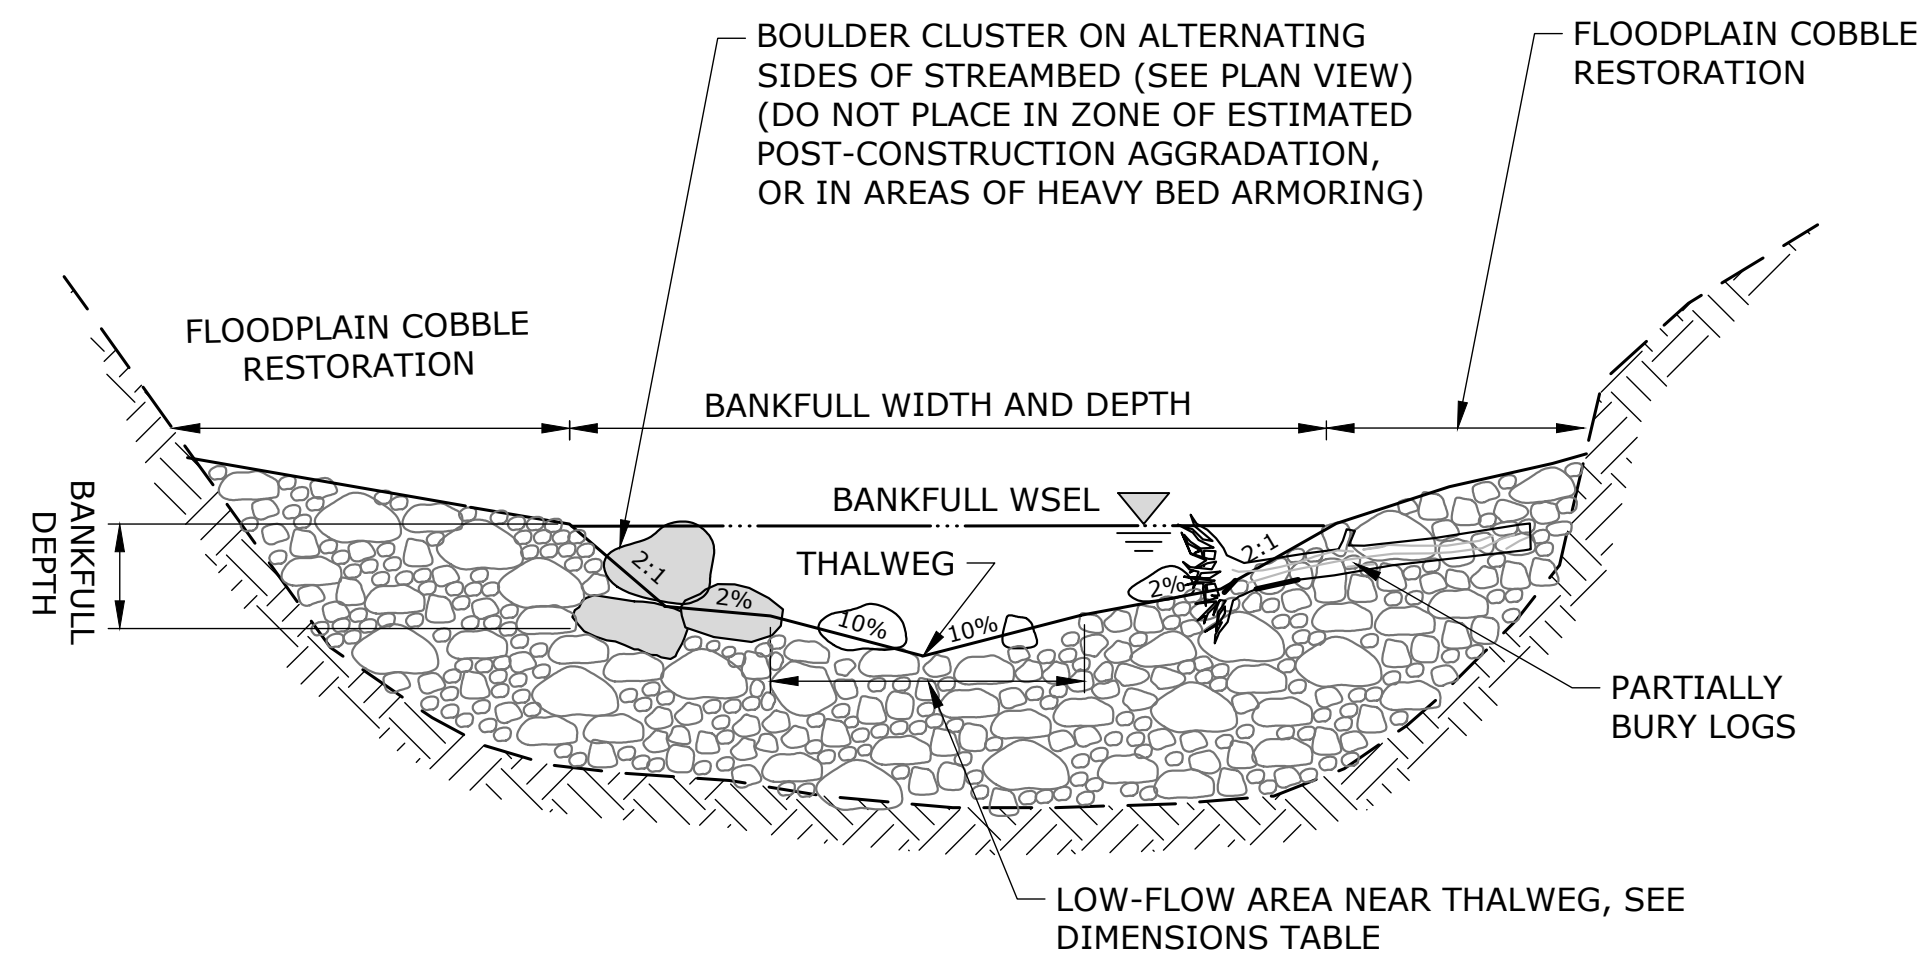
**RESTORED CHANNEL BED**

CROSS SECTION

PROFILE VIEW

**CHANNEL BED GRADING AND RESTORATION NOTES:**

- 1.1. REMOVE AND STOCKPILE ALL EXISTING SAND, GRAVEL, COBBLE, AND BOULDER TO MINIMUM 12" DEPTH WITHIN EXISTING BANKFULL CHANNEL. REUSE MATERIAL ON TOP 12" OF FINAL CHANNEL BED. ALL BOULDERS LOCATED PARTIALLY OR FULLY WITHIN THE 12" SHALL BE REMOVED FOR REUSE.
- 1.2. SAVE AND STOCKPILE ALL LOGS FOR REUSE IN FINAL BED.

- 2.1. PERFORM ROUGH GRADING OF CHANNEL.
- 2.2. DO NOT REUSE FINE-GRAINED SILTS, CLAYS, OR ORGANIC MATERIAL WITHIN THE BANKFULL CHANNEL.
- 2.3. TO ESTABLISH PILOT CHANNEL IN FILL SITUATION: FILL TO WITHIN 12" OF FINAL GRADE WITH NATURAL SAND & GRAVEL/COBBLE/BOULDER RE-USED FROM ON-SITE EXCAVATION. DO NOT USE SILTS, CLAYS, OR ORGANICS. DO NOT USE STOCKPILED BED ARMORING AS GENERAL FILL TO RAISE BED. PLACE FINAL 12" OF MATERIAL FROM STOCKPILED MATERIAL, AND SUPPLEMENT WITH BED ARMORING AS DESCRIBED BELOW.

- 3.1. SHALL BE A V-SHAPED CHANNEL WITH 10% SLOPE FROM DEEPEST POINT TO BANKS, SEE DIMENSIONS TABLE.

- 4.1. SHALL CONSIST OF A 30-FOOT WIDE FLOW AREA UPLAND OF THE LOW-FLOW CHANNEL. IT SHALL GENERALLY SLOPE AT 2% TOWARDS THE LOW FLOW CHANNEL, AND BANKFULL DEPTH HEIGHT BANKS AT 2:1 SLOPE ALONG THE OUTER LIMITS. SEE PLAN AND DETAIL.

- 5.1. PLACE 18"-48" NATIVE BOULDER, SEE PLANS FOR SPACING AND LOCATIONS. SEE CHANNEL ROUGHNESS DETAIL FOR ROCK PLACEMENT AND ORIENTATION.
- 5.2. CHANNEL BED SHOULD BE ROUGH AND "MESSY". SEE UNDAMMED CHANNEL FOR LOCAL EXAMPLE.
- 5.3. INSTALL SAVED LOGS, STUMPS, AND ROOT WADS. PARTIALLY BURY IN BED OR BANKS TO CREATE HABITAT FEATURES.

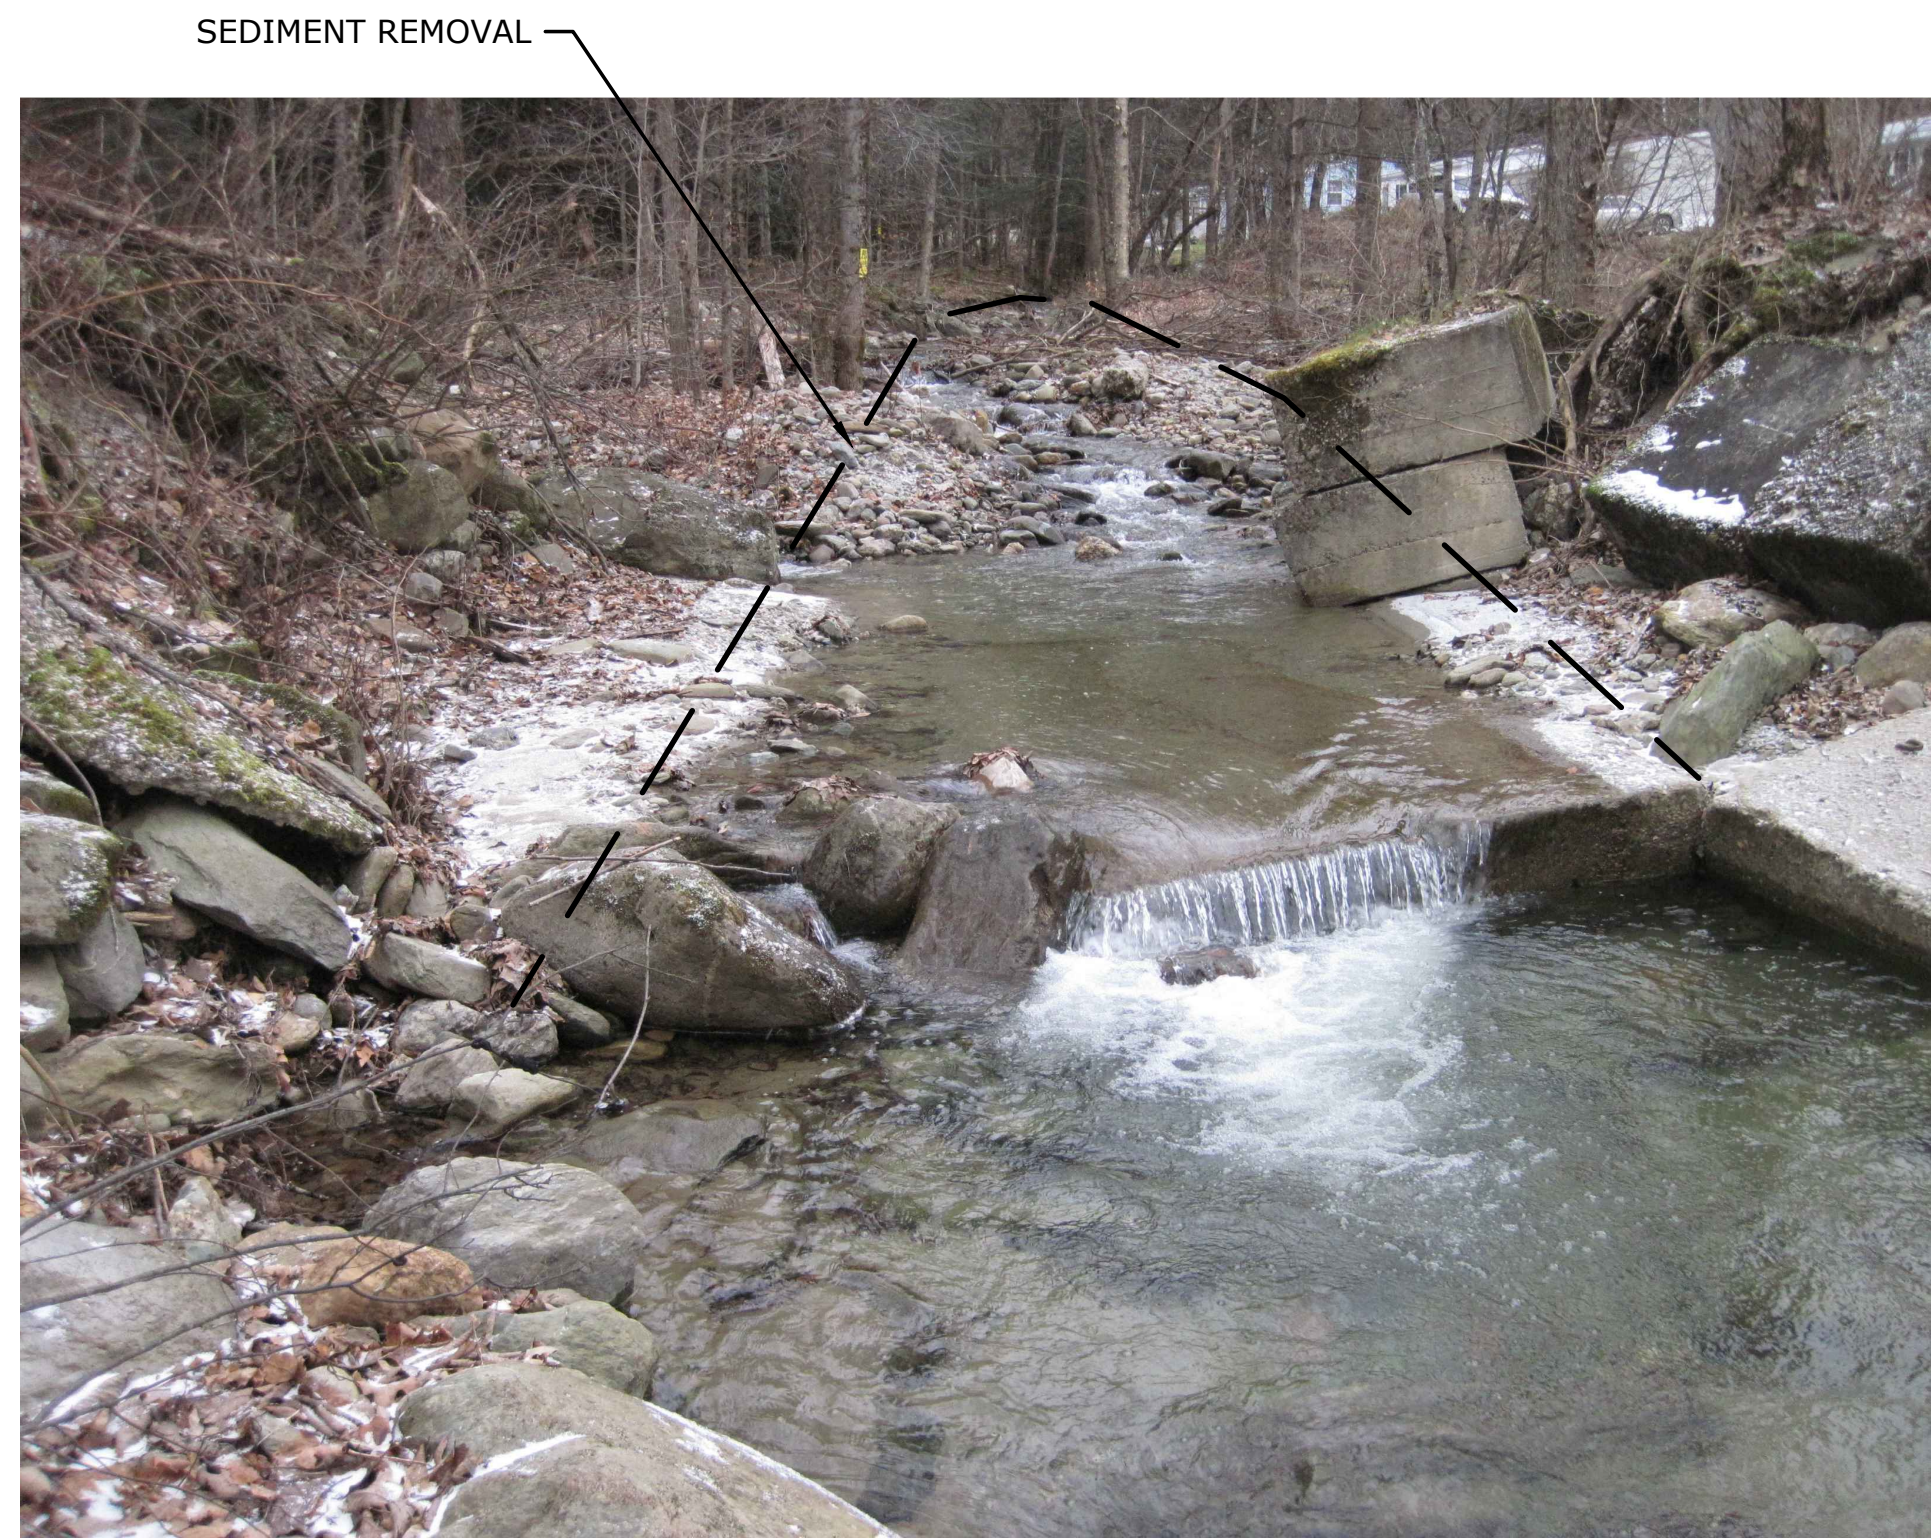
**SEDIMENT REMOVAL OLD BRIDGE**
