## AHEAD OF THE STORM

Site: Hollow Brook Refugia Design

Location: Hollow Brook, Sugarhouse Lane, Starksboro, Vermont

## EXISTING CONDITIONS SUMMARY

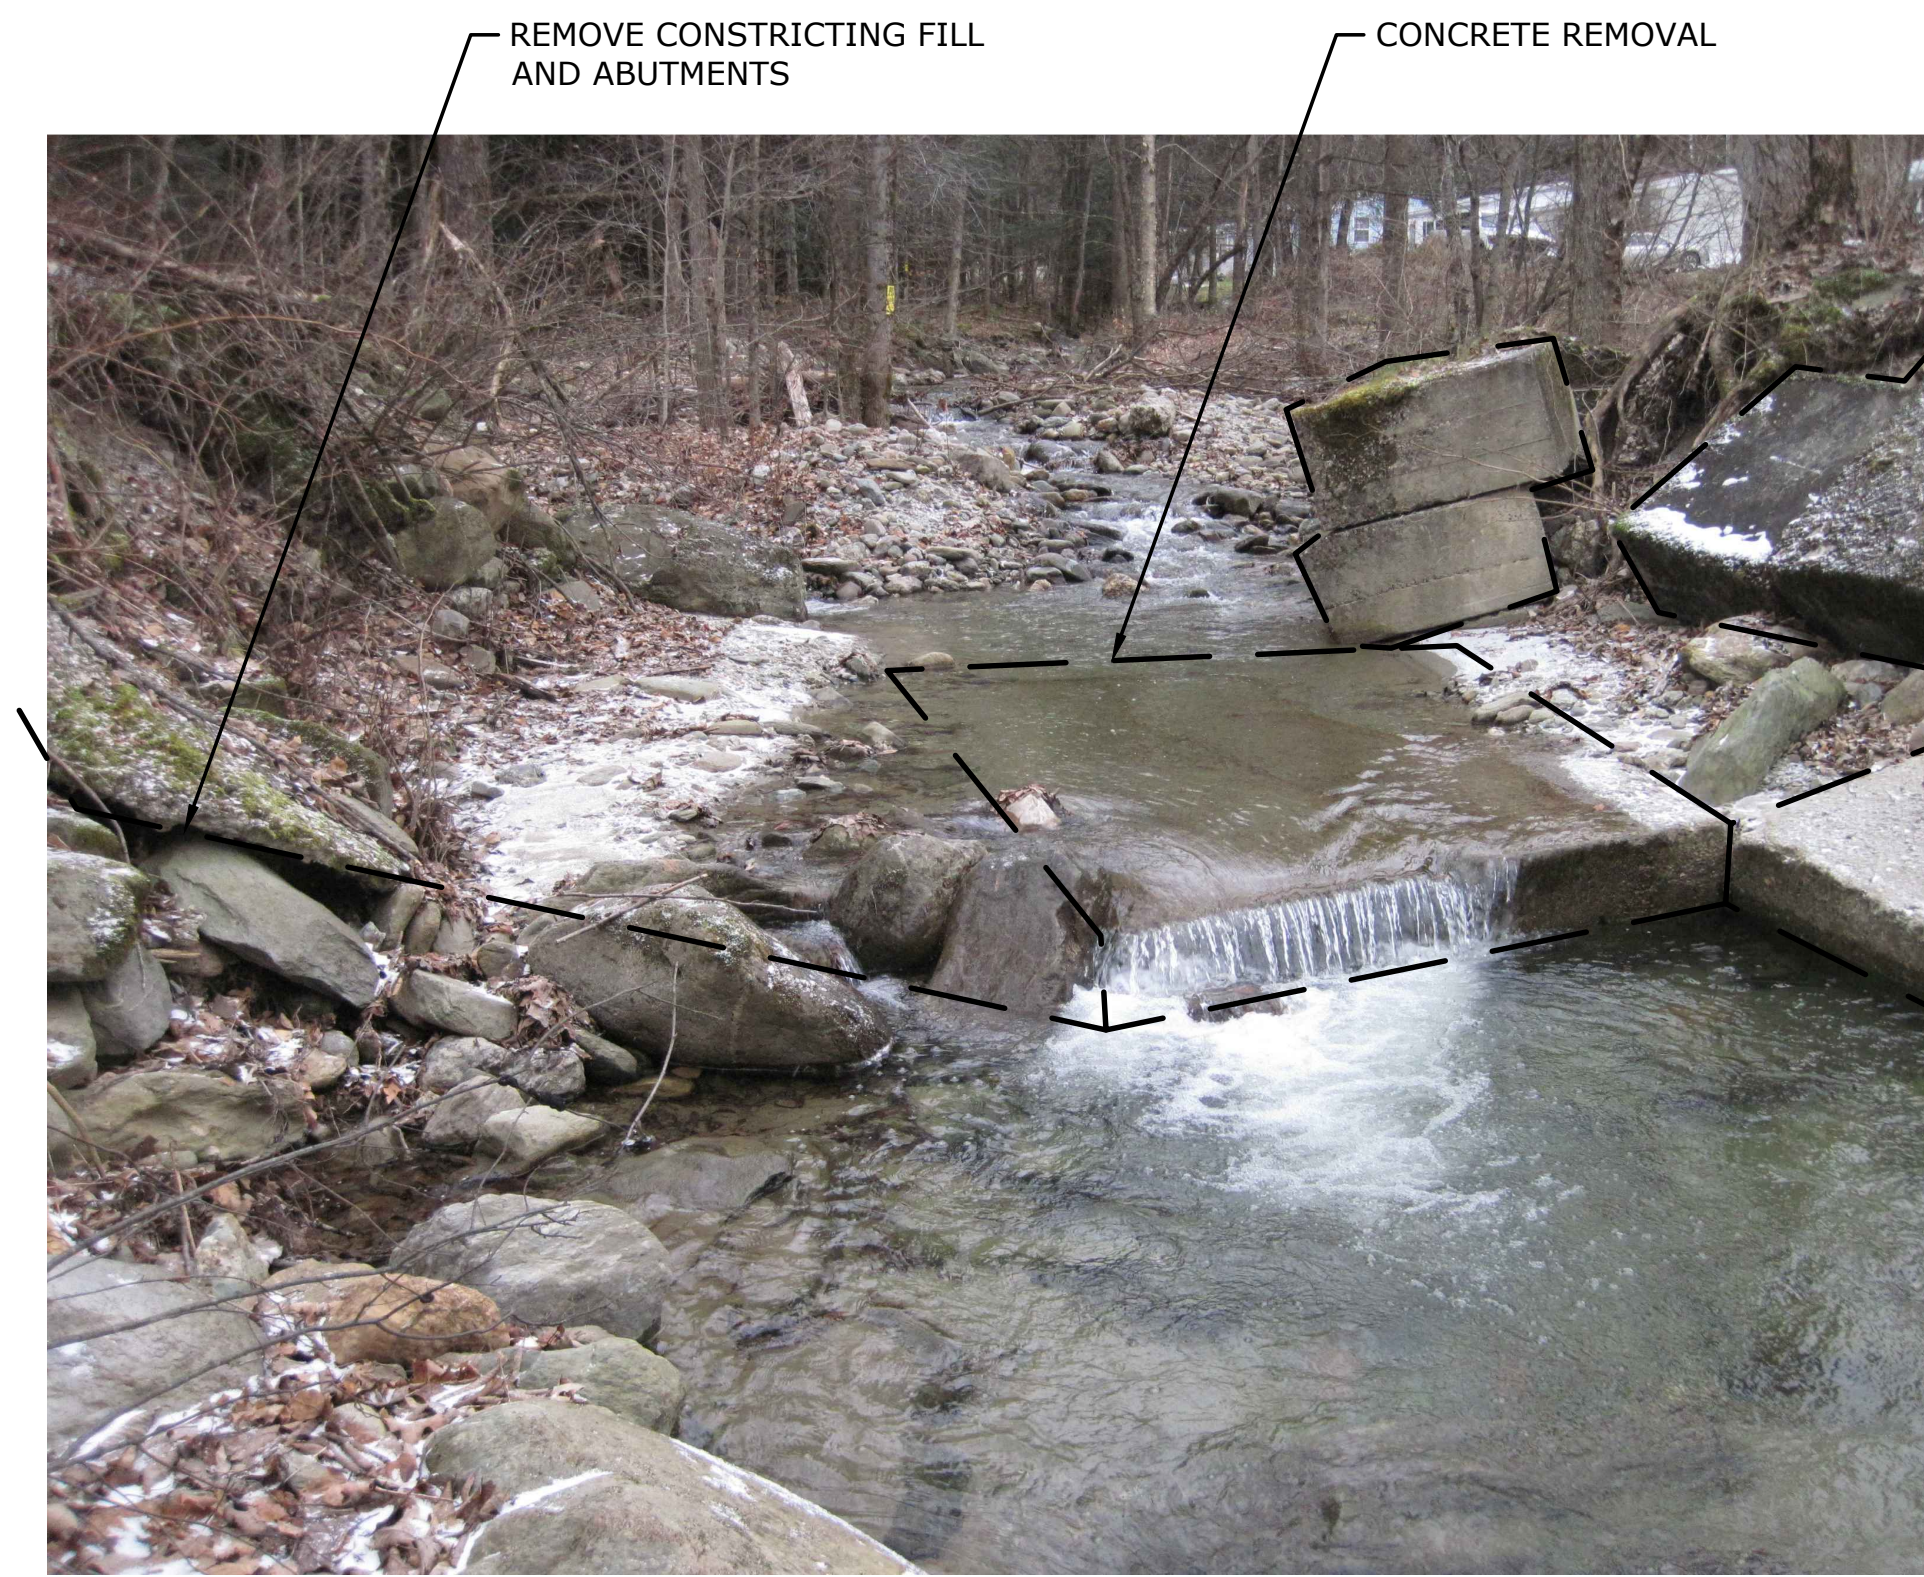
**CONCRETE, FILL, AND ABUTMENT REMOVAL OLD BRIDGE**

- RESTORE CONSTRUCTION AREA TO EXISTING CONDITIONS OR BETTER.
- PLANT FLOODPLAIN AND RIVER EDGE AREAS WITH NATIVE SHRUBS, TREES, AND SEED MIX

- REMOVALS ARE INTENDED TO RESTORE STREAM DYNAMIC EQUILIBRIUM TO ALLOW THE STREAM TO NATURALIZE OVER TIME. THE CHANNEL WILL CONTINUE TO MOVE SEDIMENT THROUGH THIS LOCATION AND MAY CHANGE SHAPE OVER TIME.
- VEGETATION IS TO BE MONITORED DURING THE GROWING SEASON FOR TWO YEARS TO EVALUATE A SUCCESSFUL VEGETATION ESTABLISHMENT OF 80% AERIAL COVERAGE.
- ANY AREAS OF POOR VEGETATIVE COVER SHALL BE REPLANTED ACCORDINGLY.
