Final Report

LaPlatte Watershed Volunteer Water Quality Monitoring Program – 2004

(Background and Interpretation of Results)

**LaPlatte Watershed Partnership
and
Champlain Water District**

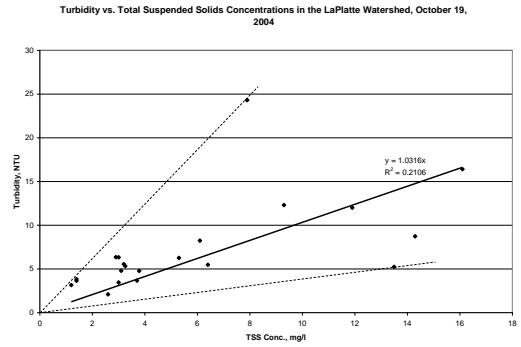
Fig. 18. Turbidity vs. Total Suspended Solids in the LaPlatte Watershed, 2004

Relation of Turbidity to Total Suspended Solids Concentrations. Overall, the relationship between turbidity and total suspended solids concentrations tends towards a 1:1 relationship (Figure 18). The correlation was demonstrated best on June 22. On other dates, greater scatter occurred. On July 20 and October 19, exceptional values at individual sampling stations (MB 3, LP 08, and LP 09 on July 20; MH 3, BB 1, and MB 7 on October 19) were responsible for much of the variability. On September 21, turbidities and total suspended solids concentrations were low and variable, but generally consistent with the envelopes observed on June 22, August 31, and October 19.
