**Lewis Creek Watershed:
River Corridor Conservation & Management Plan**

Addison & Chittenden Counties, Vermont
Starksboro, Monkton, Hinesburg, Charlotte, Ferrisburgh

March 2010

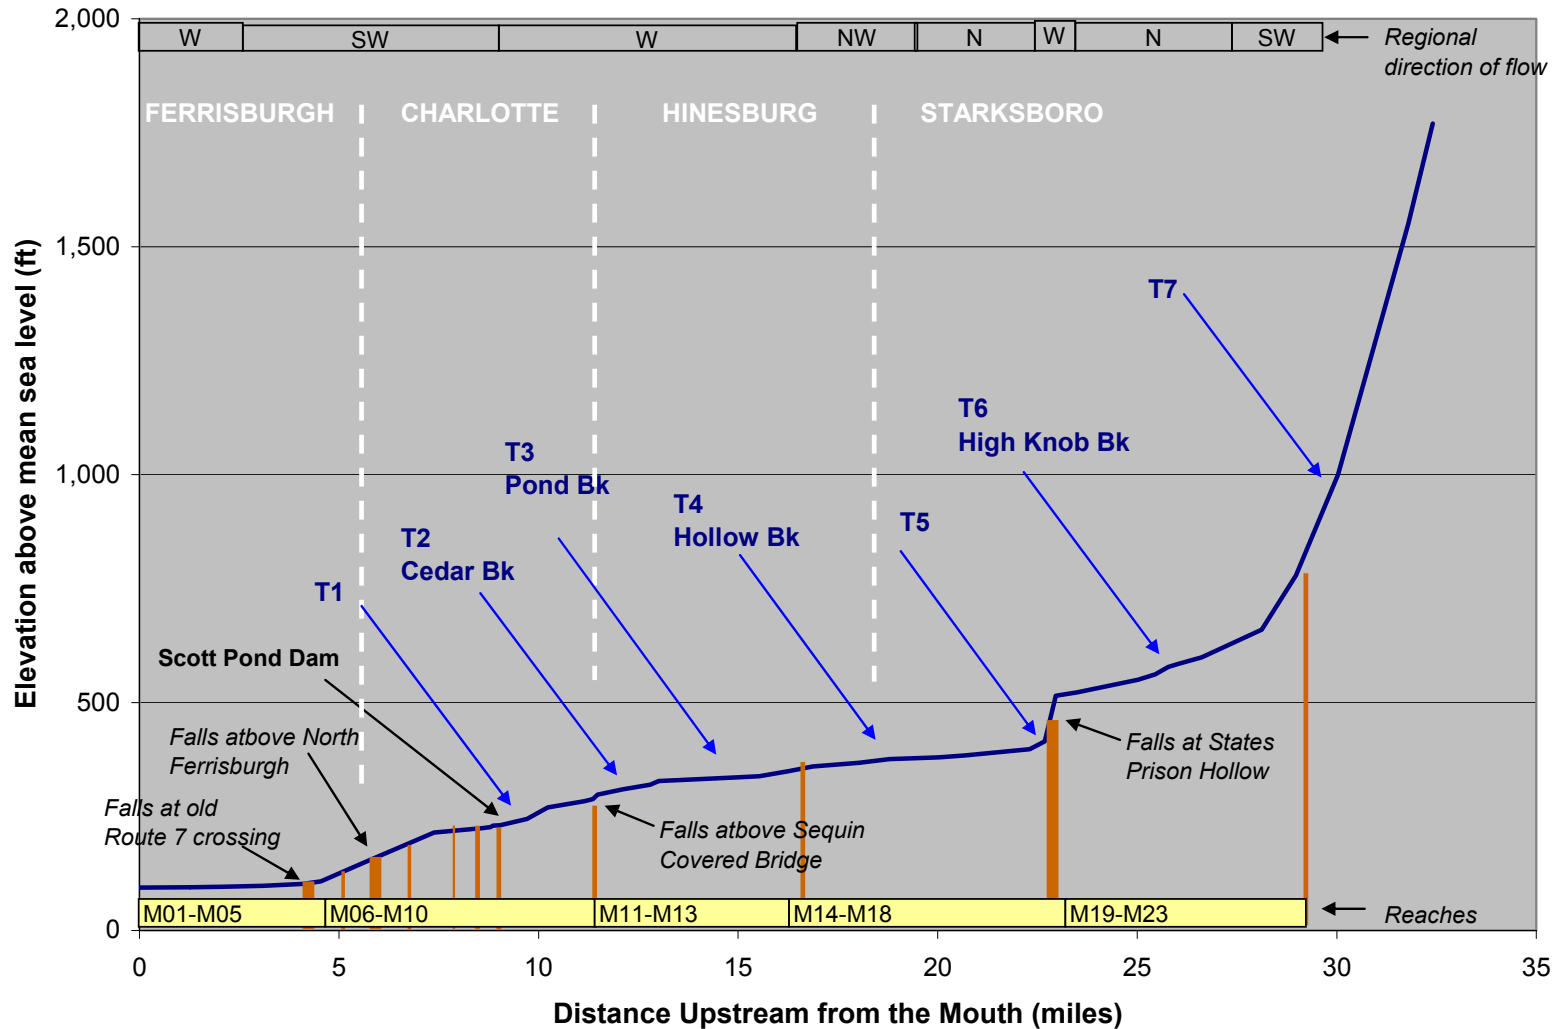
Figure 8. Longitudinal Profile of Lewis Creek main stem
(Orange vertical bars indicate approximate location of channel-spanning bedrock outcrops).

Figure 8 (next page) illustrates the Lewis Creek main stem in longitudinal profile; bedrock outcrops are indicated in orange. Generally, valley and river channel slopes become shallower with distance downstream toward Lake Champlain. Relief in the watershed varies from highest elevations of nearly 2,250 feet above mean sea level (ft amsl) in the headwaters on the western flanks of Hillsboro Mountain in eastern Starksboro, to approximately 95 ft amsl at the mouth in Lake Champlain.

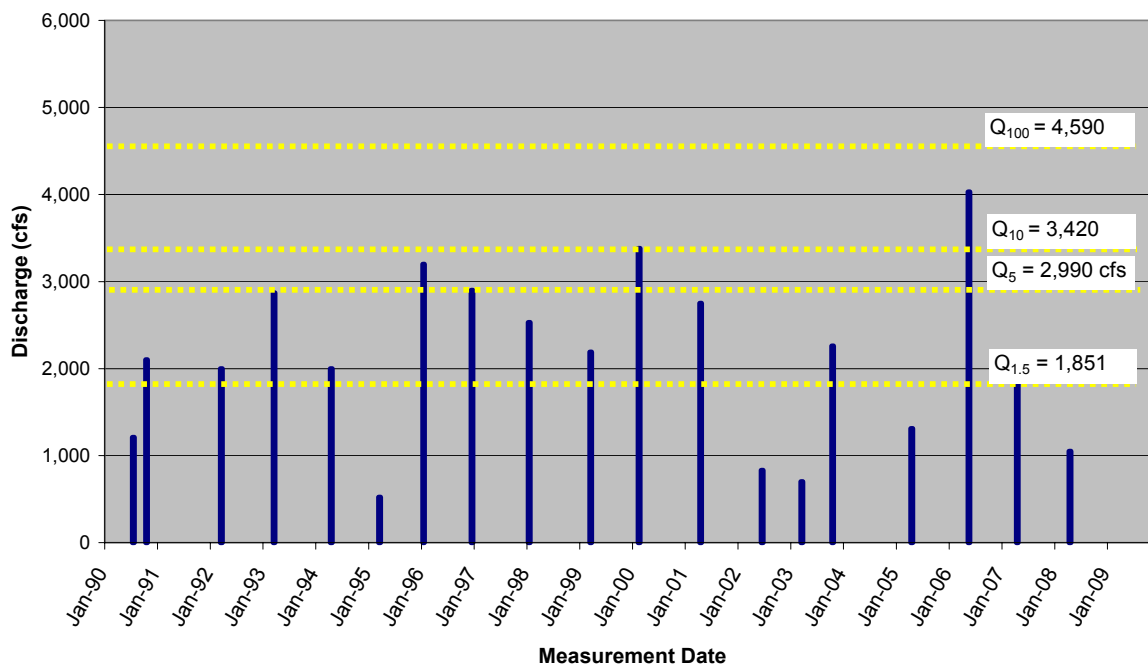
Figure 10. Recorded Peak Flows for Lewis Creek at North Ferrisburgh, VT gage, USGS Stn #04282780 77.2 square miles, reach M05 (compared to estimated flood peaks after Olson, 2002)

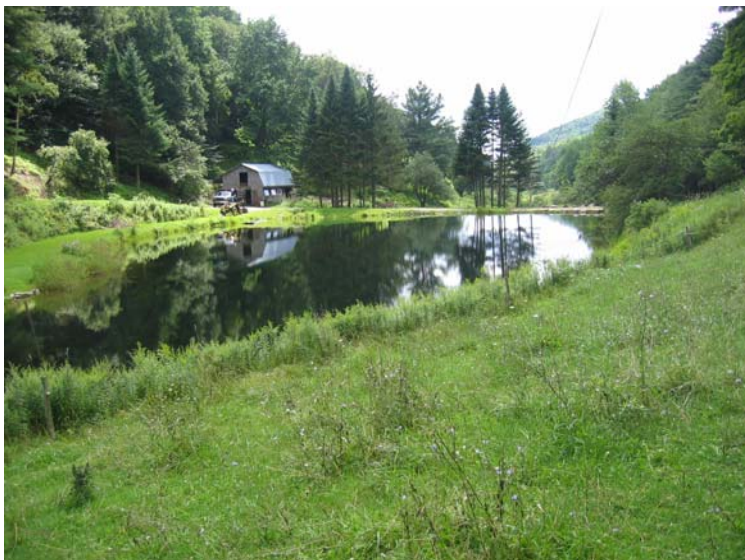
Figure 17. Driveway / impoundment at 3052 Big Hollow Road, Starksboro, T6.06-B.

A 400-foot long and 100-foot wide earthen impoundment extends upstream from a driveway crossing near the mid-point of reach T6.06 (Segment B) on the High Knob Brook (Figure 17). No formal dam structure was apparent (and no such feature was identified on the Vermont Dam Inventory [VCGI, 2005]). The approximate drainage area to this location is small – an estimated 0.4 square mile. A small in-stream pond is created by the earthen dam. This impoundment is present on the 1974, 1995 and 2003 aerial photography, but absent on the 1962 and 1942 aerial photos of the region, suggesting that it was formed between 1962 and 1974. This impoundment is located in a livestock pasture and is likely utilized for irrigation.

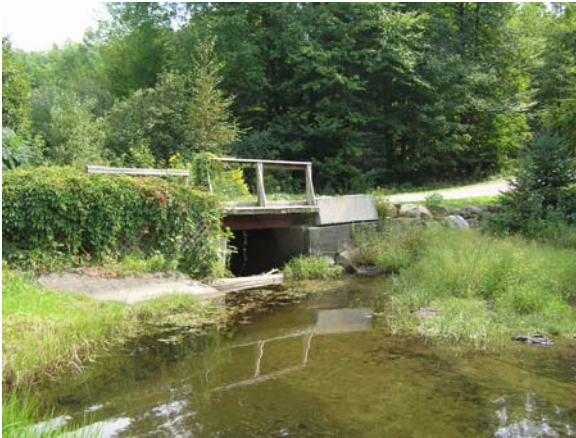
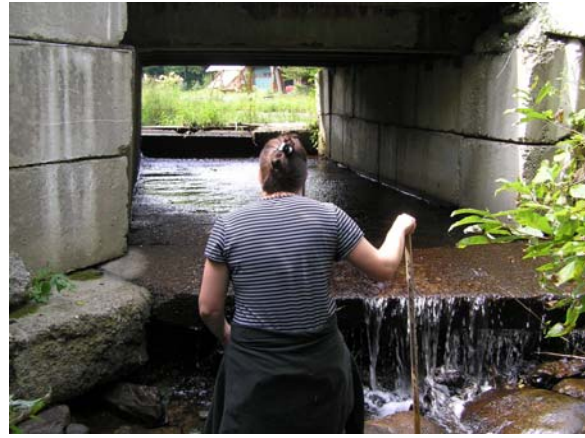
- 2538 Lincoln Hill Rd, Hinesburg, T4.05-D (Hollow Brook)
A small dam with apparent flashboards impounds a relatively wide, but shallow, pond at a residential property. The dam supports a bridge crossing for a driveway to another residence.

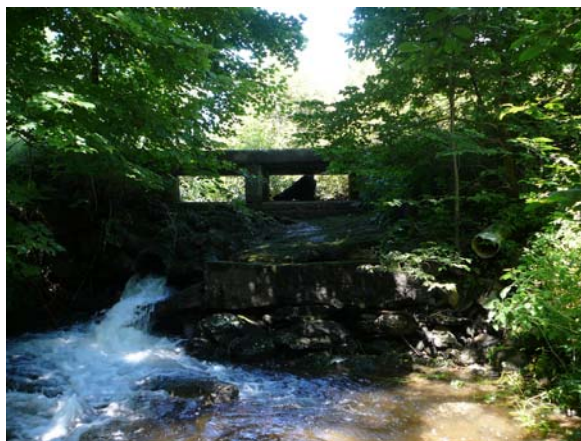
Figure 19. Culvert / dam on Hollow Brook segment T4.05-D.

- 2572 Lincoln Hill Road, Hinesburg, T4.05-D (Hollow Brook)
An instream culvert is embedded in a stone and concrete structure, with a steel trap door on the upstream side (culvert inlet). Low stage flows appear to pass through the main culvert. Moderate to high stage flows would appear to be impounded behind the stone and concrete structure when flow through the main culvert is not sufficient to pass the full discharge (such near-bankfull-stage conditions were observed on 25 July 2008). As impoundment levels rise, some flow would presumably be diverted to an overflow culvert (visible at picture right in Figure 19 below). At very high stages of impoundment, it appears that flows would pass over the top of the stone/ concrete dam and under the concrete driveway bridge that crosses over the top of the dam. The upstream impoundment area is overgrown and does not appear to have a current use.

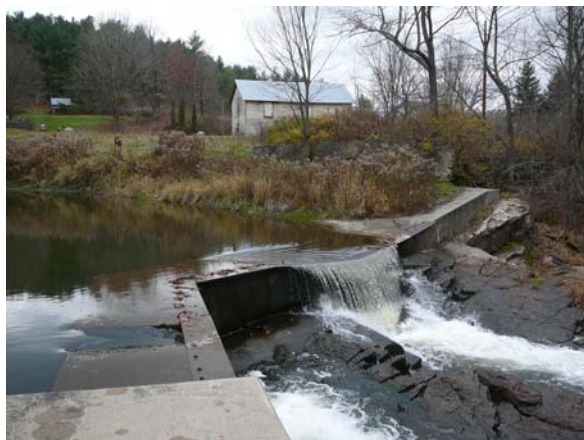
Figure 20. Scott Pond Dam on Lewis Creek segment M09-B.

Impoundment effects of the Scott Pond Dam precluded assessment on short segments M09-B and M10-A. This concrete dam is founded on bedrock, and operates as a run-of-river structure with a minimal upstream impoundment. At present, the dam is maintained as a barrier to the upstream migration of sea lamprey (USFW et al, 2001) (see Section 5.1.1 and Appendix G).

This concrete dam is founded on bedrock, and operates as a run-of-river structure with a minimal upstream impoundment. At present, the dam is maintained as a barrier to the upstream migration of sea lamprey (USFW et al, 2001). The current construction "is a concrete gravity structure approximately 130 feet long and 13 feet high at the end sections. The spillway is a 100' long concrete broad crested weir with 3.5' flat crest with a minimum crest elevation approximately 8 feet below the end sections. The dam appears to be founded on [bedrock] ledge for most of its length. It is provided with an overhanging steel lamprey interdiction plate and a stoplog spillway." (VT Dam Safety Section, 1994).

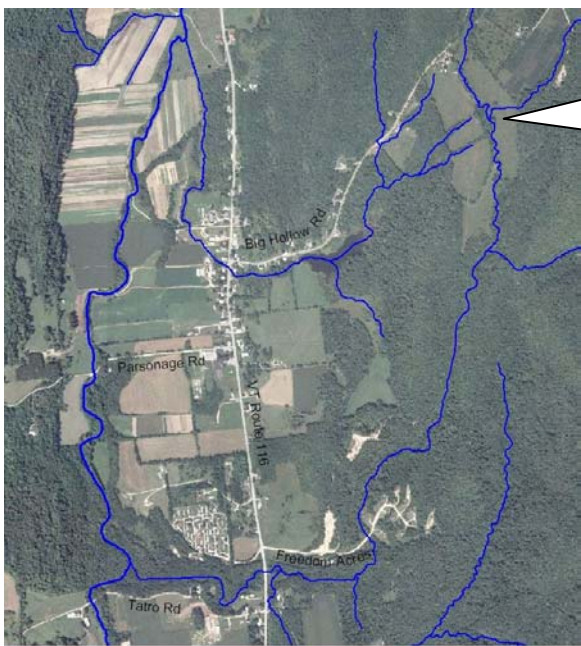
Figure 21. Potential historic diversion or avulsion of High Knob channel from a path through Starksboro village to the current planform which joins the Lewis Creek near the Tatro Rd crossing.

One curious finding in the High Knob tributary was noted during review of historic maps. According to the 1905 USGS Middlebury, VT 15-Mintue topographic map and the 1871 Beers Atlas for Addison County (Starksboro), the High Knob tributary previously continued along the Big Hollow Road, drained via the Baldwin Pond, through Starksboro village and joined the Lewis Creek main stem in reach M19 (see Figure 21). These early map publications may have been in error. This is a small tributary flowing through somewhat remote territory that would have been difficult to field survey at the time these maps were produced. Or perhaps the High Knob tributary did actually flow in this other planform at one time. If so, it is not known whether the current planform resulted from a sudden avulsion (perhaps the 1913, 1927 or 1938 flood), or as a result of channel manipulation in the early to mid-1900s. The available resources consulted in this Phase 2 assessment did not indicate either a historic avulsion or diversion of the channel in this location. In absence of specific data, neither an avulsion nor diversion was indexed.

Such a diversion would have increased hydrologic stresses to M20 and upper reaches of M19, as the drainage area would have suddenly been increased – from approximately 11 to 16 square miles – or an increase of nearly 50%. Theoretically, such an increase could have contributed (at least in part) to observed historic incision in reach M20 and M19-B, as well as observed minor to moderate incision in middle segments of the High Knob tributary (current planform).

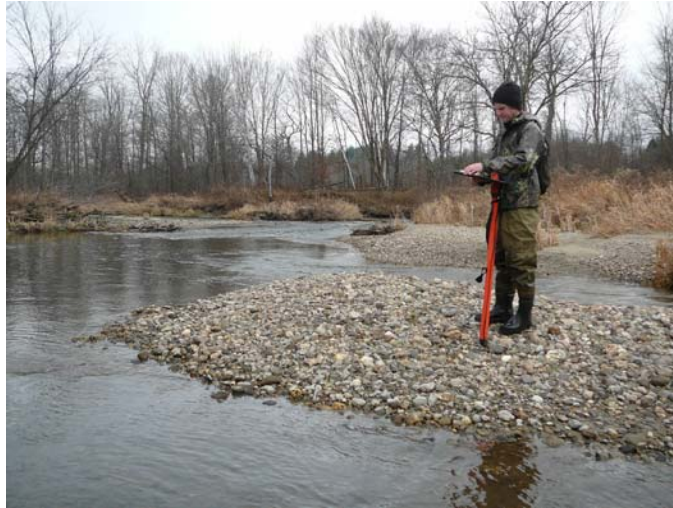
Figure 24. Location of active planform adjustment, aggradation and widening upstream of Tyler Bridge Road crossing. View downstream. Segment M15-B, 29 November 2006.

- Segments M15-B and M15-A contain multiple flood chutes and depositional bars which are suggestive of sediment loading from upstream, instream and tributary (Hollow Brook) sources. Beaver dam activity is likely to be a contributing factor. Deposition and lateral adjustments in M15-A may also be induced by the constraints of a downstream valley pinch point (reach M14).

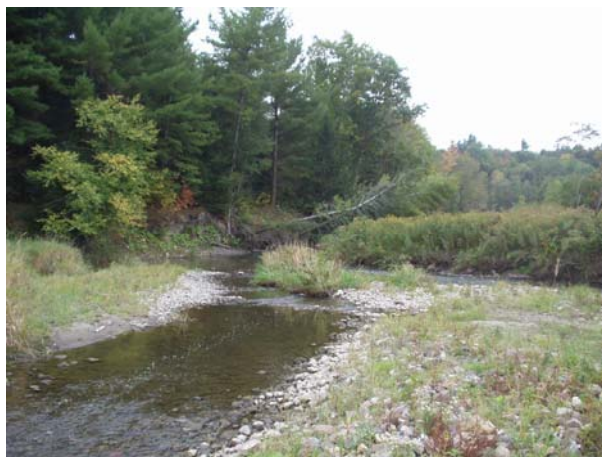
Figure 25. Location of active planform adjustment, aggradation and widening downstream of North Ferrisburgh village. View downstream. Reach M06. 2 October 2004.

- Reach M06 contains multiple steep riffles, mid-channel bars, and flood chutes. A couple of tributary confluence bars, one pre-2003 post-1995 avulsion, and two locations of channel braiding were also indexed. This mile-long reach is positioned between the somewhat steeper and bedrock-controlled upstream reach, M07, and the semi-confined and bedrock-controlled channel of downstream reach, M05. The active planform adjustment observed in this reach is, in part, a response of the channel to these natural variations in valley confinement and channel gradient. Conditions may also have been exacerbated by sediment loading from tributaries, historic removal of forested buffers, presence of erodible sediments in the channel margins, and inferred historic channelization and incision.

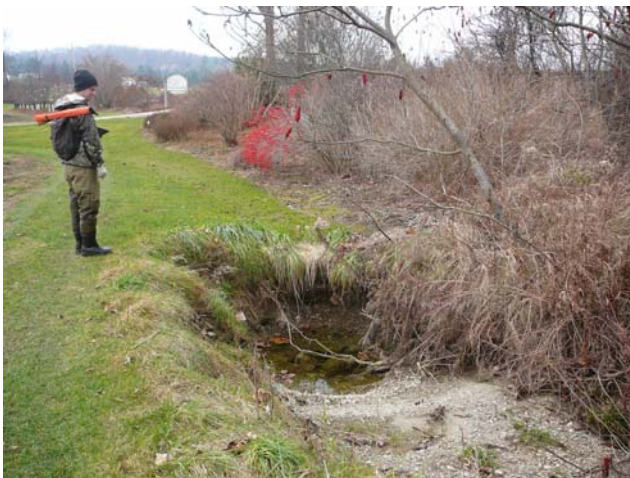
Figure 26. LB stormwater channel from commercial tree nursery in Segment M15-B just upstream of the Tyler Bridge Rd. With the addition of drainage diverted from an upstream residential property, this channel has developed into an erosional gully that has deposited gravels and sands in the Lewis Creek channel. 29 November 2006.

One significant gully site was identified on the assessed reaches of the Lewis Creek watershed in segment M15-B. A LB channel directs overland flow from a commercial tree nursery to the Lewis Creek channel and has developed into a moderately-sized gully with an associated "delta" of fine to coarse gravel sediments (see Figure 26). This gully represents a source of stormwater flows and sediment to the Lewis Creek. Potential significance of this gully site as a source of sediments may be moderated somewhat by the size of the upstream watershed of the Lewis Creek at the confluence of this stormwater channel (approximately 36 square miles).

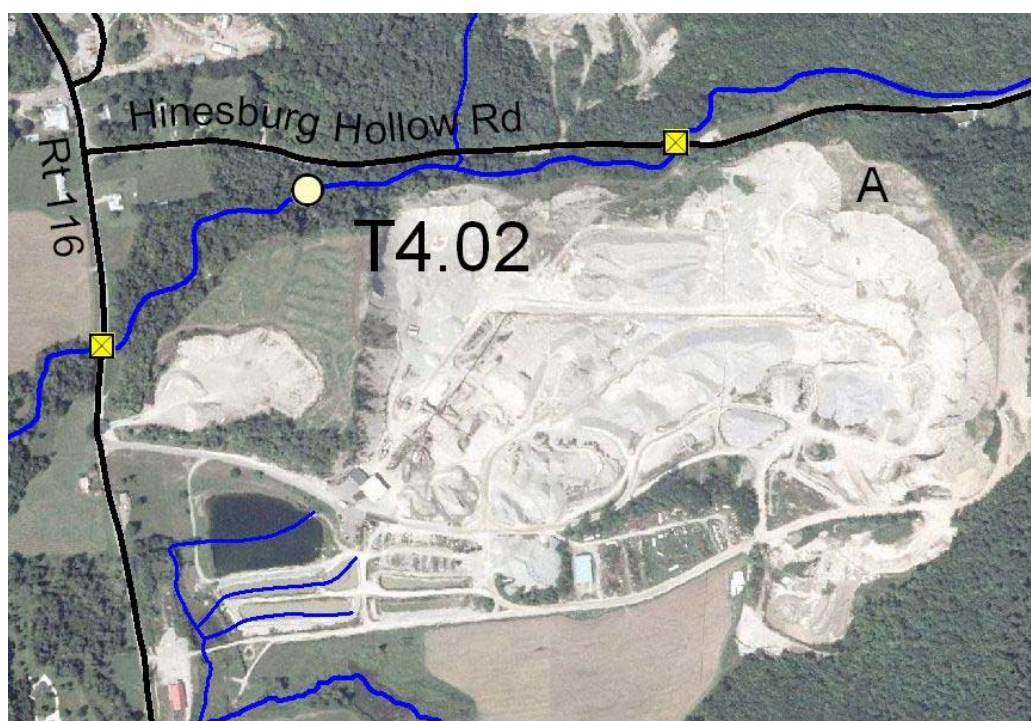
Figure 39. Potential site of Hollow Brook stream capture by Hinesburg sand & gravel quarry. (Base image: 2003. Yellow squares indicate bridge crossings with a span that is constricting to the flood-prone width of the channel.)

the berm during high flows in the Hollow Brook could result in avulsion of the channel into the Hinesburg sand and gravel quarry. A location of particular concern is the vicinity of a northern access road to the quarry located just east of the Hollow Road bridge crossing of Hollow Brook – where the berm separating the river and the sand and gravel quarry is at a low point and the access road provides a potential pathway for flood waters to enter the quarry. The bridge is undersized with respect to the flood-prone width of the channel, and is oriented at a sharp angle to the channel. A potential debris jam at this constricting structure could increase the likelihood of channel avulsion into the quarry. This potential avulsion hazard is noted for its possible destabilizing effects upstream and downstream on the Hollow Brook, and for the impacts to quarry operations and public safety.
