AHEAD OF THE STORM

Site: Charlotte Library

Location: Ferry Road, Charlotte, Vermont

POST-CONSTRUCTION SUMMARY

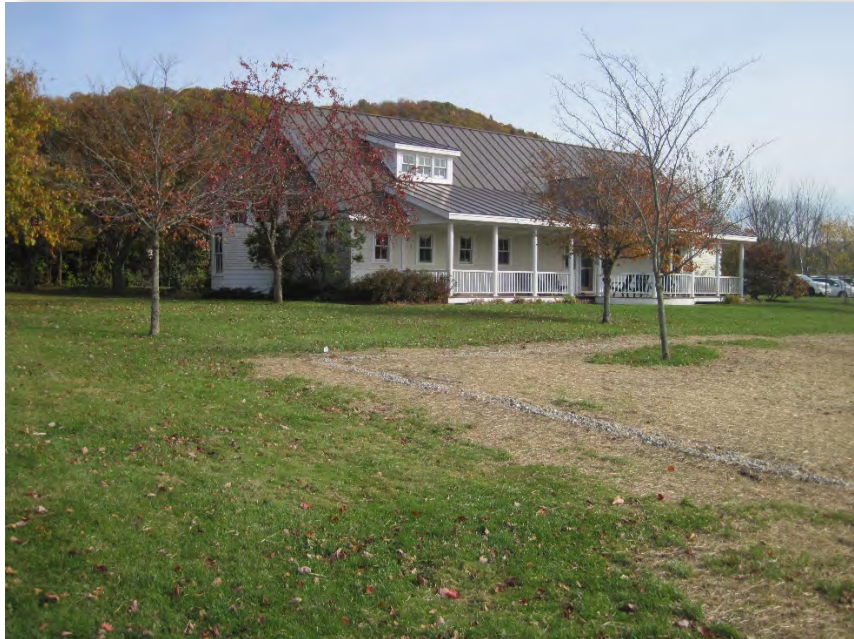
Pre-Construction, October 27, 2015: Library existing building, looking across Green. Newly installed gravel perimeter trench drain visible.

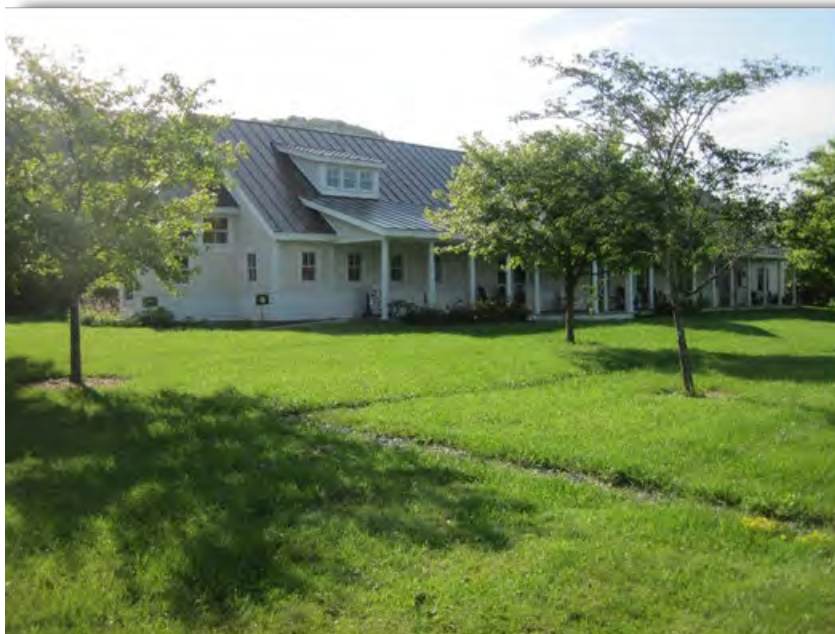
Post-Construction, July 23, 2021: Library building. Railings have been removed. Addition is visible at image right.

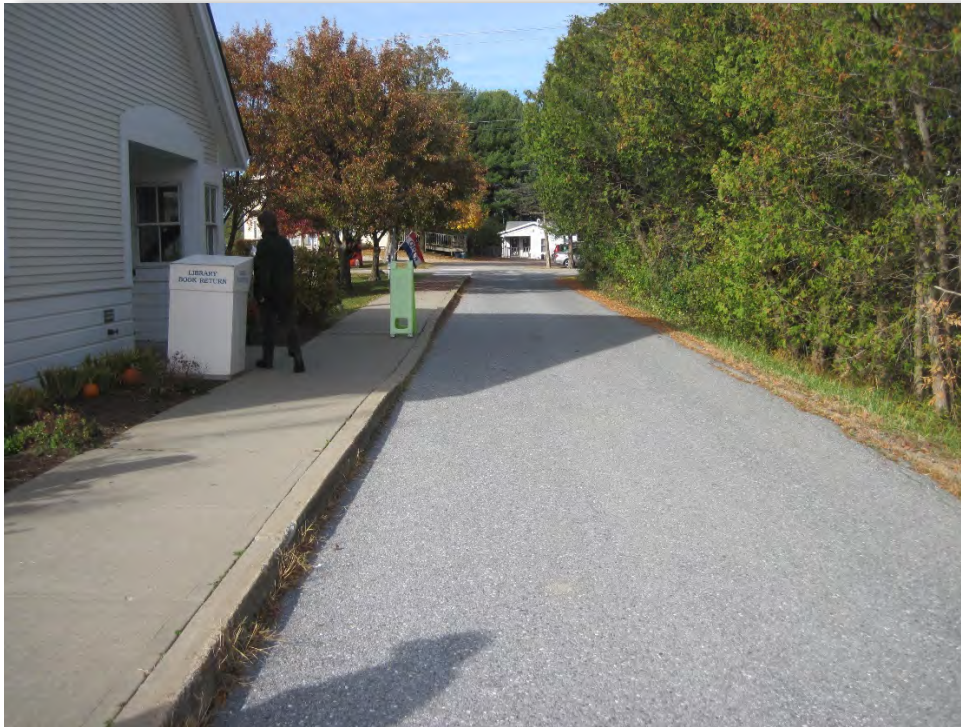
Pre-Construction, October 27, 2015: Library entrance driveway. Existing site runoff sheet flows across driveway to swale on other side in bushes.

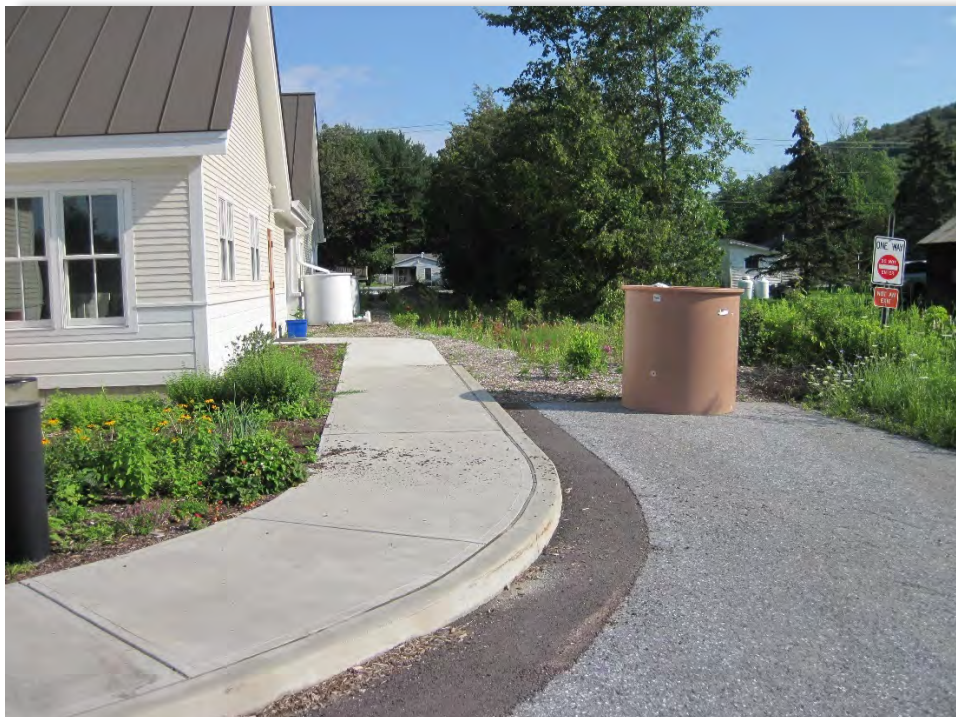
Post-Construction, July 23, 2021: A portion of the impervious surface from the library entrance driveway has been removed and a bio-retention area has been installed fed by overflow from rain barrels collecting roof runoff.

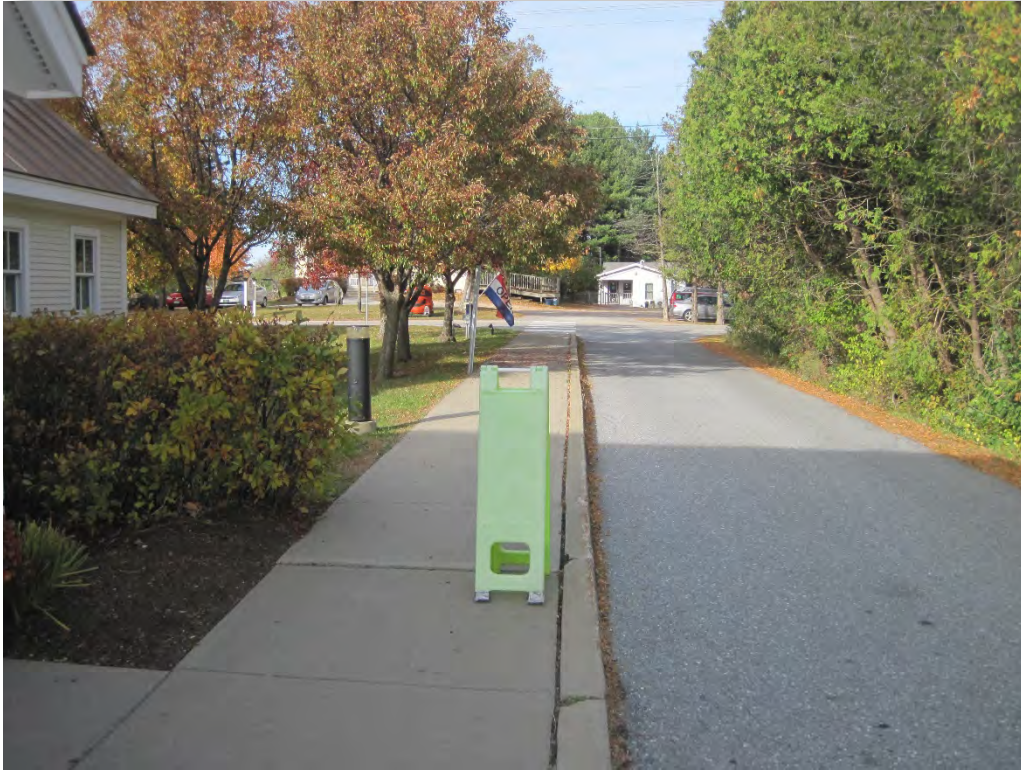
Post-Construction, July 23, 2021: North end of bio-retention area and new sidewalk at former Ferry Road library entrance.

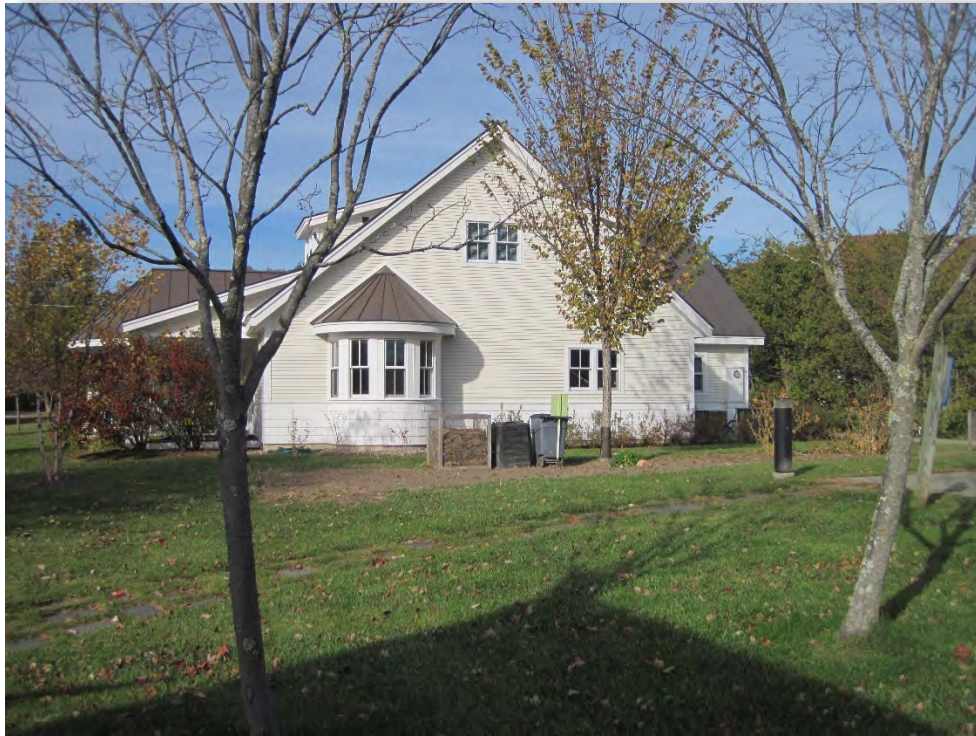
Pre-Construction, October 27, 2015: South end of library building. Existing gardens in foreground could be watered using collected rainwater.

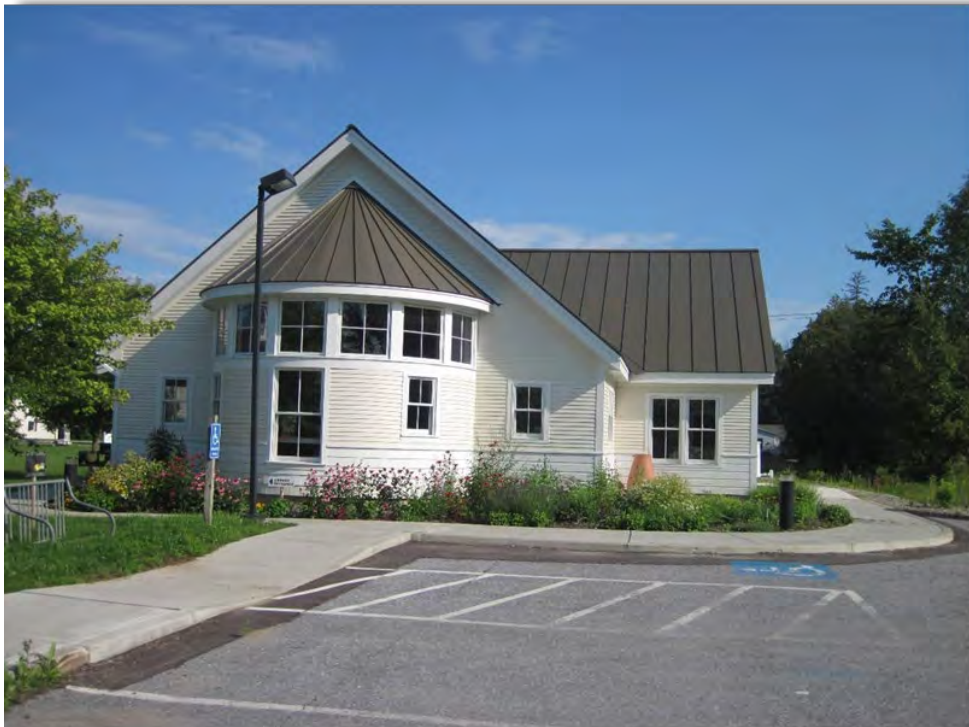
Post-Construction, July 23, 2021: South end of library building. An addition has been added at the south end of the building, rainbarrel installed, and additional gardens planted.

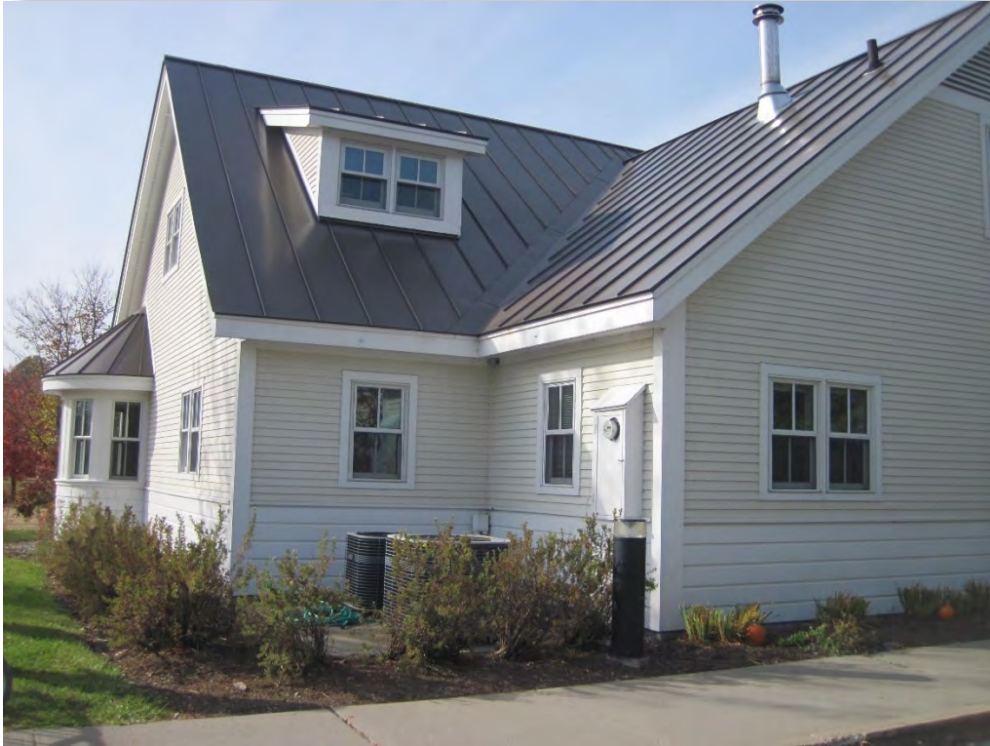
Post-Construction, July 23, 2021: Gutter, downspout, and rain barrel installed. Overflow from this rain barrel flows into the bio-retention area. Runoff collected in the rain barrel will be used for garden watering.

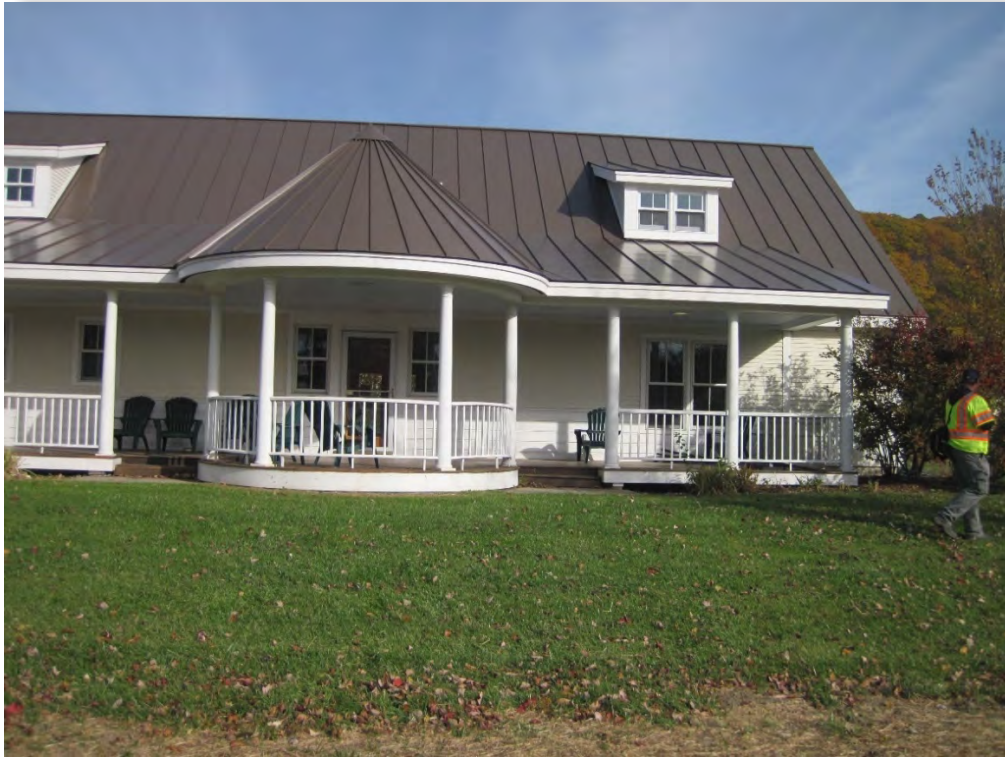
Pre-Construction, October 27, 2015: West side of the library. Roof runoff currently falls off roof and travels overland into the Green.

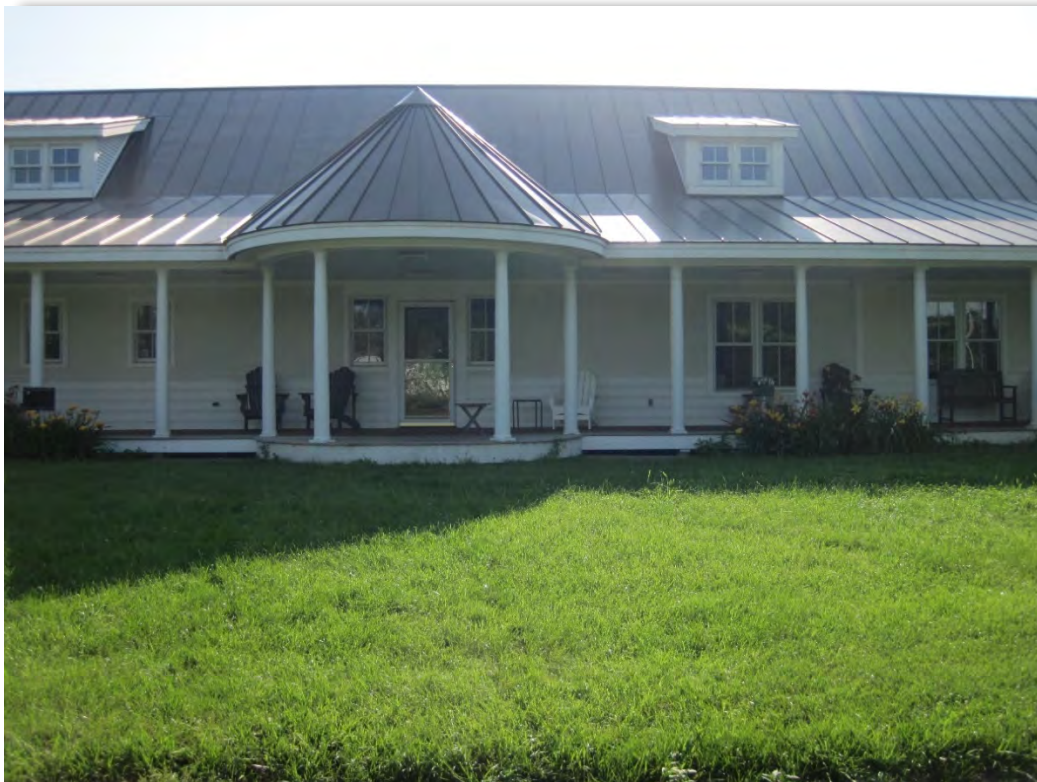
Post-Construction, July 23, 2021: West side of the library. Bio-retention areas planned in front of the porch.

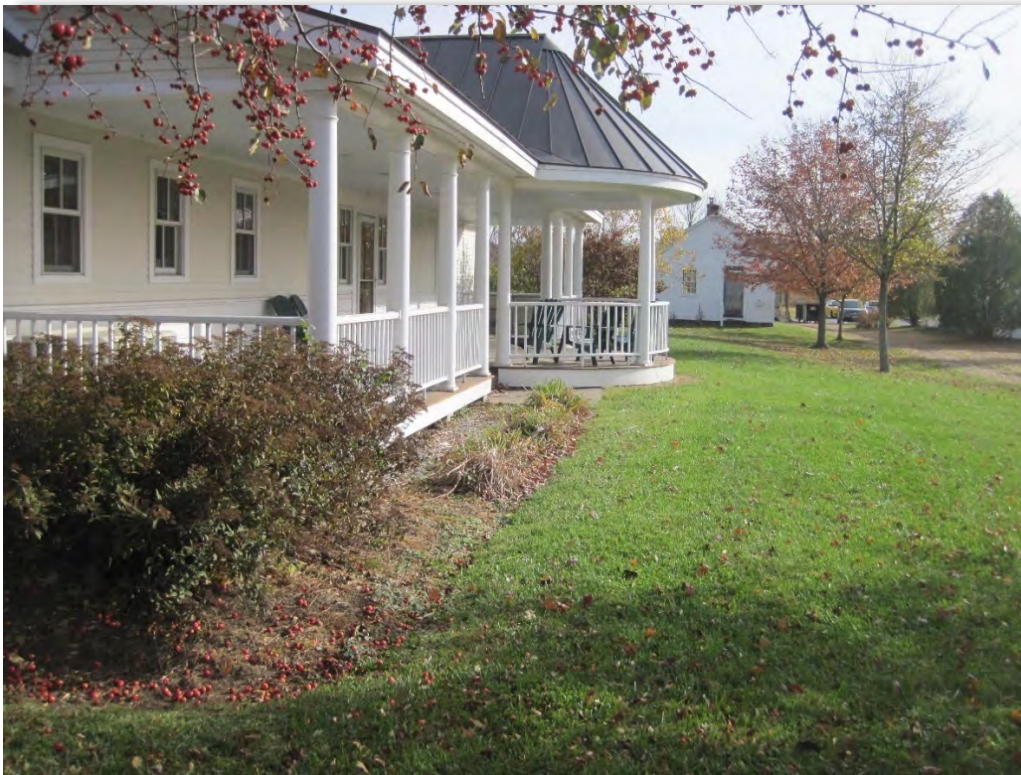
Post-Construction, July 23, 2021: A bio-retention area is planned at this location for a future phase of the project. Runoff from the sidewalk sheet flows into adjacent vegetation as a disconnection practice.

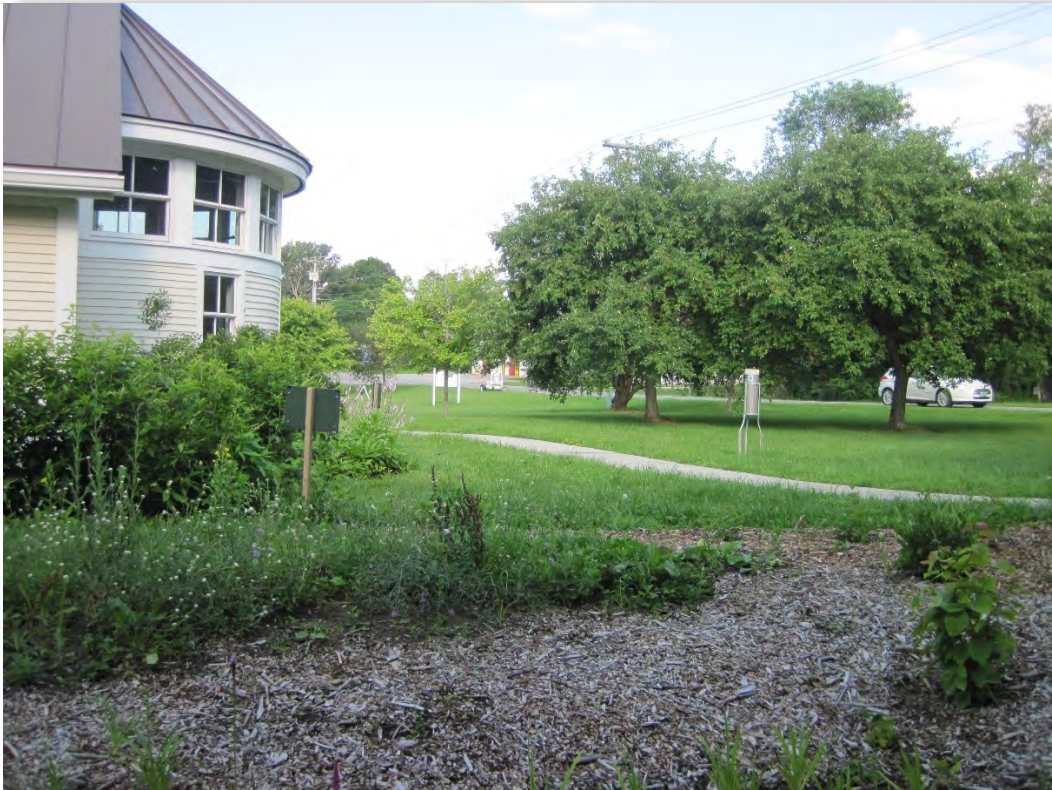
Post-Construction, July 23, 2021: North end of library viewed from the east. New sidewalk has been added providing pedestrian access from Ferry Road. A NOAA rain gage is located at the north end of the building.

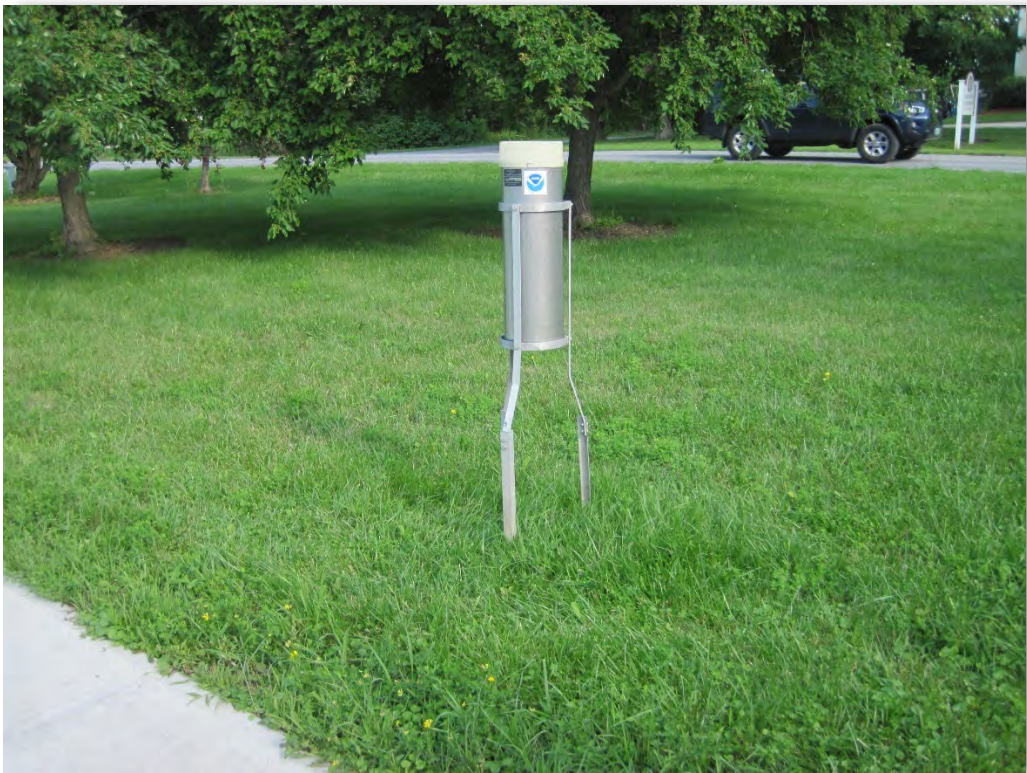
Post-Construction, July 23, 2021: NOAA rain gage.

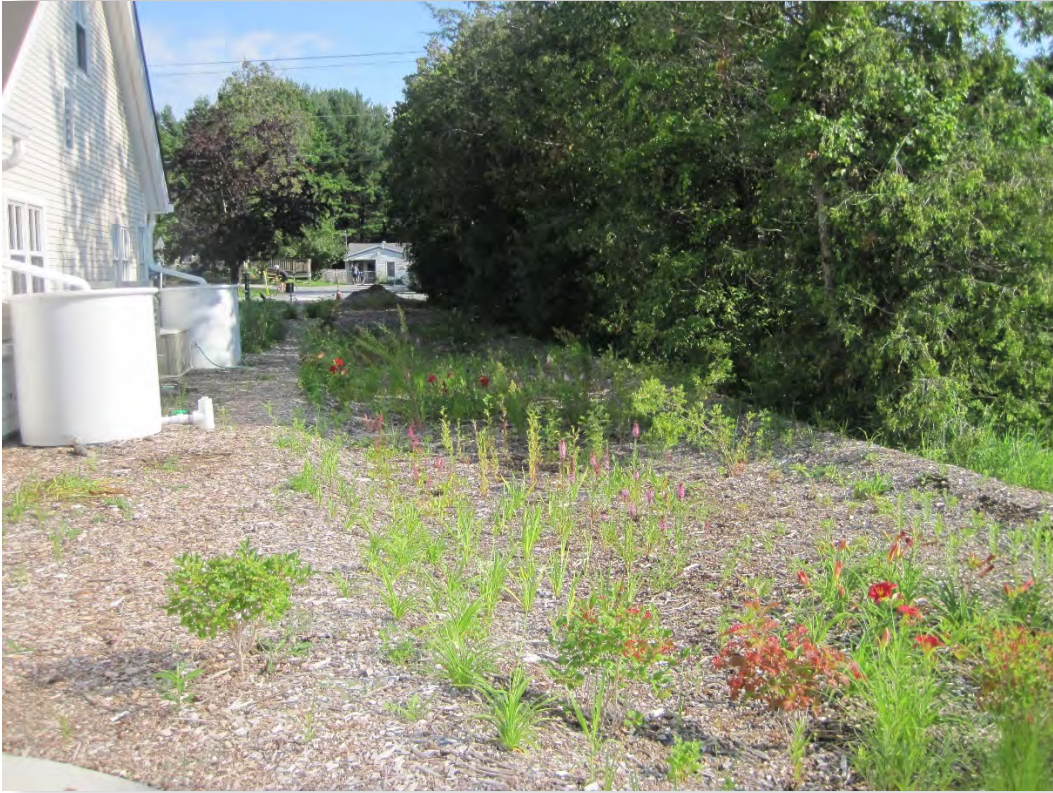
Post-Construction, July 23, 2021: Closer view of bio-retention area and rain barrels.

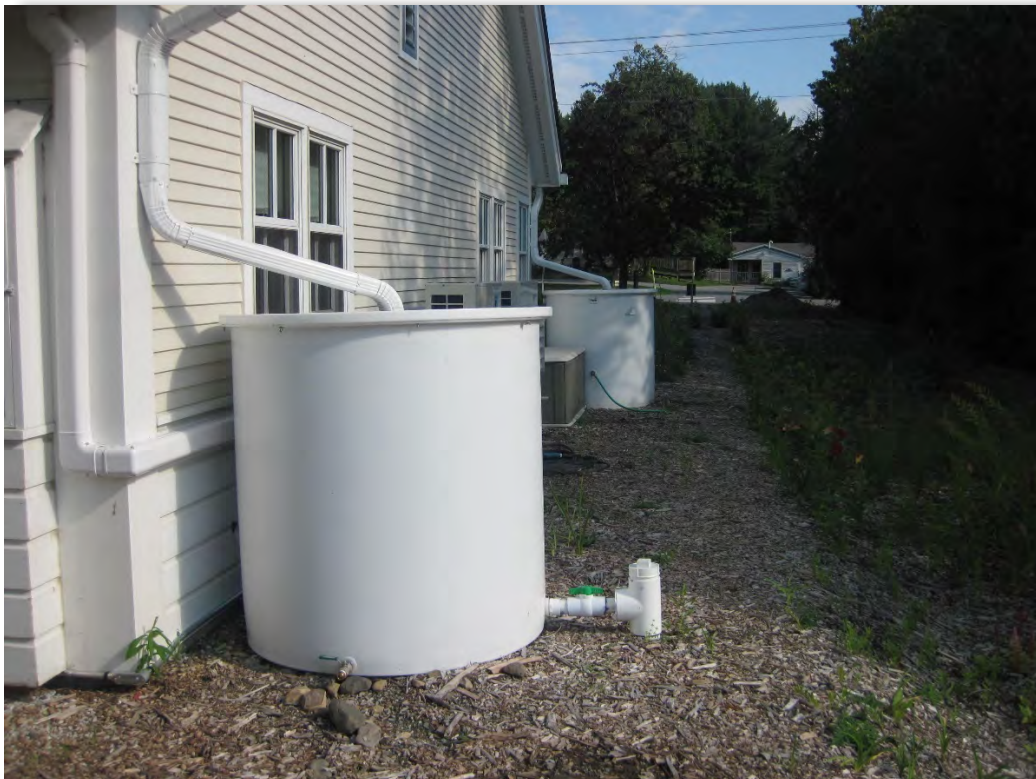
Post-Construction, July 23, 2021: The rain barrels collect runoff from the east side of the building.

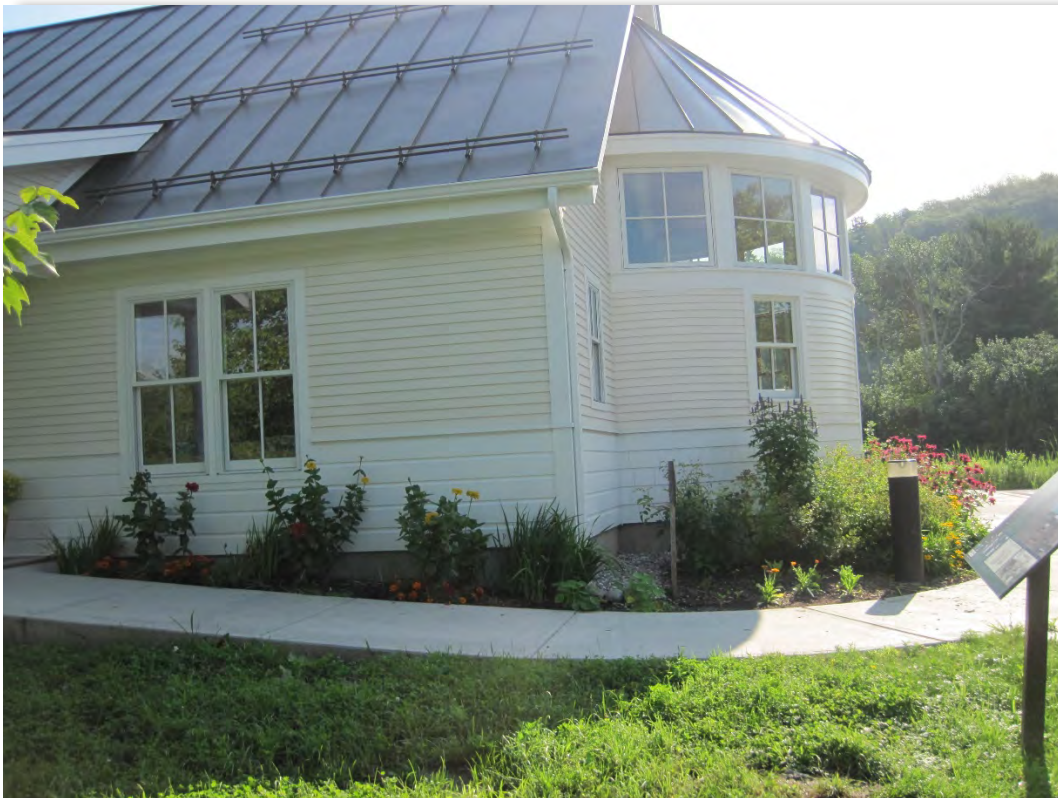
Post-Construction, July 23, 2021: Small rain barrel that will soon be replaced with a larger rain barrel (at image right). Runoff collected here will be used to water the gardens to the south of the library.
