Phase 1 & 2 Geomorphic Assessment Report
Direct Drain to Lake Champlain in Shelburne and Charlotte

Prepared by Lewis Creek Association
February 2008

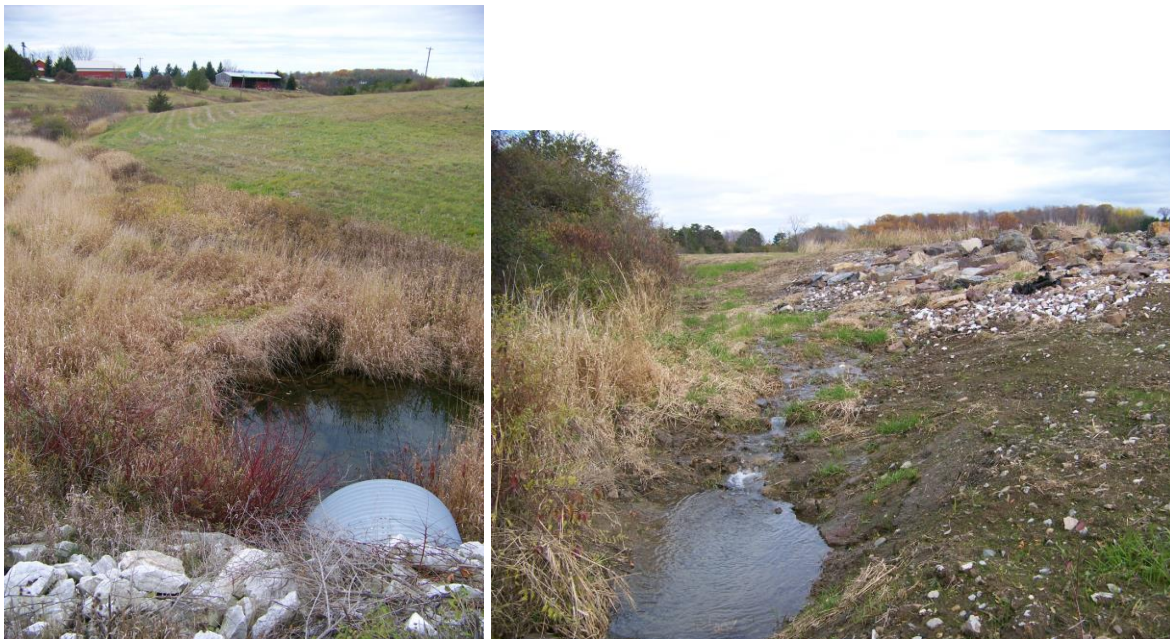
Unnamed Stream 2, or the Shelburne Beach Tributary, flows north along the east side of Greenbush Road and then Beach Road and enters Lake Champlain at Shelburne Beach. This stream has a small tributary of its own (T1S1S2.02). Watershed land cover is mainly fields with some forested area and the stream corridor is field and cropland. Most areas have little to no woody riparian buffer vegetation. Total watershed area is 1.46 square miles. The lower reach (T1S1.01) has 3 dams with ponds upstream, installed in the 1930s-1940s. These ponds comprise most of the stream length and appear to have breached recently as new repairs are visible. Another dam and pond is in the upstream reach (T1S1.03). The middle reach (T1S1.02) appears entirely straightened with significant straightening in the upper reach as well. This stream flows through 5 culverts with an additional 2 culverts on a tributary. Roads and some development encroach into the corridors. Some bank erosion was visible.

View of culvert, fields and grassy stream banks (L); view of downstream end of pond/dam with recent repairs and flow emerging (R).

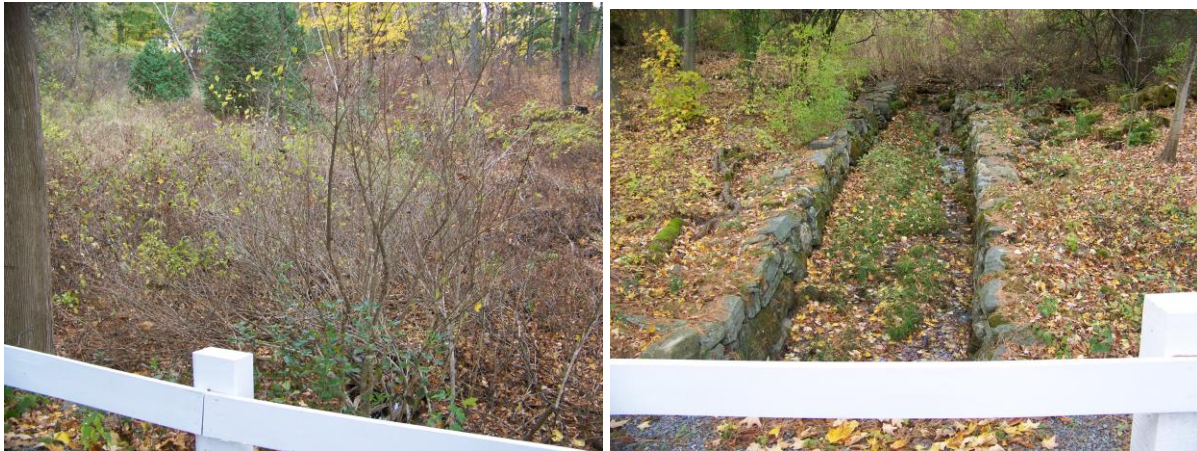
Unnamed Stream 3 flows north along the west side of Greenbush Road and then Beach Road and enters Lake Champlain south of Shelburne Beach. Watershed land cover is mainly fields with some forested area. Some areas have little to no woody riparian buffer vegetation. Total watershed area is 0.26 square miles. This stream flows through 5 culverts with some bank armoring visible from the windshield survey. About 18% of the channel appears to have been straightened with roads and development encroaching into the corridor.

Riparian area (L) and old riprap/channelization (R).

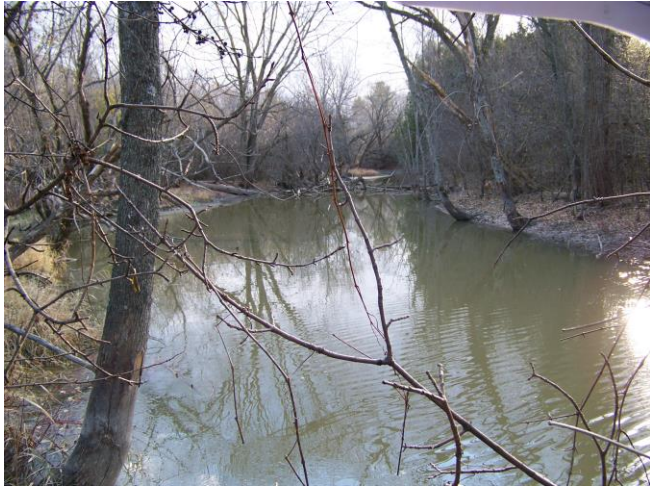
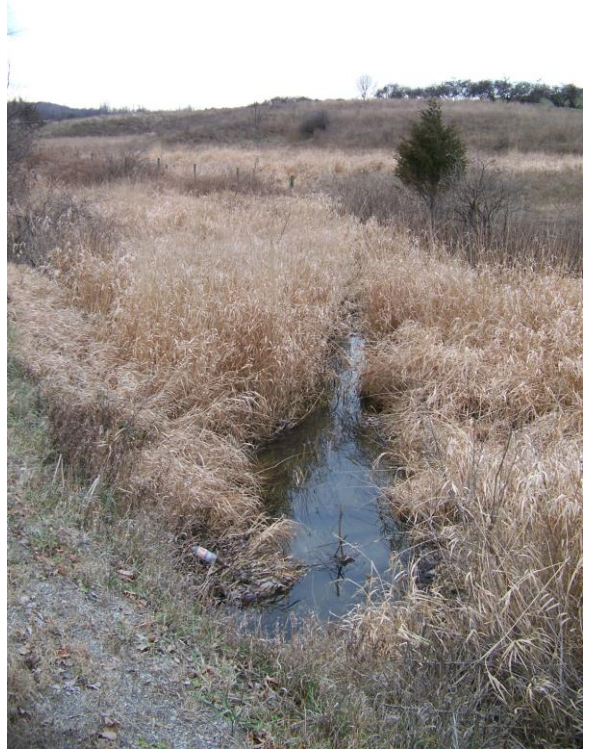
Holmes Creek begins just south of Nature Road, west of Route 7 south of the Shelburne/Charlotte boarder. It flows southwest, crossing under Greenbush Road near the intersection with the railroad track. It continues southwest until the Pringle Brook confluence, where it turns northwest and enters Lake Champlain at the Holmes Creek Covered Bridge. Dominant watershed land use is agricultural (crop and field) with some forested area, and increasing development. Many areas along upper Holmes Creek and its tributaries have little to no riparian buffer vegetation. The lower reaches of Holmes Creek appear to have good buffers. Total watershed area is 3.78 square miles. Several dams and ponds are in the upper reaches of Holmes Creek and its tributaries. The mainstem flows through 4 culverts with an additional 8 culverts on the tributaries. The upper 2 reaches of the mainstem are over 50% straightened with roads encroaching into the corridor, while the downstream reaches appear to meander freely. Some bank erosion was visible in the windshield survey.

Near the mouth of Holmes Creek (L) and upstream portion of Holmes Creek (R).

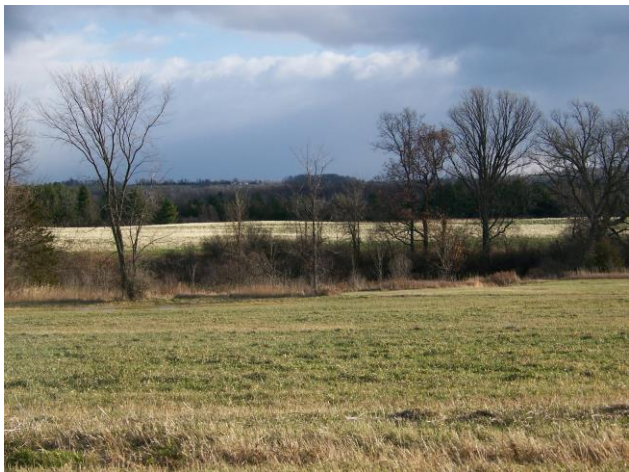
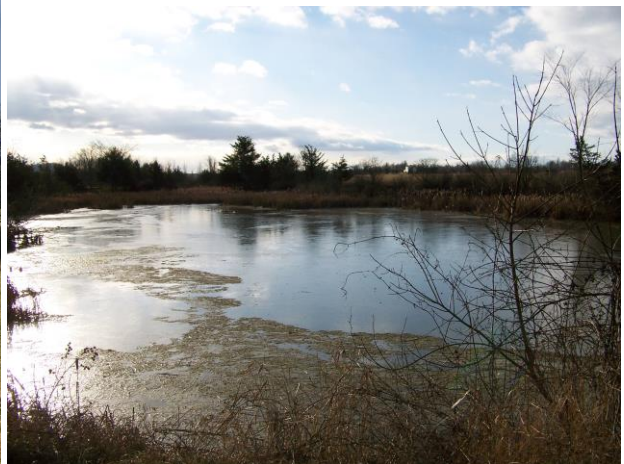
Views of Holmes Creek Tributary (T3S2) incised into the terrace (L); ponding upstream of a culvert (R).

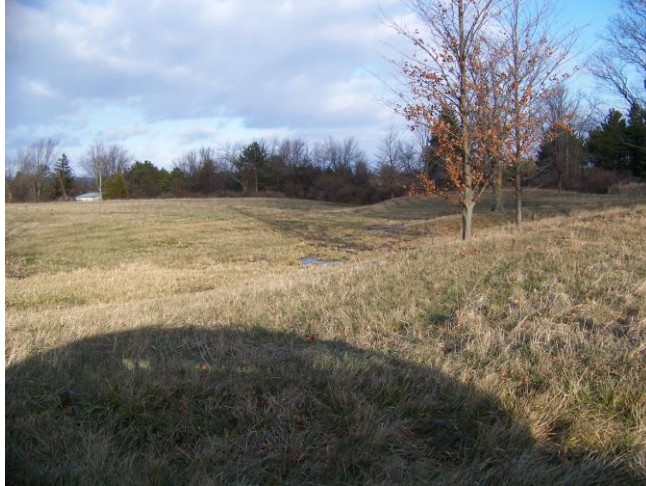
Unnamed Stream 5 flows north and enters Lake Champlain southwest of Holmes Creek. Watershed land use is field and crop with some development. Most of the stream has little to no woody riparian buffer vegetation. Total watershed area is 0.19 square miles. A dam with a pond is in the reach along with 3 culverts. About 75% of the reach appears to have been straightened with some current channel migration evident. Some roads and development encroach into the corridor along the reach.

View of the small channel and vegetation management.

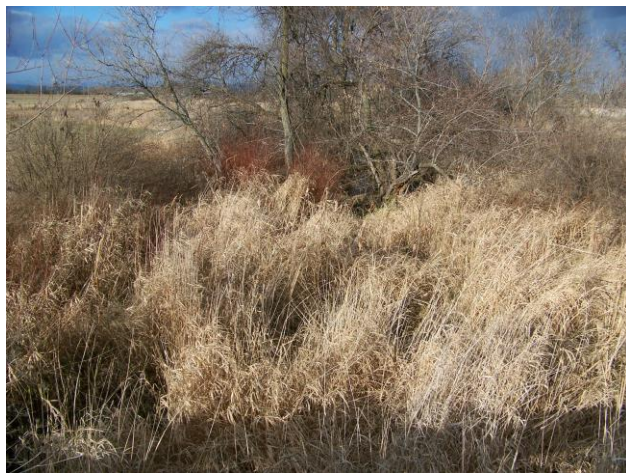
Pringle Brook is a tributary to Holmes Creek. It begins east of Greenbush Road, flowing southwest to Ferry Road, then turning north northwest to Holmes Creek. Watershed land use is field and forest with fairly high urban area (residential and commercial) in the upper 2 reaches. Many areas along Pringle Brook have little to no woody riparian buffer vegetation. Total watershed area is 1.02 square miles. Three dams with ponds are along Pringle Brook along with 5 culverts in the upstream section. Significant channel straightening is evident with some signs of current channel migration. Some roads and development encroach into the corridor, especially along Hinesburg Road.

View of Pringle Brook near Hinesburg Rd with thin buffer vegetation.

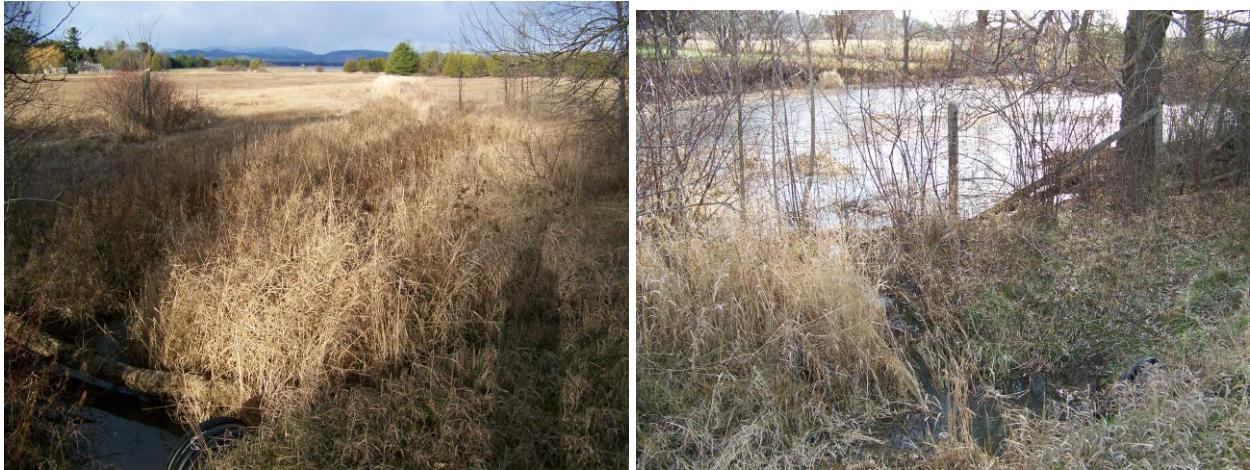
Unnamed Stream 6 flows northwest, crossing Whalley Road and enters lake Champlain north of Wings Point. Watershed land use is forest and field, with residential use dominant in the riparian corridor. Most of the stream has little to no riparian buffer. Total watershed area is 0.3 square miles. A dam with pond is in the reach along with 2 culverts. Over 70% of the reach appears

straightened with some migration evident. Few roads and development encroach into the corridor.

Channel flowing through fields to lake (L) and ponding upstream of road crossing (R).

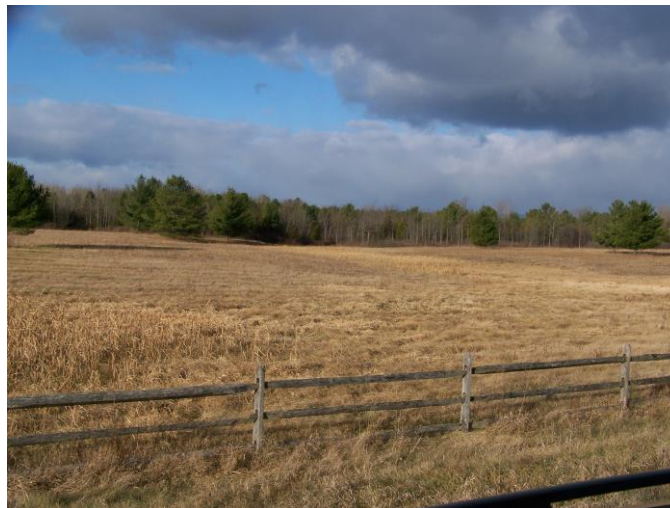
Unnamed Stream 7 flows northwest, crossing Ferry Road then Whalley Road and enters lake Champlain at the north end of Wings Point. Watershed land use is urban (35%) and forest. The riparian corridor also has significant development, reducing woody riparian buffer in some areas. Total watershed area is 0.47 square miles. This stream flows through 3 culverts. About half of the stream appears straightened with migration evident. Few roads and development encroach into the corridor.

View of stream corridor with hardly a defined channel and significant vegetation management.

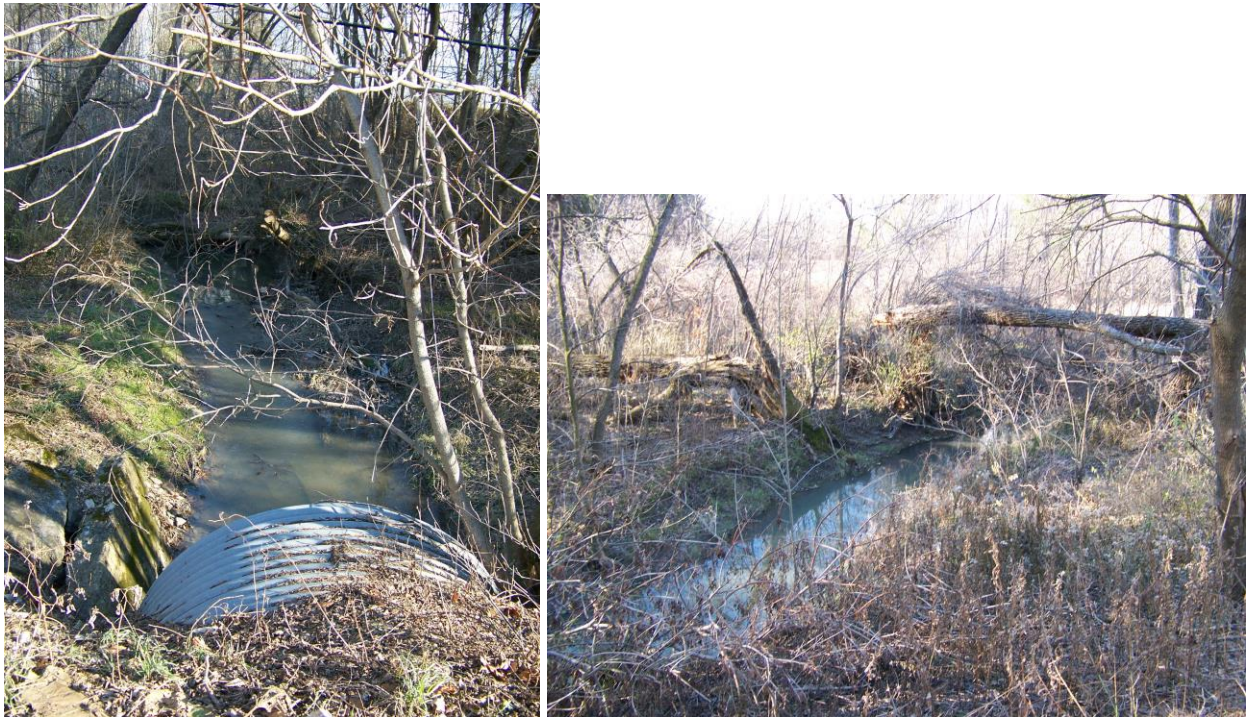
Thorp Brook and its 4 tributaries flow mainly south from the Route 7 and Hinesburg Road area across East Thompson's Point Road and Greenbush Road, entering Lake Champlain in Town Farm Bay. Watershed land use is field and forest with increasing development. Many areas have little to no woody riparian buffer vegetation. Total watershed area is 3.8 square miles. One dam with pond is present along the mainstem with several more on tributaries. Relatively little straightening is evident, however the channel appears to be migrating, especially in the downstream reaches. The mainstem flows through 5 culverts with 10 more on tributaries. Relatively few roads and developments encroached into the corridor. Some bank erosion was visible in the windshield survey. Invasive aquatic plants and algae are present in the bay.

View of a culvert and bank erosion (L) and the stream channel (R).

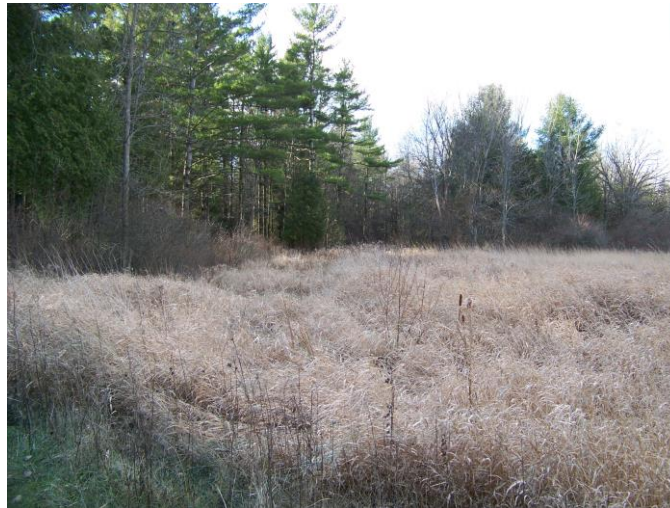
Unnamed Stream 9 begins at Lake Road just north of the Thompson's Point Road intersection and flows southwest, crossing Thompson's Point Road and entering Lake Champlain at the north end of Town Farm Bay. Watershed land use is forest and field with some residential development. Most of the reach (mainly the upstream portion) has little to no woody riparian buffer vegetation. Total watershed area is 0.32 square miles. This stream flows through one culvert. Over 50% of the reach appears straightened with some roads encroaching into the corridor.

The small channel flows through fields and then forest.

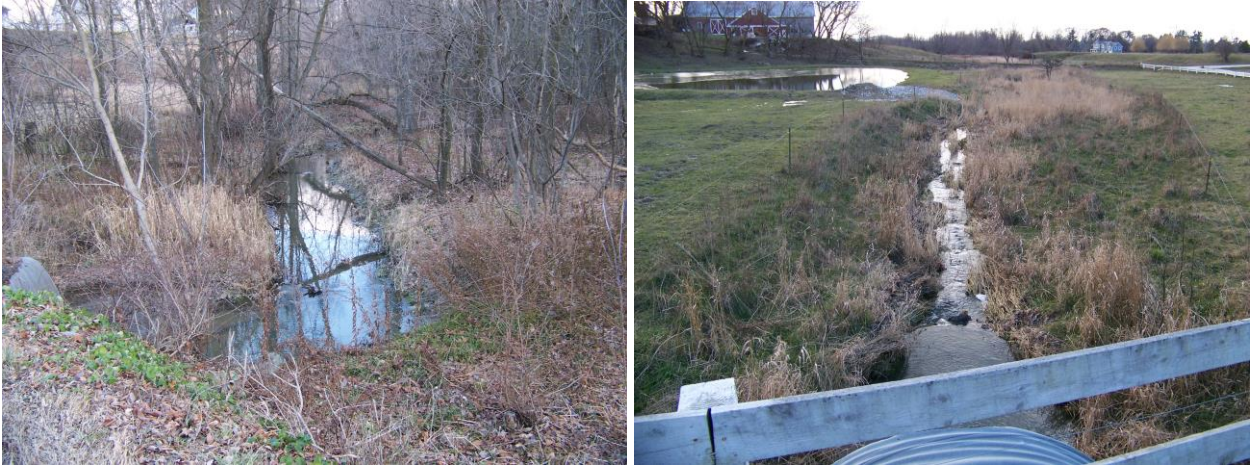
Kimball Brook begins northeast of the Mt. Philo Road and One Mile Road intersection. It flows southwest crossing Route 7 and Greenbush Road before turning northwest and enters Lake Champlain at the south end of Town Farm Bay. Watershed land use is field and cropland with increasing residential development, especially in the subwatersheds near Route 7. Many areas have little to no woody riparian buffer vegetation. Total watershed area is 2.45 square miles. Almost the entire stream appears to have been straightened historically with much current channel migration evident. Kimball Brook flows through 11 culverts and has one dam and one water withdrawal evident. Some roads and development encroach into the corridor. Some bank erosion was visible in the windshield survey. Invasive aquatic plants and algae are present in the bay.

Downstream area of Kimball Brook (L) and upstream section with straightening and a pond (R).

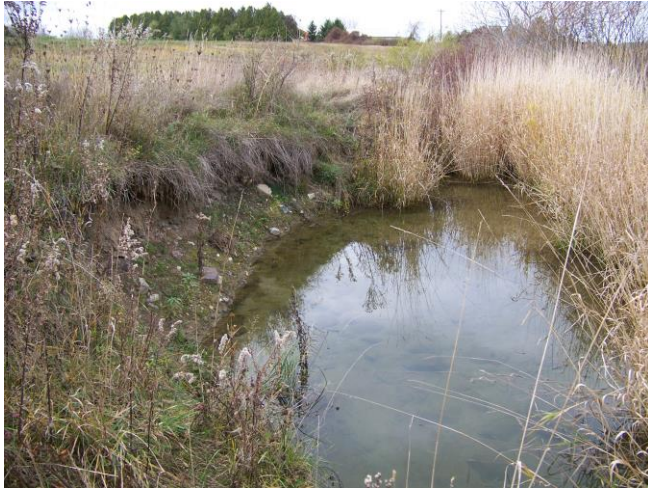
The reach begins just downstream of a large pond with a dam. The stream flows north and through a culvert under Bostwick Road where a tributary enters as well. The stream continues north and the reach break is just upstream of the first pond, where the channel begins to braid. This reach appeared to have incised, with one headcut present, so incision was still active. Some incision could be related to channel straightening or possible dredging. Almost the entire reach appeared to have been straightened historically. Some incision could also be related to increased flows out of the culvert. Overall stream channel width was 12 feet wide and the culvert width was only 5.5 feet wide, causing scour downstream. The channel did have a small floodplain area developing at the lower elevation, however the main adjustment process appeared to be incision with some widening and planform adjustments as well. The reach appeared to have experienced a stream type departure from a C (meandering) type to a B (entrenched) type.

Bank and buffer vegetation was mainly herbaceous and appeared to be cut all the way to the channel in areas. Other areas had some shrubs and saplings. Hay fields occupied the remainder of the corridor. Some bank erosion was observed. Habitat condition was “Fair” and mainly affected by a poor mix of substrate and cover types, lack of woody riparian buffer, lack of healthy pools, and bank instability.

Eroding bank at headcut with large pool (L) and channel view with herbaceous riparian vegetation and undersized culvert with scour pool downstream (R).

T1S1.02 – Protect the river corridor and plant woody buffer vegetation to eliminate vegetation cutting and potential encroachment as well as to enhance bank stability and habitat. Investigate options for restoring the channel incision downstream of Bostwick Road. Resize the Bostwick Road culvert as it is up for replacement.

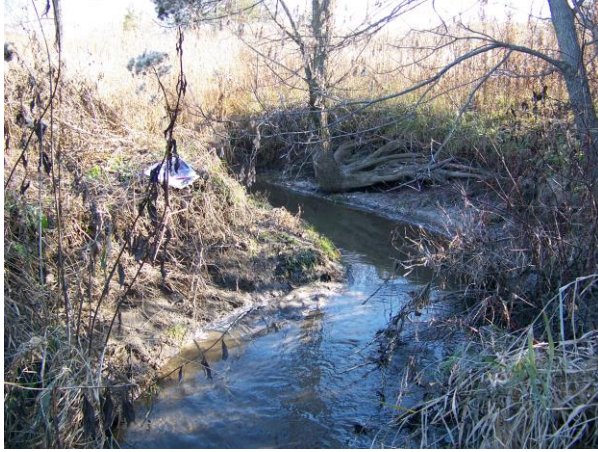
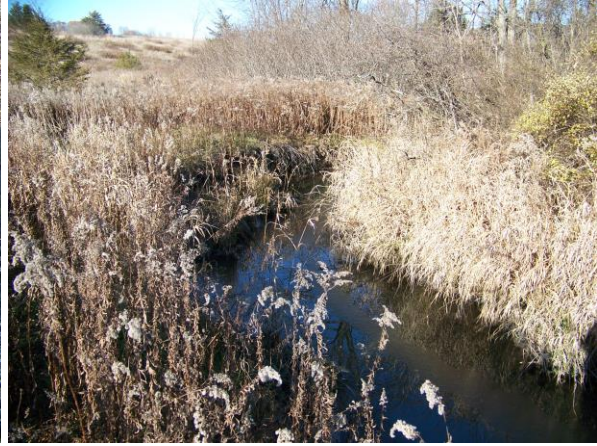
The reach begins upstream of E. Thompson’s Point Road where a tributary enters. The stream flows southwest under E. Thompson’s Point Road and continues south for approximately 200 feet. The area appeared heavily impacted by beavers with trees chewed and signs of water fluctuations such as flood chutes and channel migration. A neighbor noted a large beaver dam downstream of the reach, causing some water to back up into this reach. The reach was not segmented due to the presence of beaver activity throughout the reach and the fact that the dams are likely to move around over time. Overall stream condition appeared to be “Good” with only slight incision, likely masked by the aggradation. Current adjustments were aggradation and widening, but mainly planform. The beaver activity throughout the reach was also likely contributing to channel adjustments.

Channel views with some bank erosion/migration.

T8.03 – Protect the stream corridor to allow for continued channel migration, beaver activity, and vegetation renewal. Work with the town of Charlotte to address the issues at the E. Thompson's Point Road crossing, which may require resizing, realignment and replacement of the culverts. Much work has evidently been done here, so working with the town to learn what has been done and what they think could be improved is recommended. Expensive buffer vegetation planting is not recommended due to the beaver activity. A less expensive planting program, using mainly shrubby plantings could provide benefits while not investing in expensive tree plantings that beaver are likely to eat.

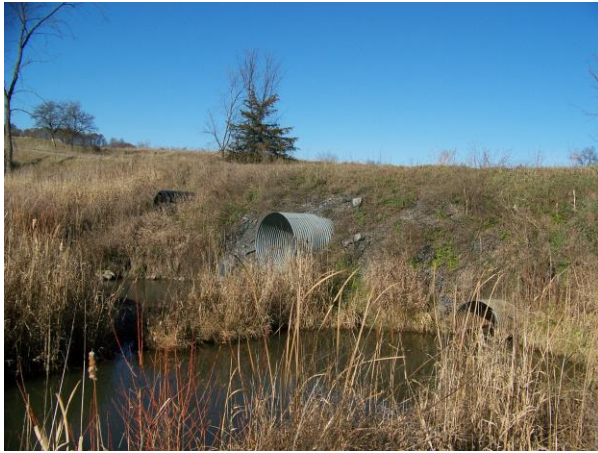
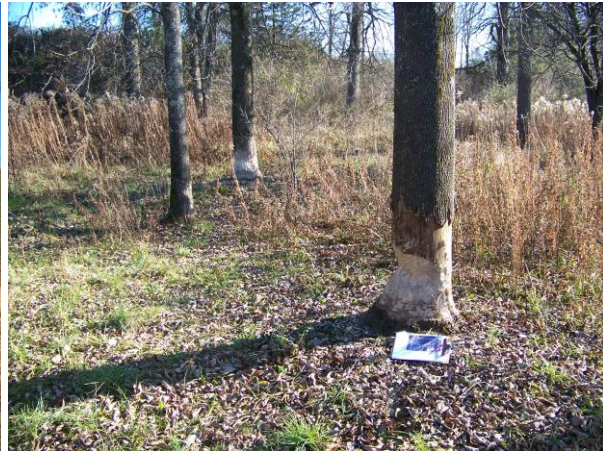
The E. Thompson’s Point Road crossing appeared to have been a site of concern for the town as much work has been done. A total of 3 culverts were at the crossing one at low flow level, one slightly higher, and one overflow. Overall channel width was 22 feet wide with the culverts being 3 (low flow), 5 (high flow) and 3 (overflow) feet wide. The low flow culvert appeared poorly aligned with overbank flows, as it was after a bend in the stream.

Culverts with overflow pipes (L) and beaver activity (R).

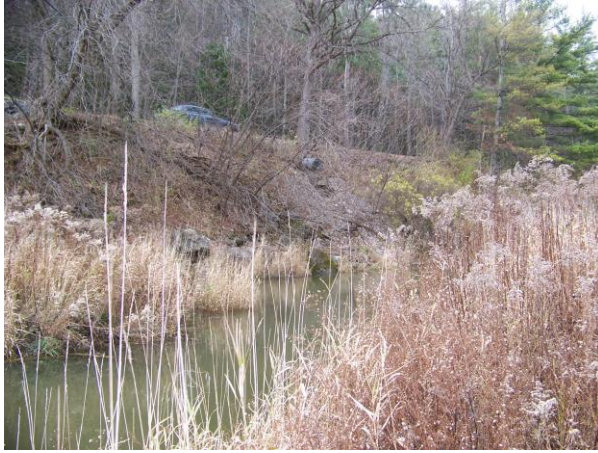
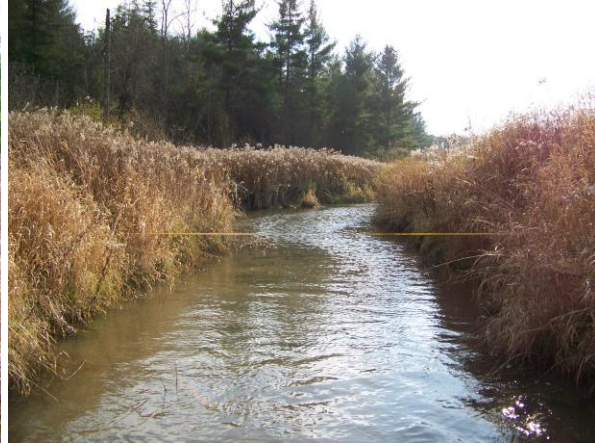
The corridor land use was wetland/grasses. The corridor area did not appear to be managed, but presumably beaver activity and flooding/ice has limited sapling growth. Habitat condition appeared to be “Fair” and mainly affected by sediment deposition, bank instability, few substrate types, and some straightening.

Channel views with Spear Street abutting the channel (L) and herbaceous vegetation (R).

T2.01 and T2.02A – Protect the river corridor and possibly restore channel incision downstream of the northern culvert and along the LaPlatte mainstem reach M08. This area is currently in crop use (corn) with some greenhouses. This project would coordinate with project recommendations for M08 on the LaPlatte. Resize the 2 culverts in T2.01 and T2.02 as they are up for replacement to eliminate the channel constriction and erosion hazards.

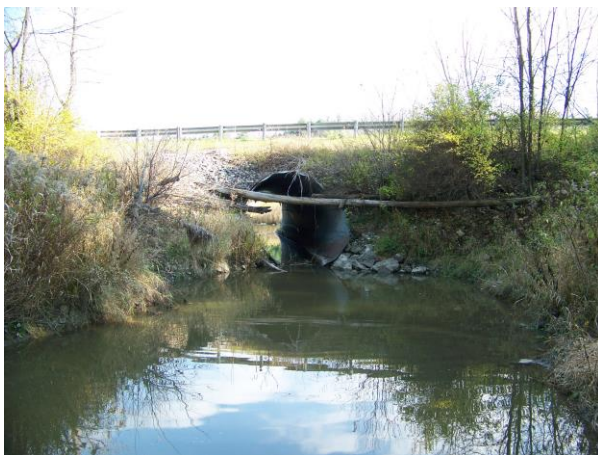
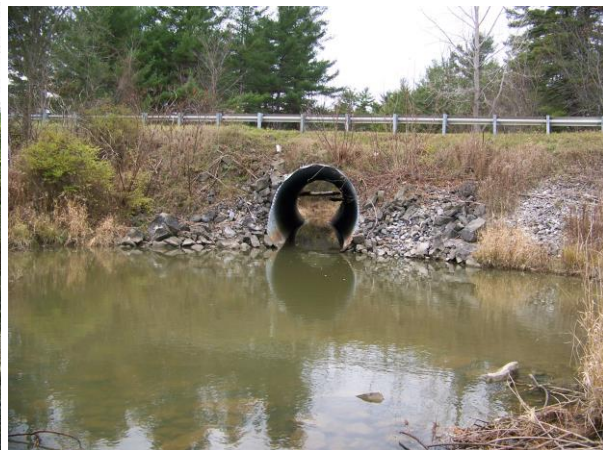
Overall channel width was 24 feet while the 2 culverts were only 14 (downstream) and 10 (upstream) feet wide. Scour was present downstream of both culverts and a beaver dam was constructed at the opening of the downstream culvert.

Upstream (L) and downstream (R) views of the southern (upstream) culvert. Note the woody debris upstream and scour downstream.

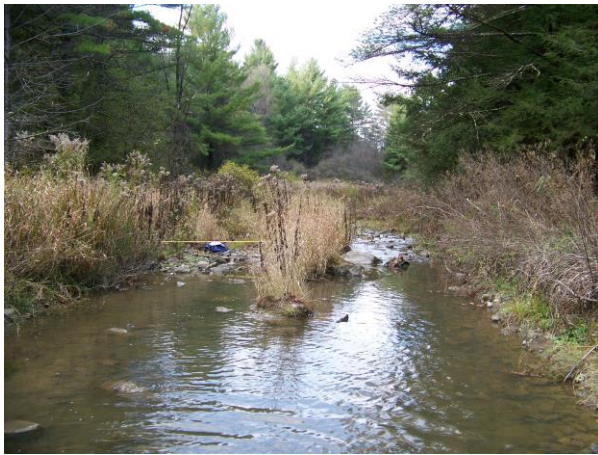
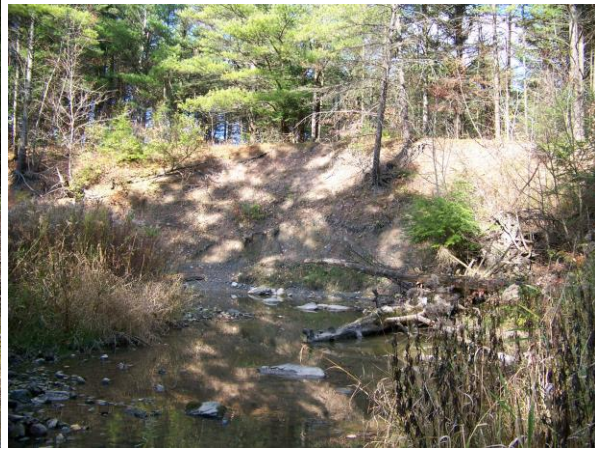
This reach flows north and northeast on the western side of Spear Street. The segment appeared to have incised historically from an upper terrace. A new terrace and floodplain are developing at bankfull elevation. The stream appeared to be in “Fair” condition with planform the dominant adjustment process. Some aggradation was present but channel widening appeared historical.

Channel view (L) and mass failure (R).

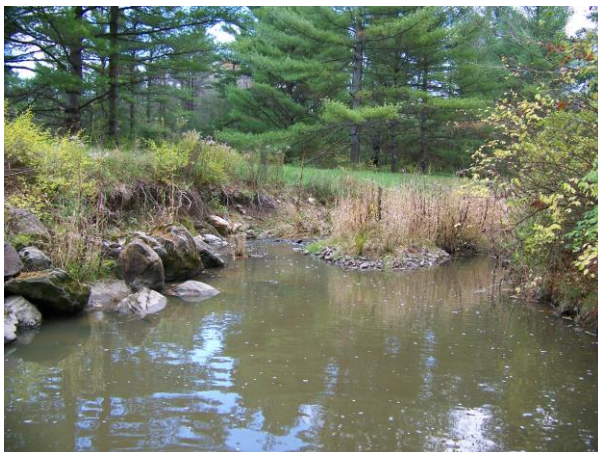
A pond was in the corridor at the upstream end of the reach. It was difficult to determine if the pond had been dug out of the floodplain or if the stream had been moved over and bermed to create the pond. An overflow pipe from the pond had evidence of scour on the terrace at the outflow.

Failing riprap and bank erosion along the pond and possible berm.
