# Ahead of the Storm Self-Guided Tour: Charlotte

## Charlotte Central School Stormwater Retention

## DuBrul Residence Rain Garden

## East Thompson's Point Road / Thorp Brook

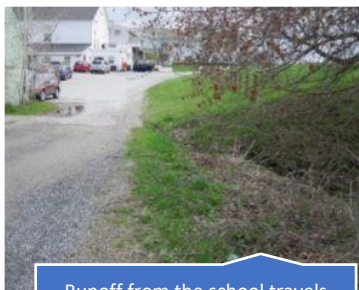
Runoff from the school travels overland and through pipes untreated to a wetland

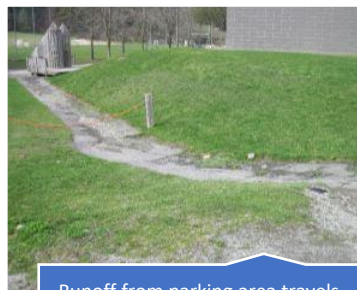
Runoff from parking area travels down the path, carrying sediment and causing erosion

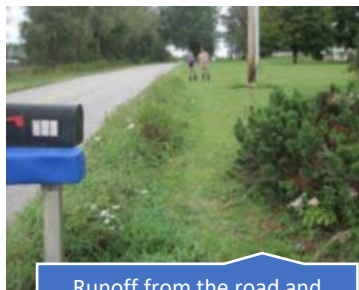
Runoff from the road and adjacent property flows toward DuBrul property

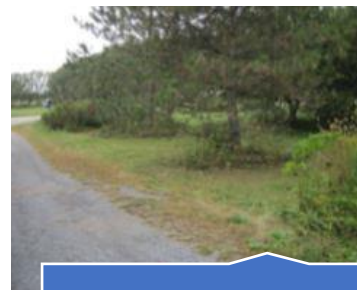
Bio-retention area identified adjacent to driveway

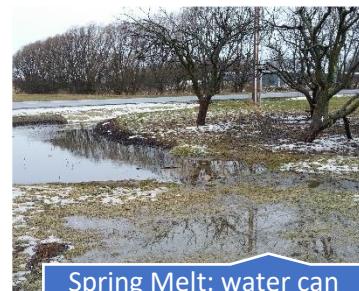
Spring Melt: water can slowly infiltrate the soil instead of running off

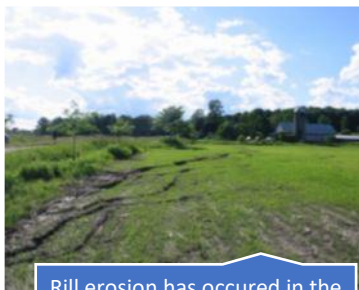
Rill erosion has occurred in the Mack farm field when water cuts across the field

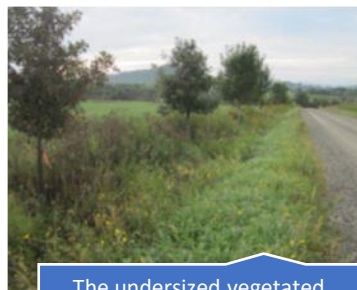
The undersized vegetated swale along E. Thompson's Point Road

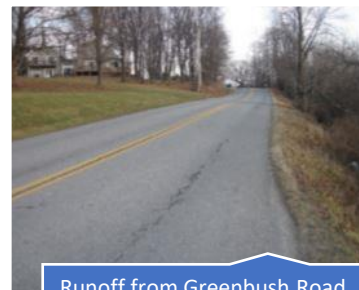
Runoff from Greenbush Road and homes travels through this site to Thorp Brook

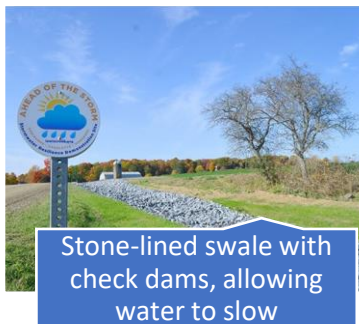
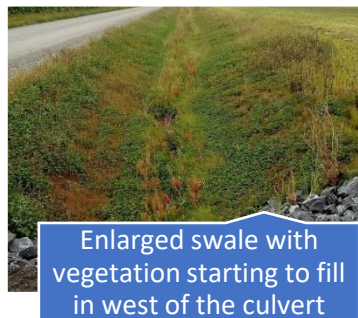
Implementation occurred in Summer 2016 by Junior Lewis Excavating. The site was excavated to increase the swale (to the west/left when looking at the sign from the road) and create bio-retention areas (directly in front of and down the hill to the right of the sign). The culvert at the crest of the hill (west of the sign) was upsized, and the adjacent part of the swale was stone lined. Stone filter berms and check dams were installed and erosion matting and seeding were put in place.
