Lewis Creek Association's South Chittenden River Watch Program

LOCAL LAND USE HISTORY, WATER QUALITY, AND
WHAT YOU CAN DO TO HELP

LEWIS CREEK ASSOCIATION'S SOUTH CHITTENDEN RIVER WATCH PROGRAM

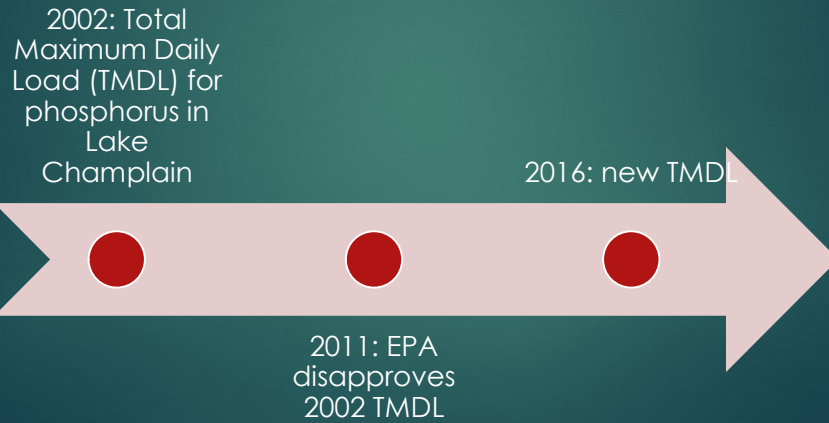
TMDL places a cap on the maximum amount of phosphorus that is allowed to enter the Lake and still meet Vermont's water quality standards

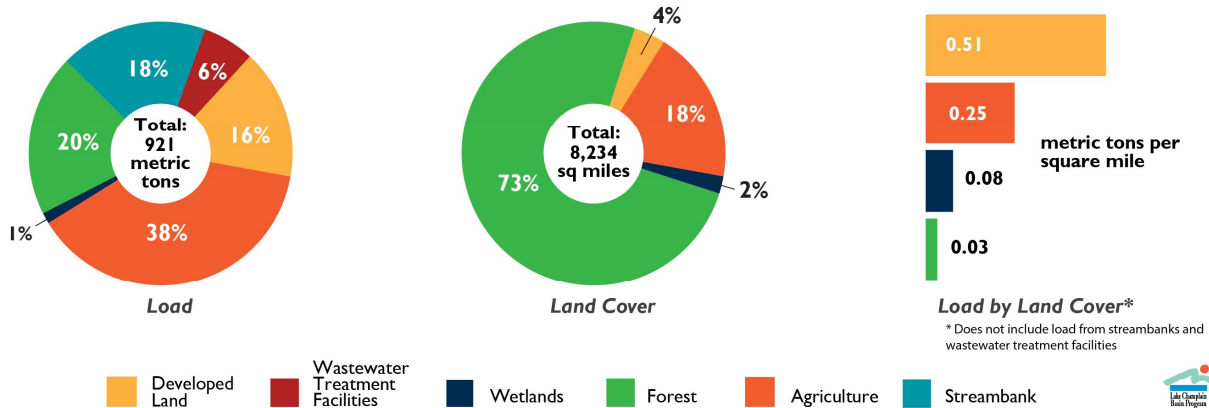
Phosphorus Load by Land Cover

This graph shows how much phosphorus goes into the lake by the type of land cover (such as forest, agriculture, or developed). On the left is the amount of phosphorus that reaches the lake. In the middle is the land cover percentages for the Lake Champlain basin. And on the right, how much phosphorus reaches the lake by land cover type. It's worth noting that despite only covering 4% of the land, developed land contributes 16% of the phosphorus to the lake (the most load by land cover, 0.51 metric tons per square mile). Agriculture has the next highest load by land cover (0.25 metric tons per square mile). Although forests contribute very little load per square mile, because they make up so much land cover (73%) they contribute a fair bit of load (20%).

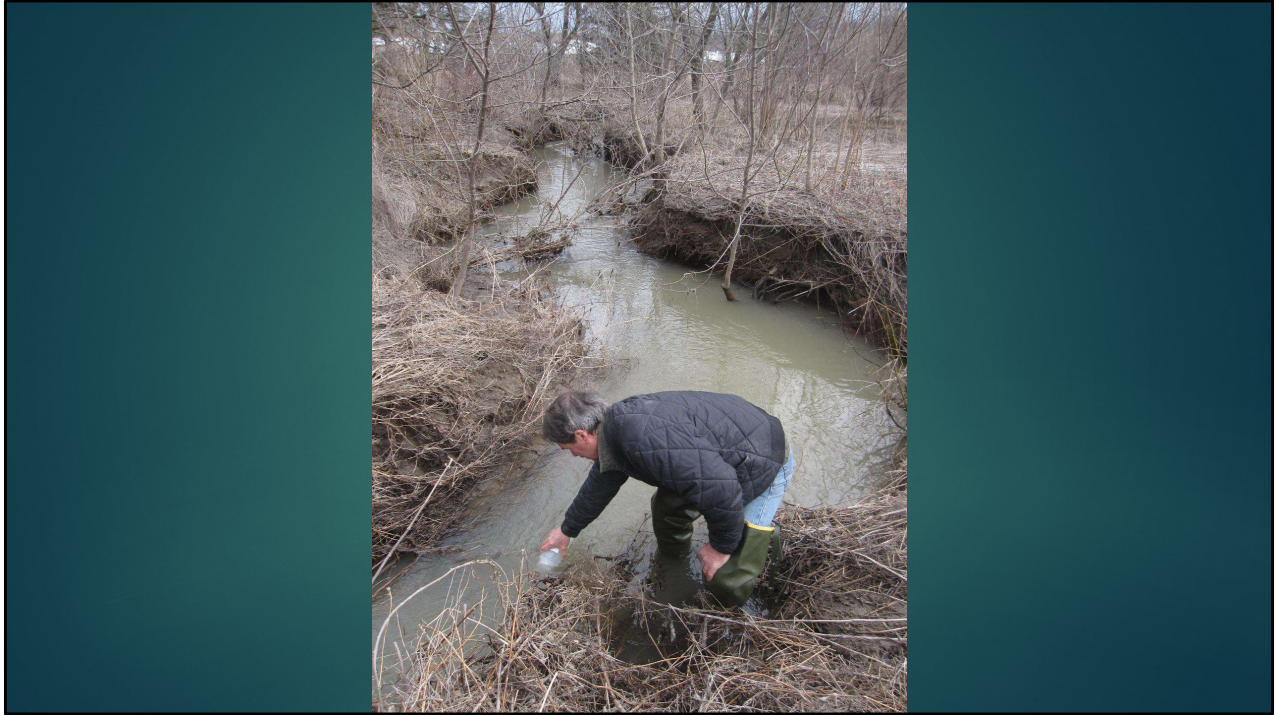
Here is what we do: take samples of water at these locations, usually after a rain storm. Samples get sent to the state lab, where they are analyzed. This is part of a larger program that is run by the state (Department of Environmental Conservation) to understand water quality.
