**WATER QUALITY PLANNING ON THORP AND KIMBALL BROOKS  
CHARLOTTE AND FERRISBURG, VERMONT**

February 1, 2010

MMI #3542-07

Lewis Creek Association  
Charlotte, Vermont

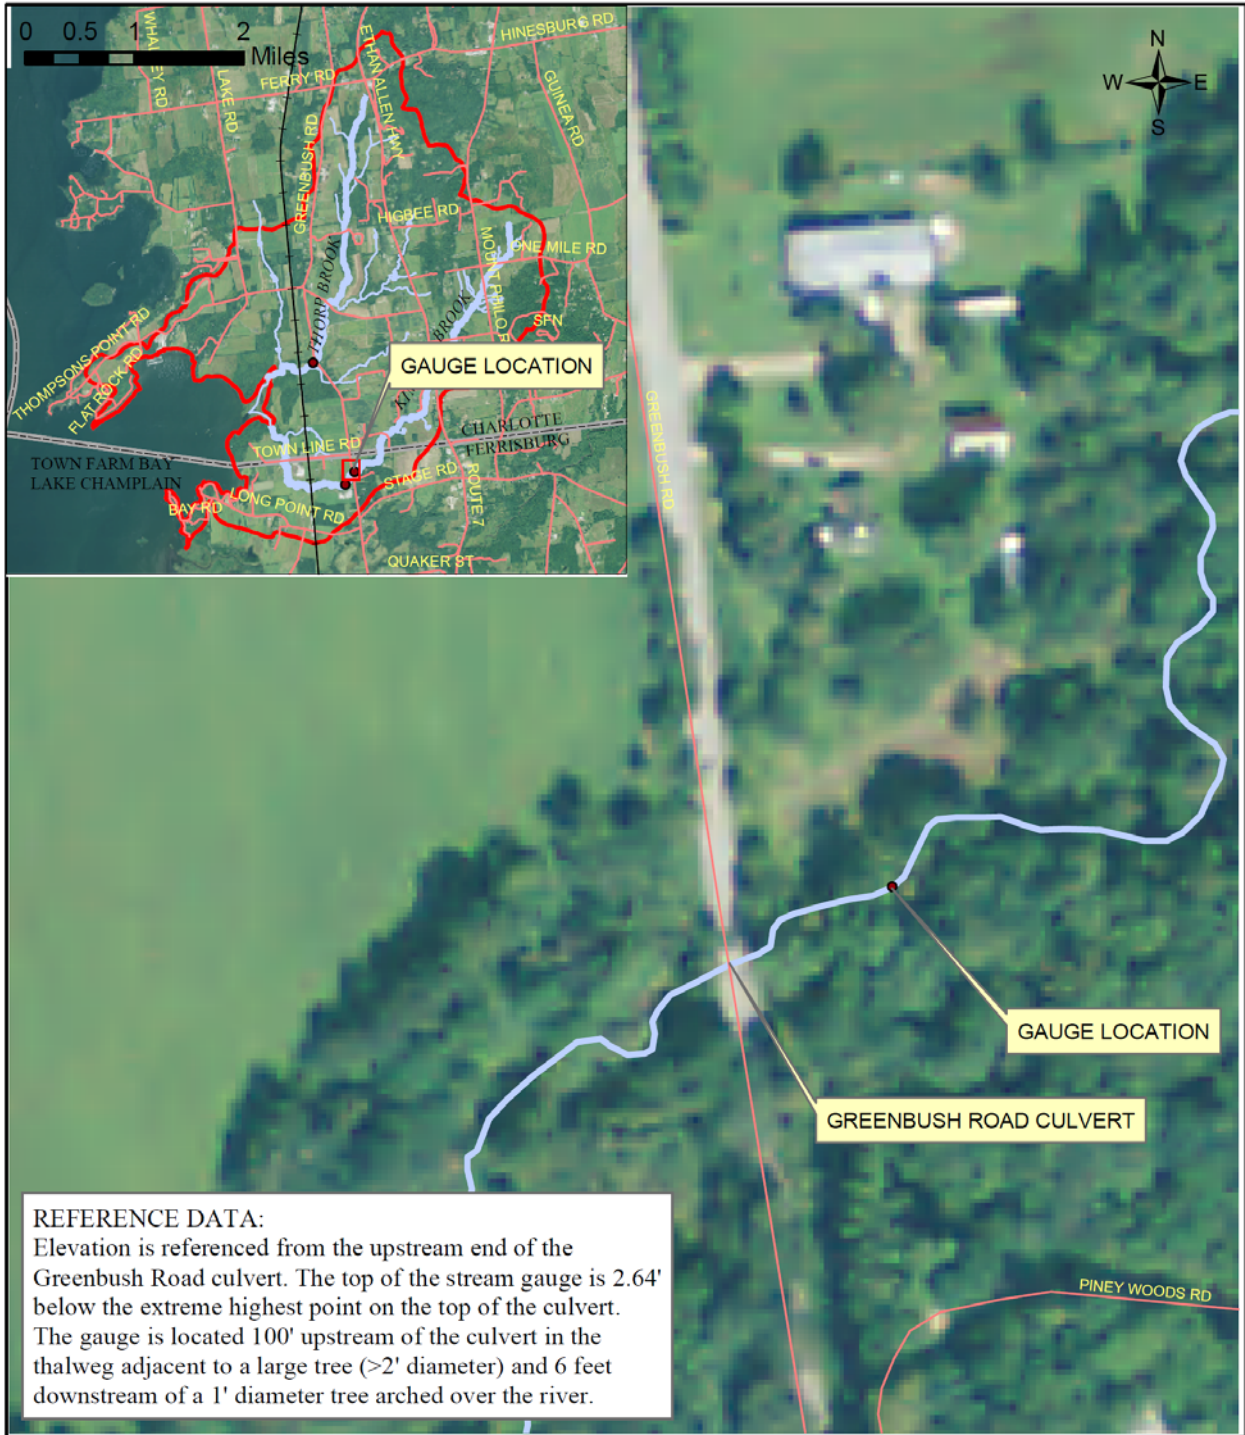
SHEET:  
**Figure 10**

The staff gauge was installed in the stream thalweg 100 feet upstream of the Greenbush Road Culvert (Figure 10). The backwater from the partially undersized culvert and road embankment does not influence flows at the gauging site except during large floods when the gauge is submerged. The gauge is adjacent to a very large tree (diameter > 2 feet) on the left bank (facing downstream). Survey was performed to document the staff gauge elevation in reference to permanent features so that it may be replaced when dislodged. The Greenbush Road Culvert (corrugate metal pipe, diameter = 6 feet) was used as a local survey reference. The highest point on top of the upstream end of the culvert is 2.77' above the top of the staff gauge and 2.64' above the top of the fence post. Therefore, the top of the culvert is equivalent to 6.1' on the staff gauge were it to extend that tall.

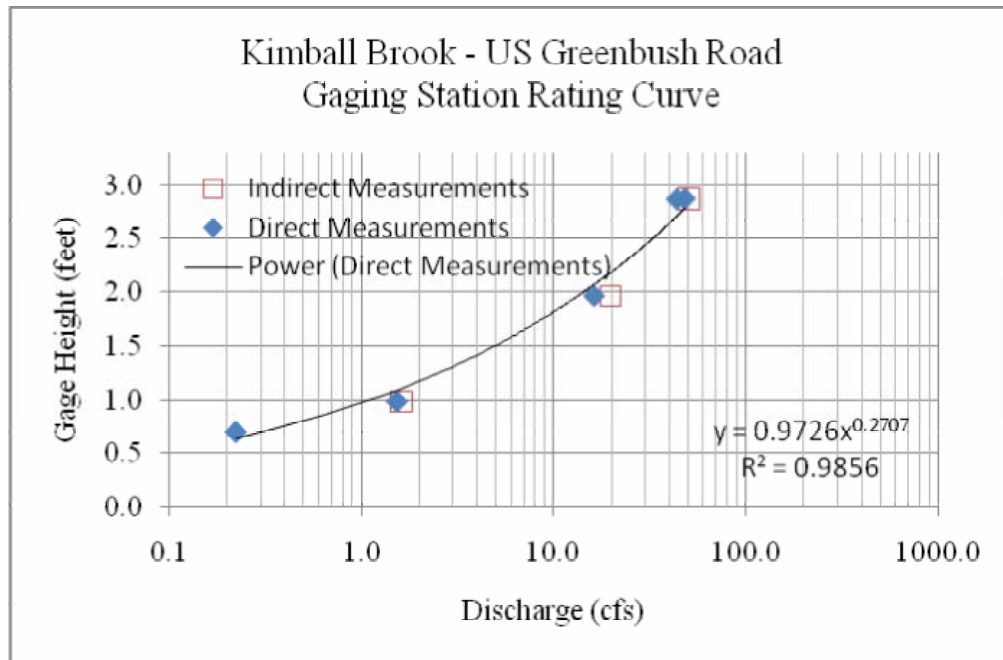
Figure 11: Kimball Brook staff gauge rating curve.

Five discharge measurements were made to establish a rating curve on Kimball Brook (Figure 11, Appendix E). The staff gauge documents flows between 0.2 and 48.6 cubic feet per second.

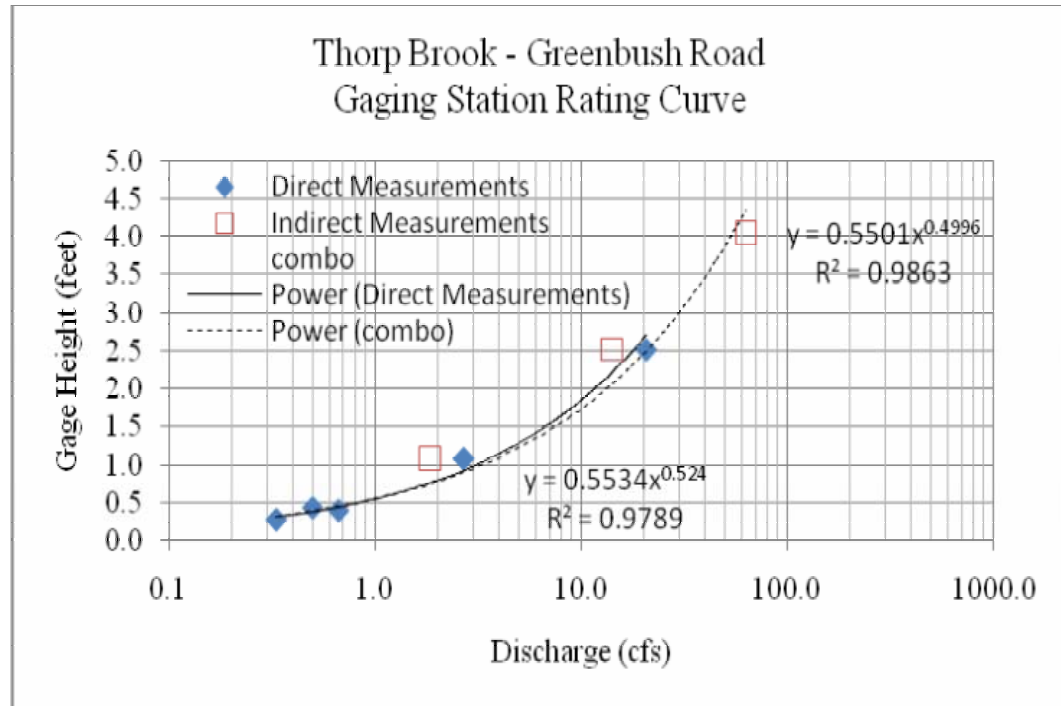
Figure 13: Thorp Brook rating curve.

Five discharge measurements were made to establish a rating curve on Thorp Brook (Figure 13, Appendix F). The direct measurements documented flows between 0.3 and 20.7 cubic feet per second. The Greenbush Road culvert was used for an indirect flow measurement during a high flow event. A flow of 63 cubic feet per second was measured at the upstream side of the culvert.
