## AHEAD OF THE STORM

Site: Champlain Valley Union School

Location: 369 CVU Road, Hinesburg, Vermont

### Greenhouse Area Concept Design

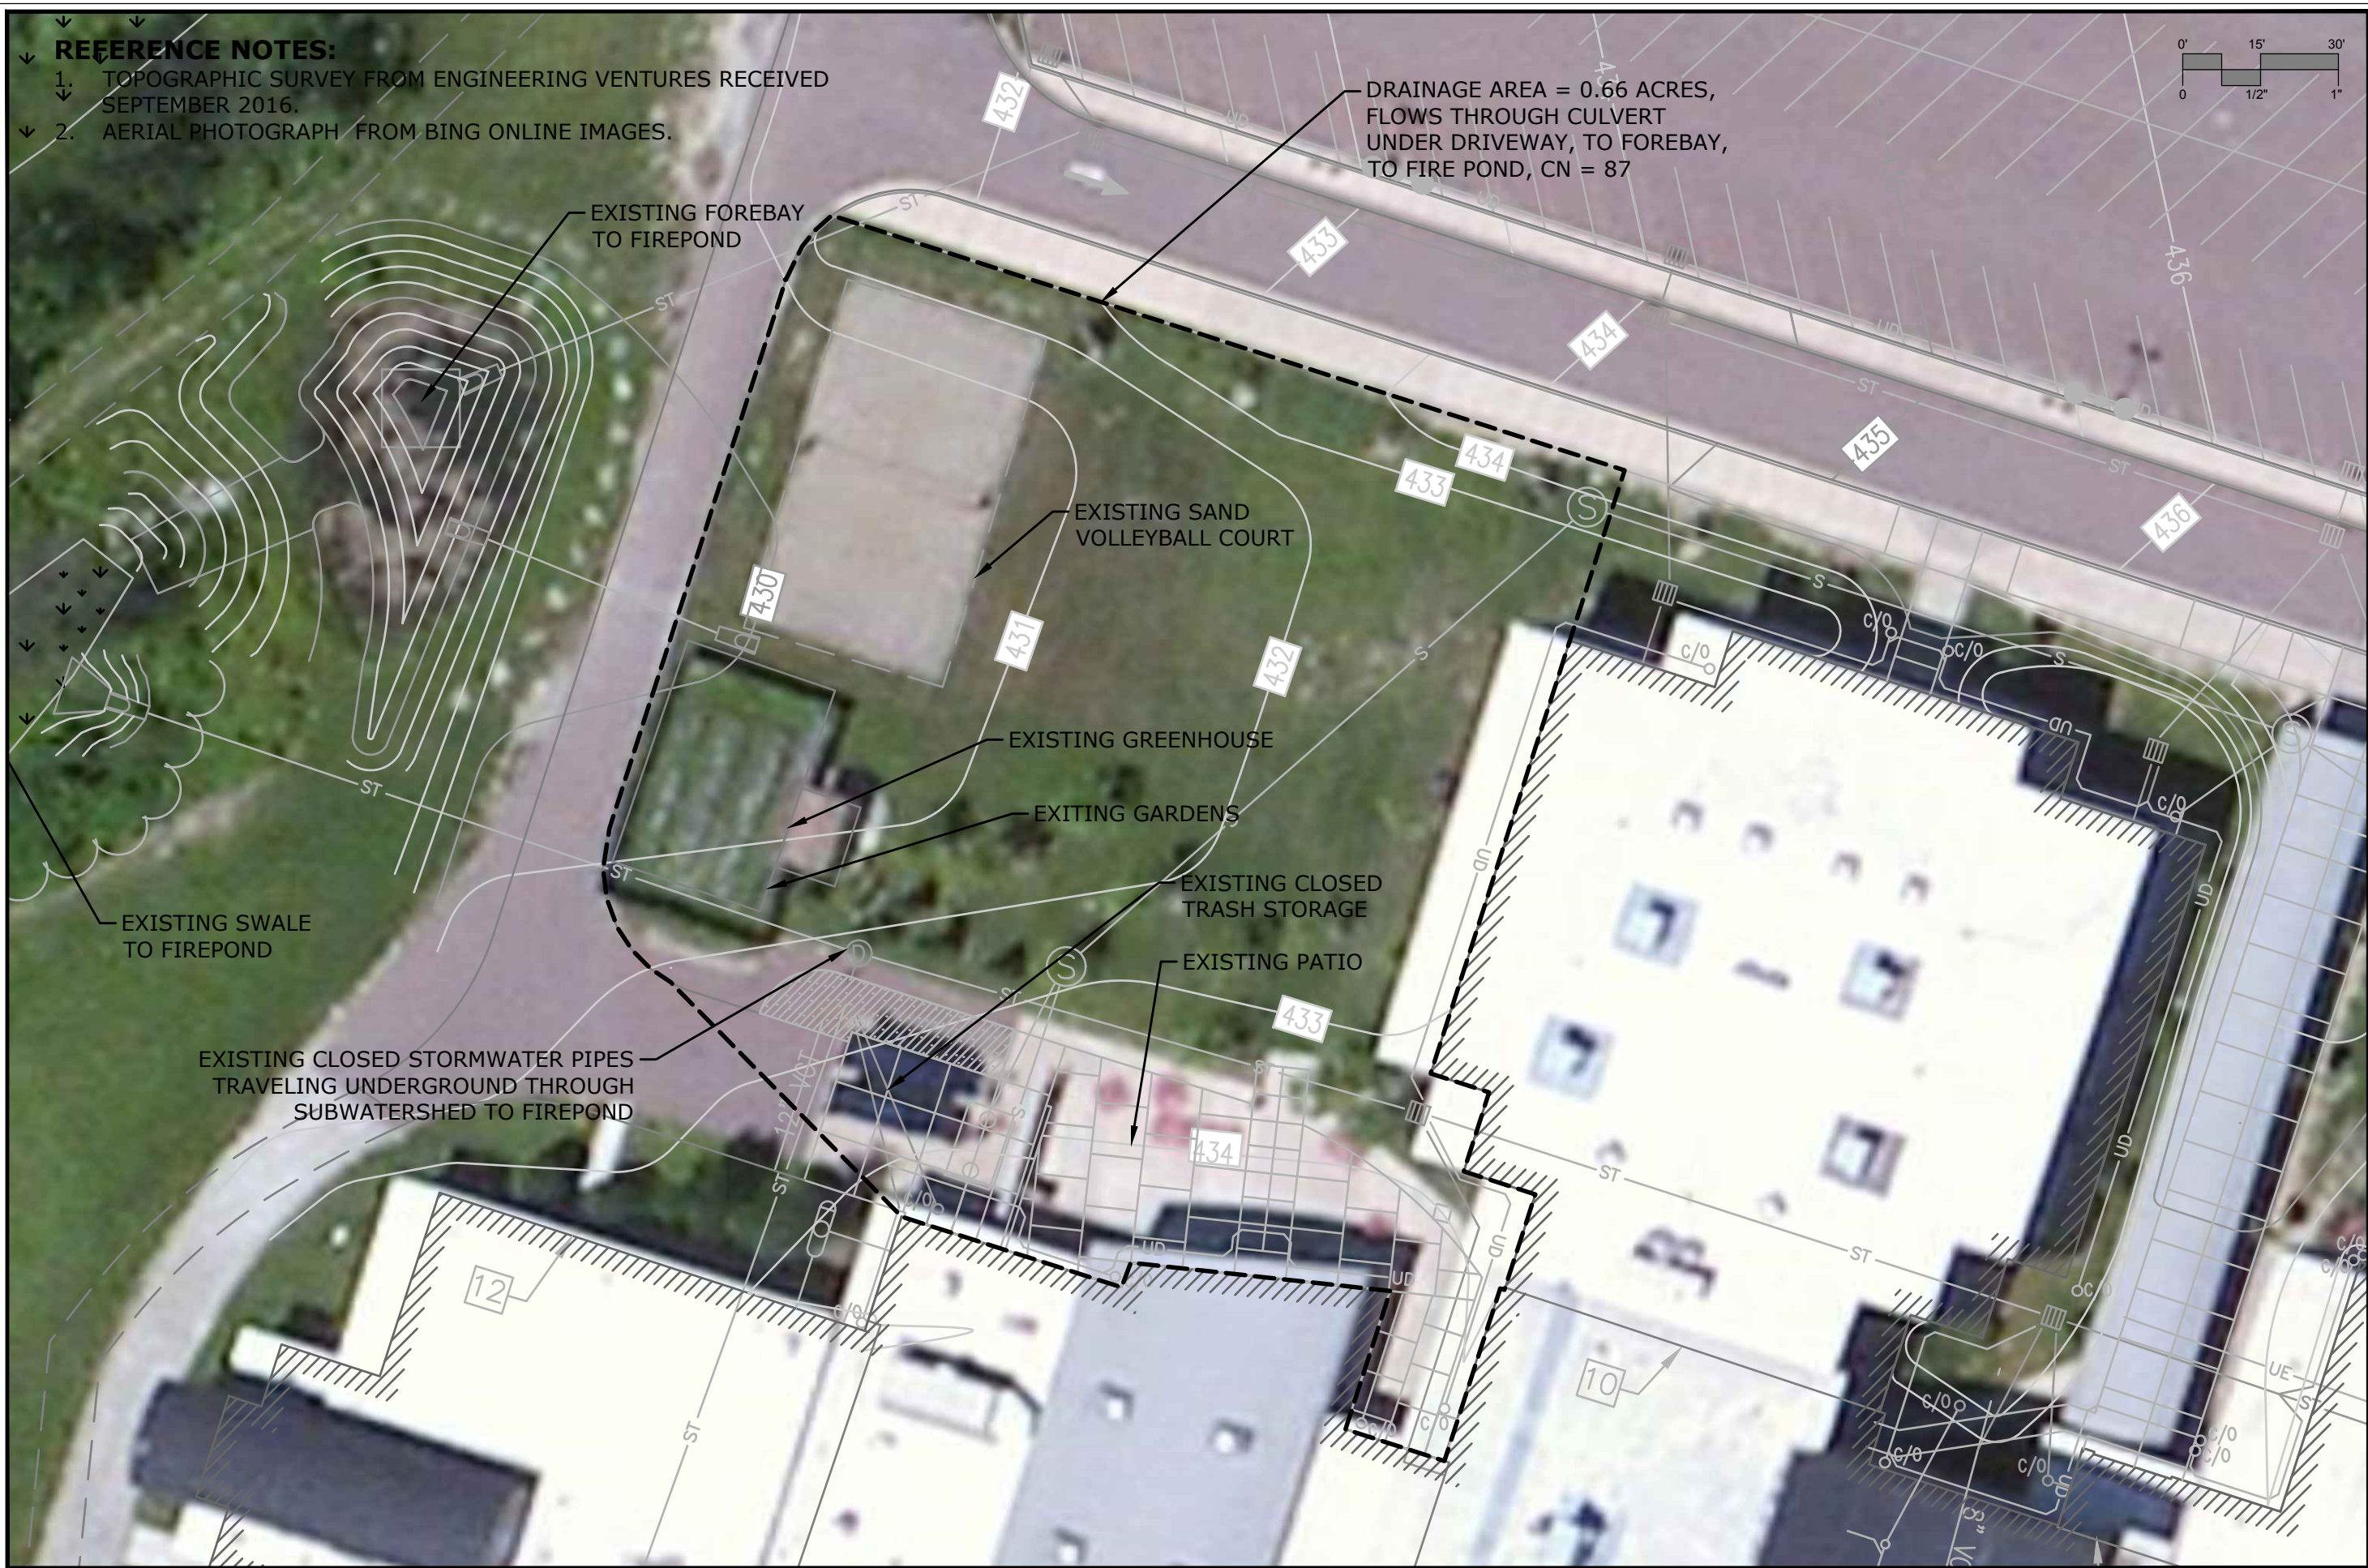
GREENHOUSE AREA EXISTING CONDITIONS

DRAINAGE AREA = 0.66 ACRES,  
 FLOWS THROUGH CULVERT  
 UNDER DRIVEWAY, TO FOREBAY,  
 TO FIRE POND, CN = 87

EXISTING FOREBAY  
 TO FIREPOND
