LaPlatte River Corridor Plan Reaches M6 – M11 Towns of Charlotte and Shelburne, Vermont

Prepared by the LaPlatte Watershed Partnership

April, 2008

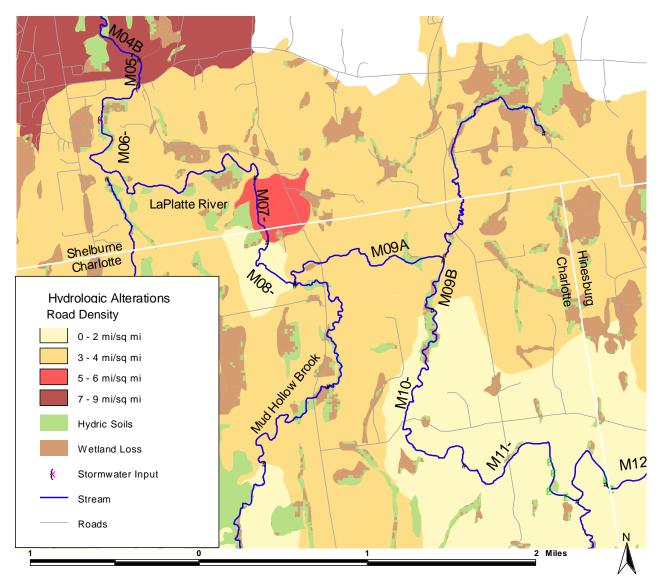
Figure 5.2. Hydrologic Regime Map. Note that no dams were present on the reaches examined in this plan.

The subwatersheds are shaded according to the density of roads. Road density is listed in 4 categories, related to effects on streams. Road density has been correlated to percent impervious cover following work by Fitzgerald (2007). In Fitzgerald's research, a road density of 4% correlated to 5% impervious cover, which was the threshold for impacts to stream geomorphology described by Fitzgerald (2007).

This study area was part of a larger study of impervious surface cover by South Mountain Research and Consulting (2005). The impervious surface study had larger subwatersheds than depicted here; so all subwatersheds in this study were grouped into one area found to have 4% impervious surface cover. That research as well as the mapping shown here indicates that these subwatersheds are close to the 5% impervious cover threshold described by Fitzgerald (2007).

Stormwater inputs were only seen in reach M06, however more stormwater inputs are likely, as they may enter tributaries before entering the mainstem and therefore were not identified during the assessment. An inventory of stormwater infrastructure and outfalls would be useful to determine the extent of stormwater impacts in the watershed.

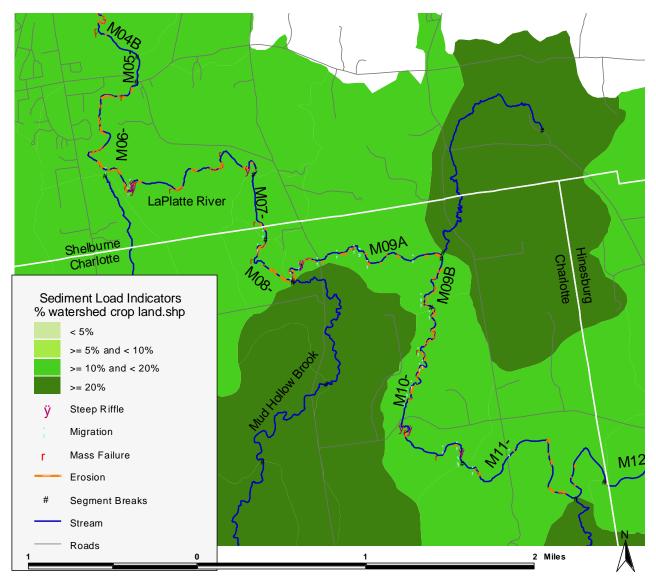
Figure 5.3. Sediment Load Indicators Map. All subwatershed cropland coverages were over 10% with some over 20%. Tributary rejuvenation was observed in reaches M06 and M09A.

Subwatersheds in Figure 5.3 are shaded according to the percent cropland in each. Cropping tends to result in exposed soils, prone to erosion. Other sources of sediment such as bank erosion, channel migration, and mass failures are also highlighted.

The subwatersheds in the study area had over 10% cropland use with tributary streams (including Mud Hollow Brook) having over 20% cropland use. Such high percentages of cropland can contribute significantly to the sediment load. Additionally, many areas of bank erosion, channel migration, and mass failures were present, contributing sediment to the stream.

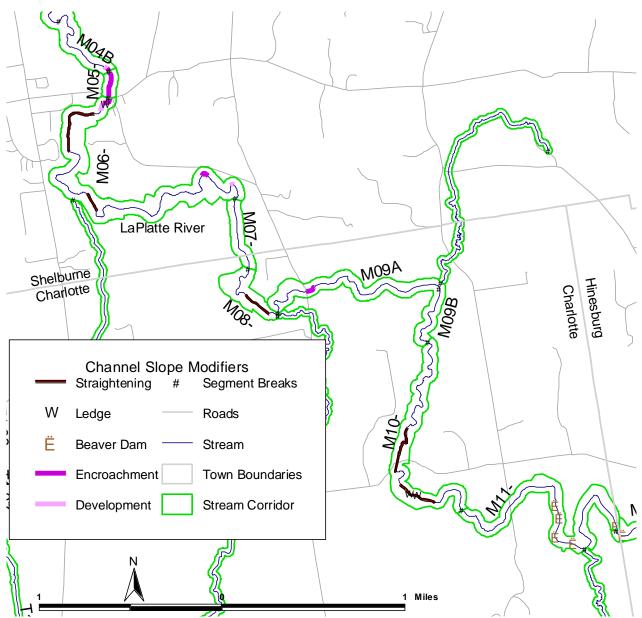
Figure 5.4. Channel Slope Modifiers Map. No dams were in the study area, although beaver dams were seen in reach M11.

Historical channel straightening affects sections of reaches M06, M08, and M10, resulting in increased channel slope. Bedrock ledges provide grade control, limiting channel incision, at the

downstream end of reach M06 and in reach M10. Overall, relatively little development, roads or berms have encroached into the stream corridor.

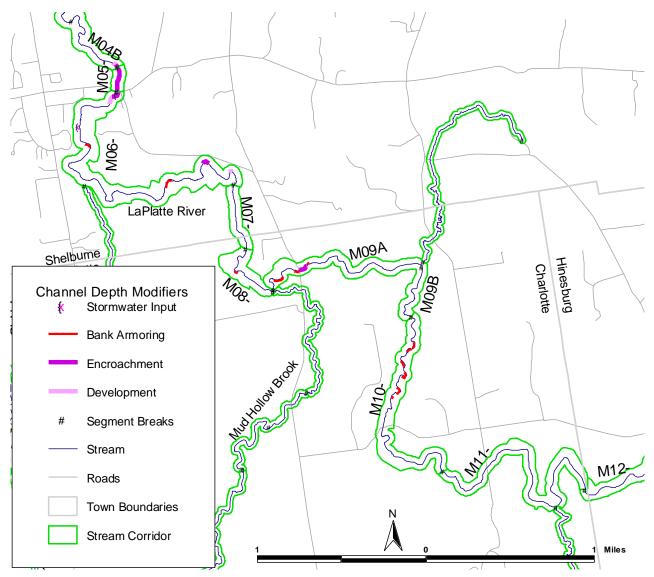
Figure 5.5. Channel Depth Modifiers Map. No documentation or signs of dredging were found, although past dredging activities may have occurred, especially in straightened sections.

Some areas of bank armoring (riprap) were identified and could impact channel depth. Additionally, straightening, as shown in figure 5.4, can also lead to channel incision. Channel incision was noted in all study reaches except for reach M11.

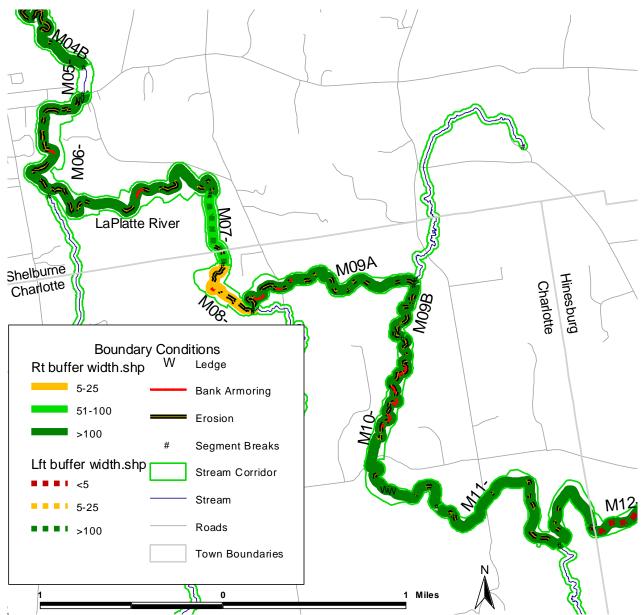
Figure 5.6. Boundary Conditions Map. No dams were present in the study reaches.

Removal of woody bank vegetation can decrease boundary resistance, leading to bank erosion and channel migration. Reach M08 had reduced buffer width (5-25 feet) and significant bank erosion. Other reaches had adequate woody buffer widths, although some areas within the reaches had low buffer widths, such as in M06, M09A, and M10.

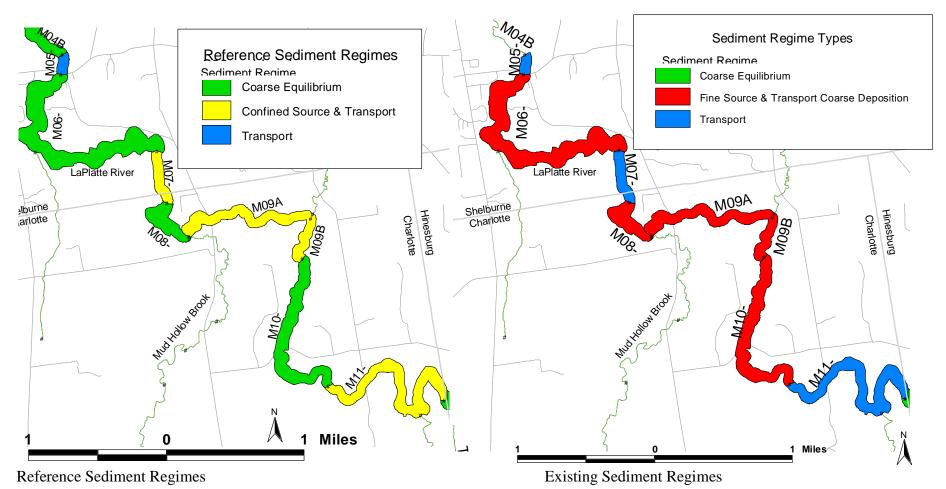
The reference sediment regimes in the study area (Figure 5.7) were alternating sections of Transport (M05, M07, M09, M11) and Coarse Equilibrium areas (M06, M08, M10). Existing sediment regime types, based on Phase 2 data, show departures in regime in all but the most confined transport areas, M07 and M11. Reaches M06, M08, and M10 have changed from Coarse Equilibrium regimes to Fine Source and Transport, Coarse Deposition regimes. This indicates an increase in fine sediments produced in these reaches and transported downstream, as also illustrated in figure 5.3. Segments M09A and M09B experienced a departure in sediment regime from Transport to Fine Source and Transport, Coarse Deposition. This indicates that while these segments may be storing more coarse sediment than they were under reference conditions, they are now considered sources of fine sediments. Deposition of coarse sediments can lead to large bar features that induce channel migration and can lead to channel avulsions and flood damage.

Figure 5.7. Reference and existing sediment regimes for the LaPlatte study area. Reaches M07, M09, and M11 have valley slopes less than 2% so have

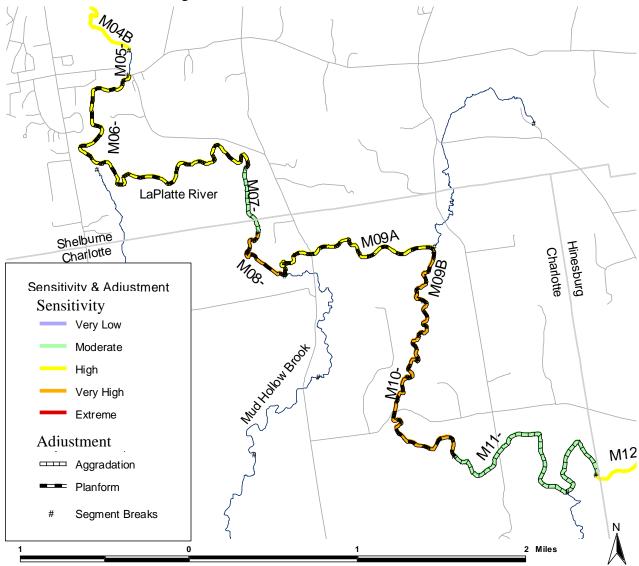
All reaches in the study area except for M07 and M11 show high to very high sensitivity with lateral channel migration (planform) being the dominant adjustment process. This implies that continued and future stressors to these reaches are likely to result in further channel migration, avulsion, and/or flood damage.

Figure 5.8. Stream Sensitivity and channel adjustment process.
