AHEAD OF THE STORM

Site: LaPlatte Headwaters Town Forest

Location: Gilman Road, Hinesburg, Vermont

MANAGEMENT PLAN AT GULLY EROSION ON HEADWATER TRIBUTARY

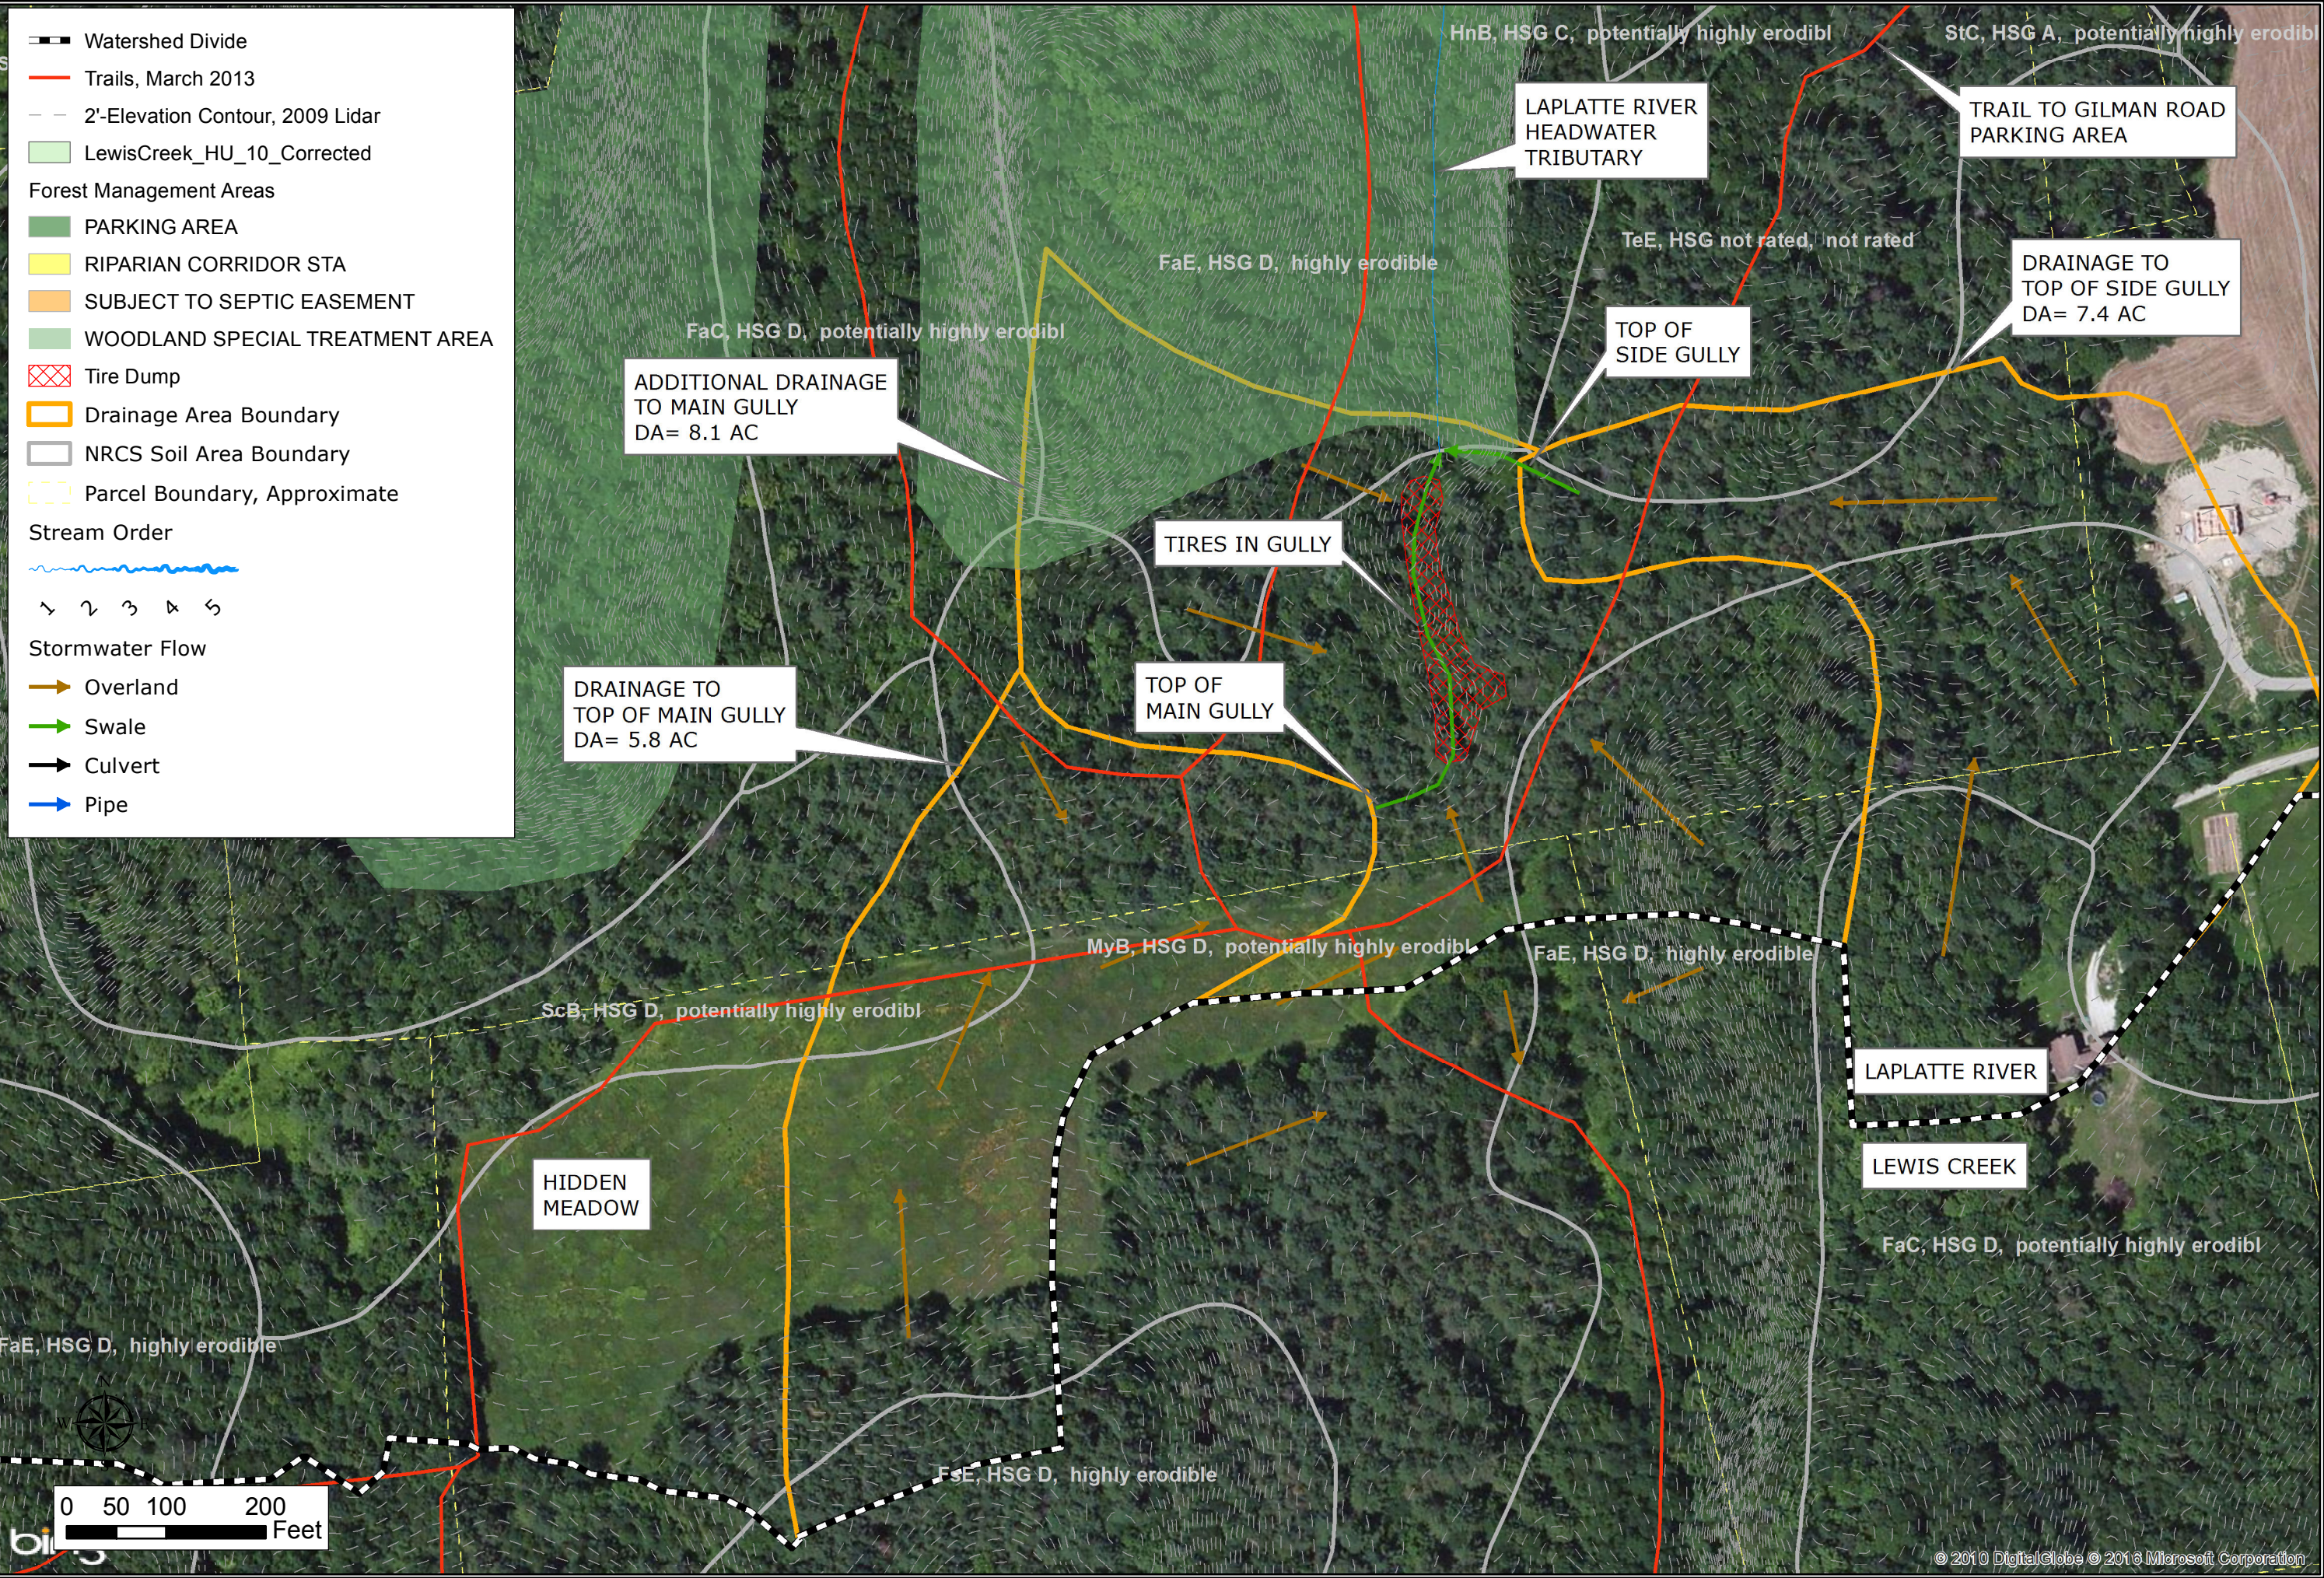
Gully erosion is occurring in several areas of the LaPlatte Headwaters Town Forest Area, specifically at the upstream end of two branches of a headwater tributary of the LaPlatte River. The gully erosion and headcutting are likely caused by increases in runoff from historic changes to land use associated with farming and clearing the land between the 1800's and mid-1900's. This may have also been influenced by channel incision in the downstream LaPlatte River and subsequent tributary regeneration (incision of the tributary to match the new elevation of the receiving stream base elevation). Increased rainfall intensity and magnitude may also have led to the expansion of minor initial erosion to the larger erosion observed today. Many years ago car tires were thrown into the gully to stop the erosion. This project created a management plan for the gully erosion to improve water quality and flood resilience. *(See existing conditions site summary and plan.)*

Gully erosion is occurring in several areas of the LaPlatte Headwaters Town Forest Area (Figure 1). The erosion was first discovered due to a conflict with one of the Hinesburg Area Recreation Trails (Bissonette Loop) that has since been relocated away from the head of the gully. This project will advise on management of the erosion to improve water quality and flood resiliency.

Seven Optimal Conservation Practices (OCPs) are recommended to mitigate stormwater runoff at the site.

1. Reroute trails if they are subject to erosion from the expanding gully.
2. Manage the site so that flow is not concentrated.
3. Apply proper optimal conservation practices during timber management.
4. Consider changing the LHTFMP High Priority Action to leave the tires in place and manage around them.
5. Place brush and logs in the upper gully to replicate the natural storage of sediment with wood.
6. Replicate the natural storage of sediment with wood in the gully.
7. Cover tires with soil and revegetate the gullies.

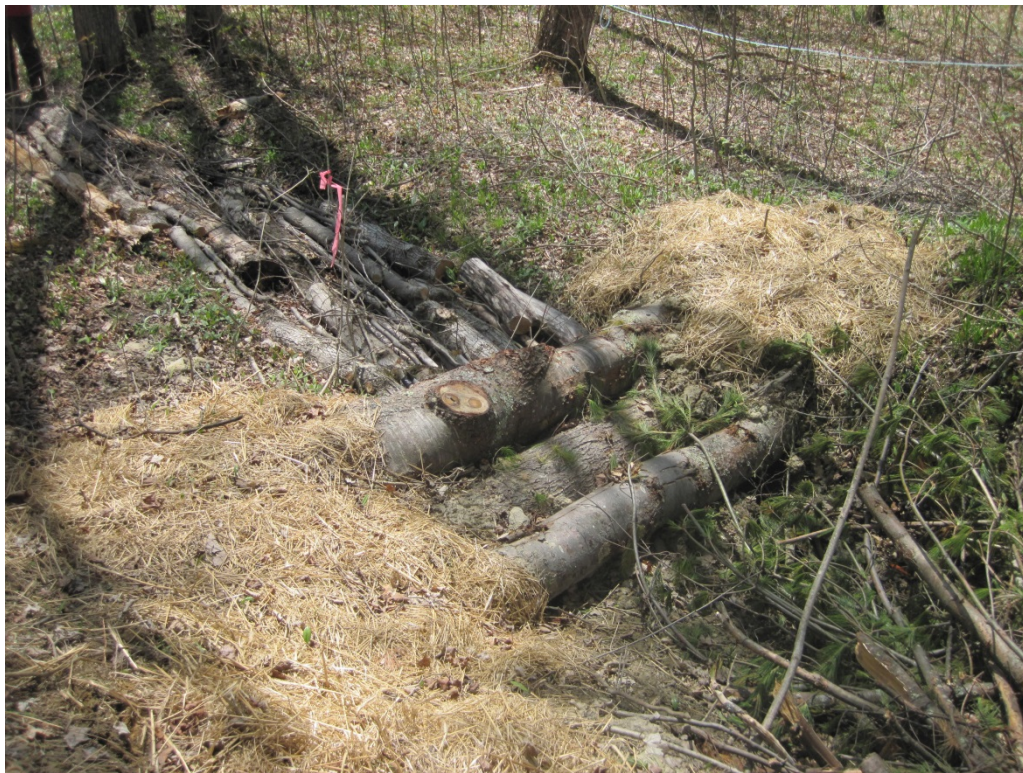
Photo 2. Example of log check dam and brush and small log application at gully erosion site adjacent to Pond Brook in Monkton, Vermont. This photo was taken at time of installation, prior to accumulation of sediment between the logs and brush.

Description: The upstream extent of the gully erosion has continued to move upgradient. It is recommended that brush and logs are placed in the upper gully to slow water and catch sediment. This will slow the rate of erosion. This technique replicates the natural storage of sediment. In the narrow upper section of the gullies volunteers can likely perform the labor by hand. Logs and brush could be accumulated from the forest during routine management. Examples of natural wood applications are included below that apply to this and the following recommendation. Wood was observed holding back sediment in the channel downstream of the gullies and can be used as an example (Photo 1). A nearby recent gully erosion repair project was completed using natural wood techniques that could be applied here (Photo 2). Typical engineering details of this type of natural wood application are found below including “Brush and Small Log Application”, “Log Stack Application”, and “Log Check Dam” (Figures 1, 2, and 3).
