LaPlatte Watershed Partnership

Phase 2 Stream Geomorphic Assessments
Lower LaPlatte River & McCabe's Brook
Shelburne and Charlotte, Vermont
June 2007

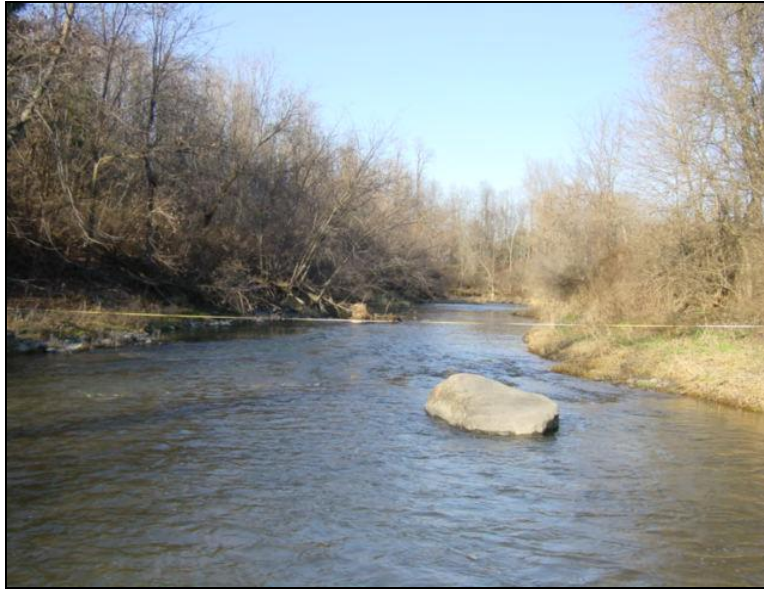
Reach M06 began just southwest of the intersection of Spear Street and Thomas Road and ended upstream of Shelburne Falls (12,025 feet long). The reference stream type for this reach appeared to be a C4 Riffle-Pool, but due to channel incision, the reach experienced a stream type departure to a B4c Plane Bed type. Floodplain access was limited, although old channels and/or flood chutes on the upper terrace could provide additional floodplain access and relief from high flows. Incision appeared to be historical, as did channel widening. Current channel adjustments appeared to be aggradation and major planform. Bank erosion, islands, and multiple mass failures were indicators of these adjustments with significant contributions to sediment loads. Also contributing sediment were rejuvenating tributaries in the reach and gullies from stormwater inputs. Shelburne Falls at the downstream end of the reach provided grade control.

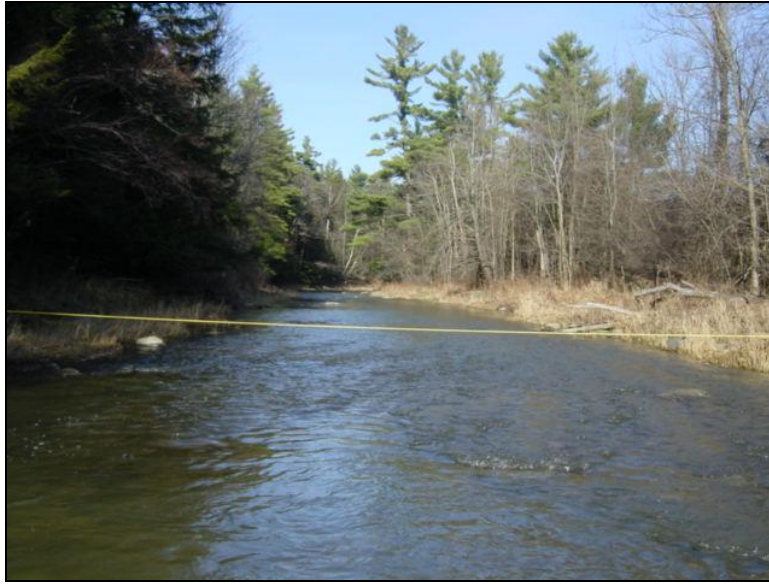
Reach M07 was fairly short, 2158 feet long, and appeared naturally straight in a narrowly confined valley setting with little floodplain. The “reference” stream type was B5 Step-Pool, however major aggradation filled pools, leaving the stream a Plane Bed type. Overall, geomorphic condition appeared “Good” with historical widening and the current aggradation adjustments. RHA condition was “Good” with low mix of substrate types, embedded particles, incomplete riffles, and sediment deposition affecting scores. Some hay fields on the right bank encroached into the otherwise forested corridor.

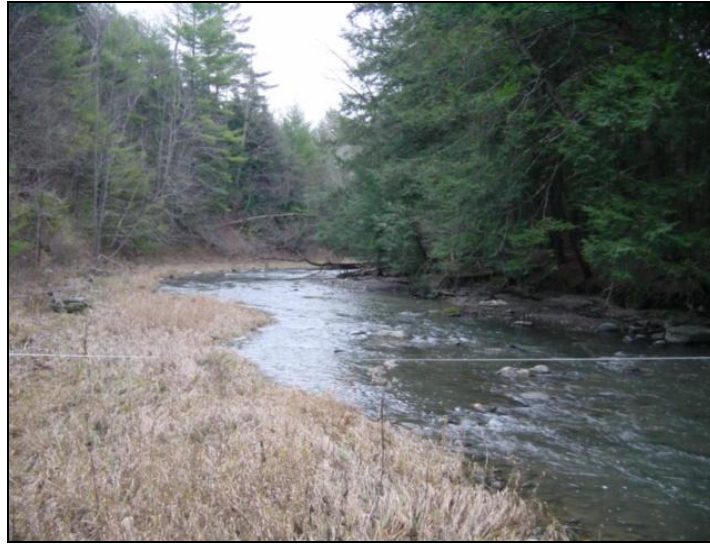
Reach M09 was segmented into two segments due to varying planform and slope characteristics. Segment M09A (downstream segment) had a steeper slope and appeared to be a B4 Plane Bed stream by reference. Adjacent side slopes in the narrow valley were steep to very steep. The channel appeared to have incised from an older terrace in the past, with current adjustment processes being minor aggradation, widening, and planform. Overall stream condition appeared “Fair” and the channel in stage IV of evolution. RHA condition appeared “Fair,” affected by bank instability, infrequent riffles, sediment deposition, and lack of cover. Some crop areas encroached into the corridor on both banks with forest in the majority of the corridor. Bank vegetation was dominated by herbaceous species. Multiple sediment deposits (bars) were present. A bridge at Spear Street constricted the bankfull width, with signs of deposition upstream.

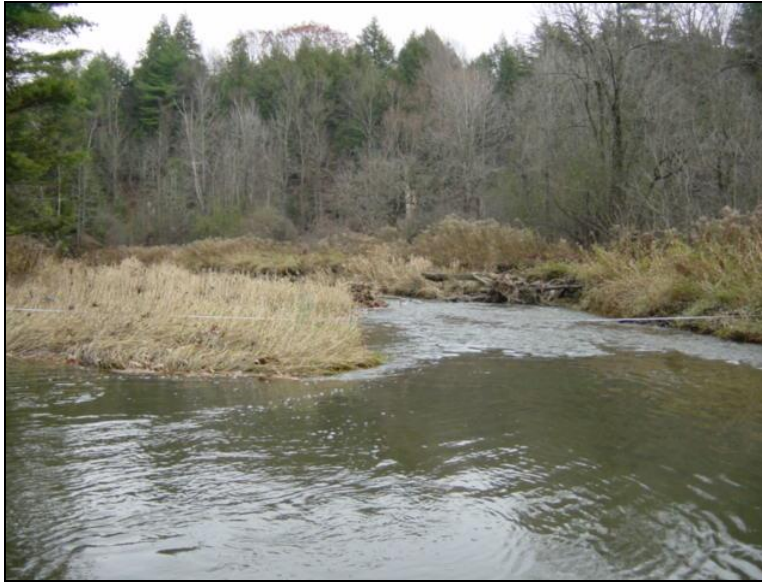
Segment M09B appeared to be in a slightly shallower valley, although also narrow, with a stream type of C5 Riffle-Pool. The riparian corridor was forested, with the same herbaceous bank vegetation as in M09A. This segment also appeared to have incised from an older terrace in the past, with current adjustment processes being planform with minor aggradation. Overall stream condition appeared “Fair” and the channel in stage IV of evolution. RHA condition appeared ‘Good’ with bank instability and sediment deposition being the main factors affecting habitat. Some signs of beaver activity were observed in the segment.

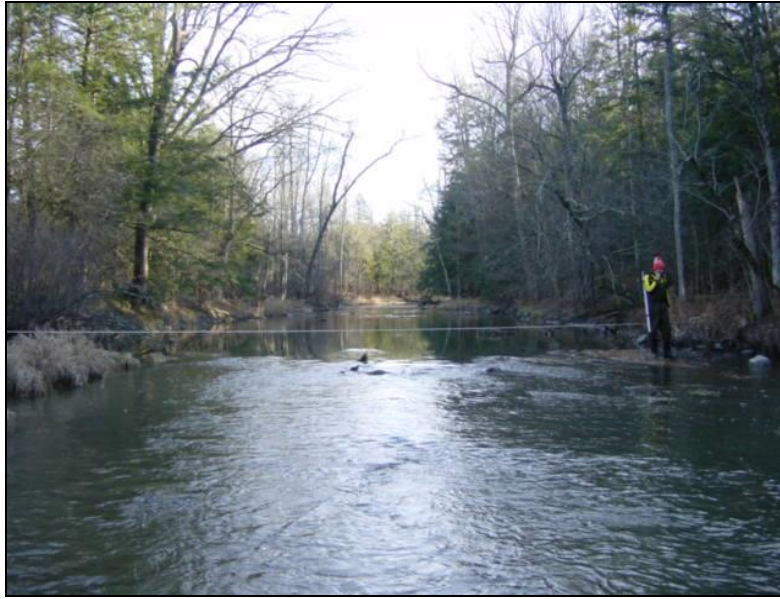
Reach M11 had a fairly shallow slope for its confined valley setting. The stream type appeared to be B4c Dune-Ripple. Beaver activity increased toward the upstream end of the reach, with a large dam and pond on a tributary. The riparian corridor was forested, however downstream of the bridge, cows had free access to the channel and many crossing areas and areas where banks were trampled noted. The channel did not appear incised, however tributary rejuvenation was noted, possibly due to beaver activity in the upstream areas, and land use at the downstream end as well as possible channel adjustment in the tributary itself. One bridge constricted the floodprone width and had scour downstream. Trash and deer carcasses were seen dumped on the banks at the bridge. Trash and old farm equipment were dumped on the right bank roughly in the middle of the reach. RGA condition appeared “Good” with only minor aggradation observed. The reach was considered “in regime.” RHA condition was also “Good.” Few substrates for food and cover were present. Riffles and diversity of velocity/depth patterns were infrequent.

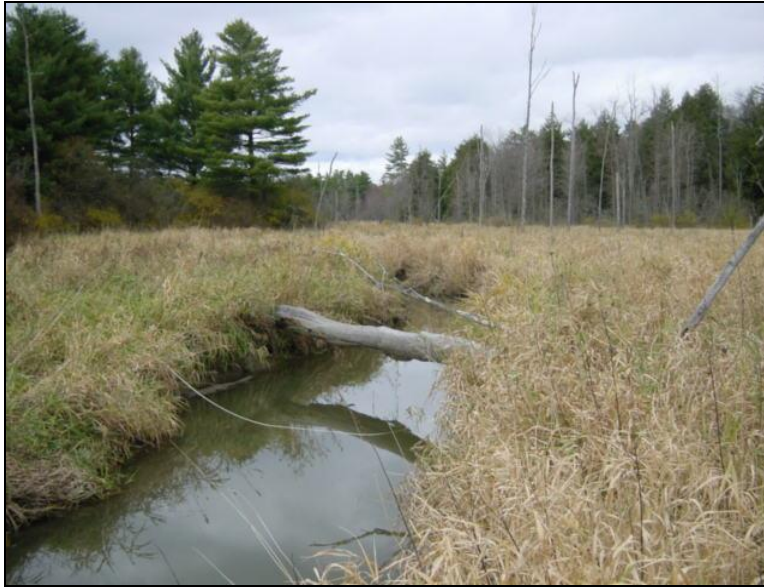
Reach T1.02 was a low gradient stream in a very broad valley setting. The stream had high sinuosity and appeared to be an E5 Ripple-Dune stream type. The riparian corridor had wetland areas and herbaceous and sapling vegetation. The outer corridor and adjacent lands were forested. Banks were fairly unstable with more slumping rather than erosion observed. Several debris jams and signs of beaver activity were seen in the reach. Two meander bend cutoffs were noted. At the downstream most end of the reach, water was backed up, likely from beaver activity in T1.01 and from lake effects. The reach appeared to have been straightened historically and the topographic map shows a significantly straighter stream line than the recent orthophotos. The reach did not appear incised, with current adjustments being planform with minor widening and aggradation. Overall, the reach appeared to be in stage IV of channel evolution and in “Good” condition. RHA condition appeared “Good.” Bank instability was the main factor affecting habitat with additional effects from sediment deposition in pools.

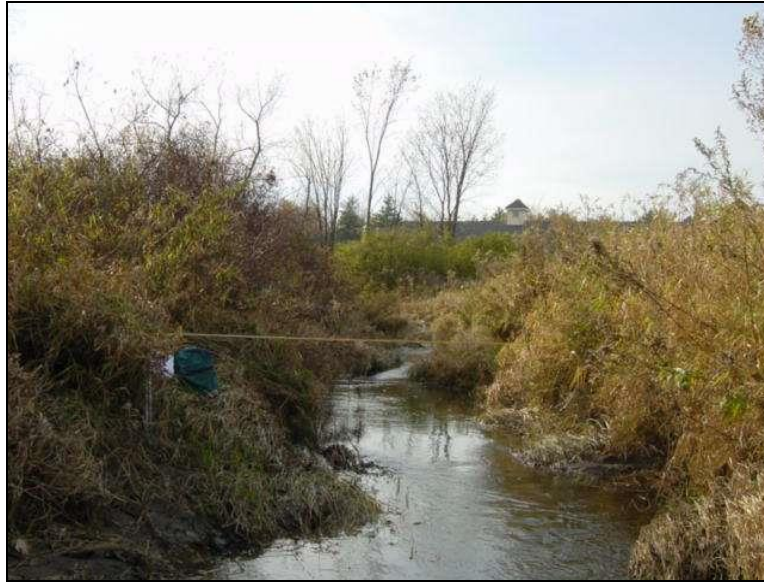
Reach T1.03 was also a low gradient stream in a very broad valley with an E5 Ripple-Dune stream type. Bank and buffer vegetation was herbaceous with some shrubs and saplings and deciduous trees. One bridge constricted the bankfull width with deposition upstream and scour downstream. Much bank slumping and erosion on outside bends was noted, signaling planform adjustments. The Town of Shelburne garage and sand pile encroached into the corridor at the downstream end of the reach. Evidence of beaver activity was also seen in the reach, especially toward the upstream end and into T1.04A. RGA condition appeared “Fair” with major planform and minor aggradation adjustments. The reach appeared to be in stage III of channel adjustment. RHA condition appeared “Fair,” affected by bank instability, sediment deposition, and lack of substrates for food and cover.

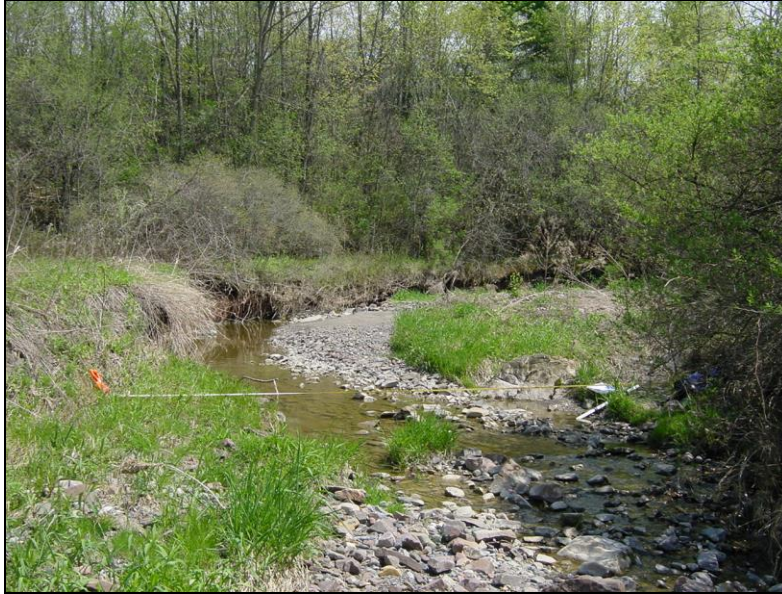
Segment T1.05A began at the T1.05 reach point (south of Bostwick Rd and the railroad crossing) and ended approximately 700 feet downstream of the Route 7 crossing. Segment T1.05A had several bedrock ledges acting as grade controls, providing bed stability. The segment appeared to have incised from a former terrace, resulting in a stream type departure (C to F). Bed substrate was gravel. Current adjustment processes appeared to be widening and planform. Multiple gravel bars signaled minor aggradation.

Close to the channel was open with herbaceous vegetation and invasive honeysuckle. Further out in the corridor was more forested with deciduous trees and shrubs/saplings. Overall habitat was “Fair,” affected by sediment deposition and bank instability. Many fish and frogs were seen in the channel however.

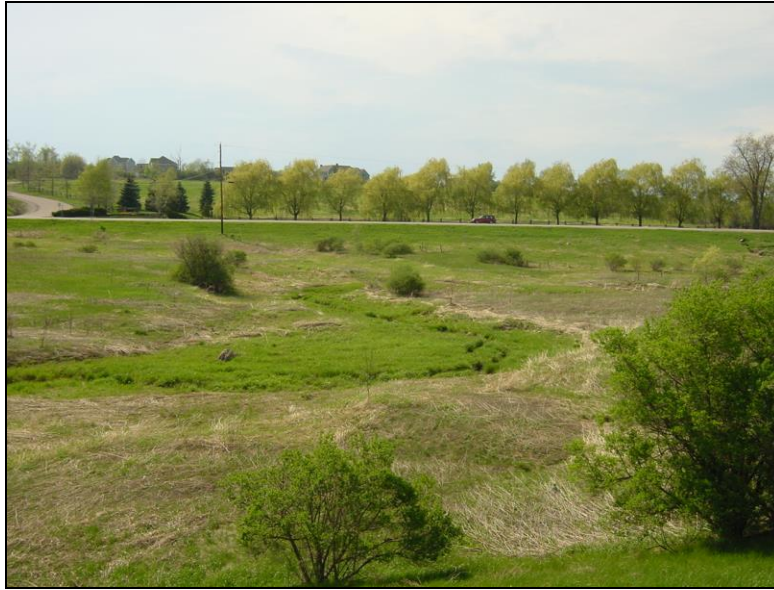
Segment T1.05B had a shallower slope, smaller substrate size and in a broad valley setting. The segment appeared to be “in regime,” being a C Dune-Ripple stream type and in “good” condition. Minor planform and widening processes were observed, and could be related to the lack of woody bank vegetation.

Bank and buffer vegetation was herbaceous with some shrubs/saplings. Some areas of forested corridor were present in the upstream portion of the segment. RHA condition was “good” but lacking sufficient mix of substrates and large pools. A cattle watering area had been fenced out in the channel and had turned into a large pool. For water quality purposes, cattle should be fenced out of the channel and alternative watering methods used.
