**PHASE 2 GEOMORPHIC ASSESSMENT AND CORRIDOR PLANNING  
MCCABE'S BROOK WATERSHED  
CHARLOTTE AND SHELBURNE, VERMONT**

FEBRUARY 10, 2012

MILONE & MACBROOM, INC.  
1233 Shelburne Road, Suite 150  
South Burlington, Vermont 05403  
802.864.1600  
[www.miloneandmacbroom.com](http://www.miloneandmacbroom.com)  
MMI #3452-13

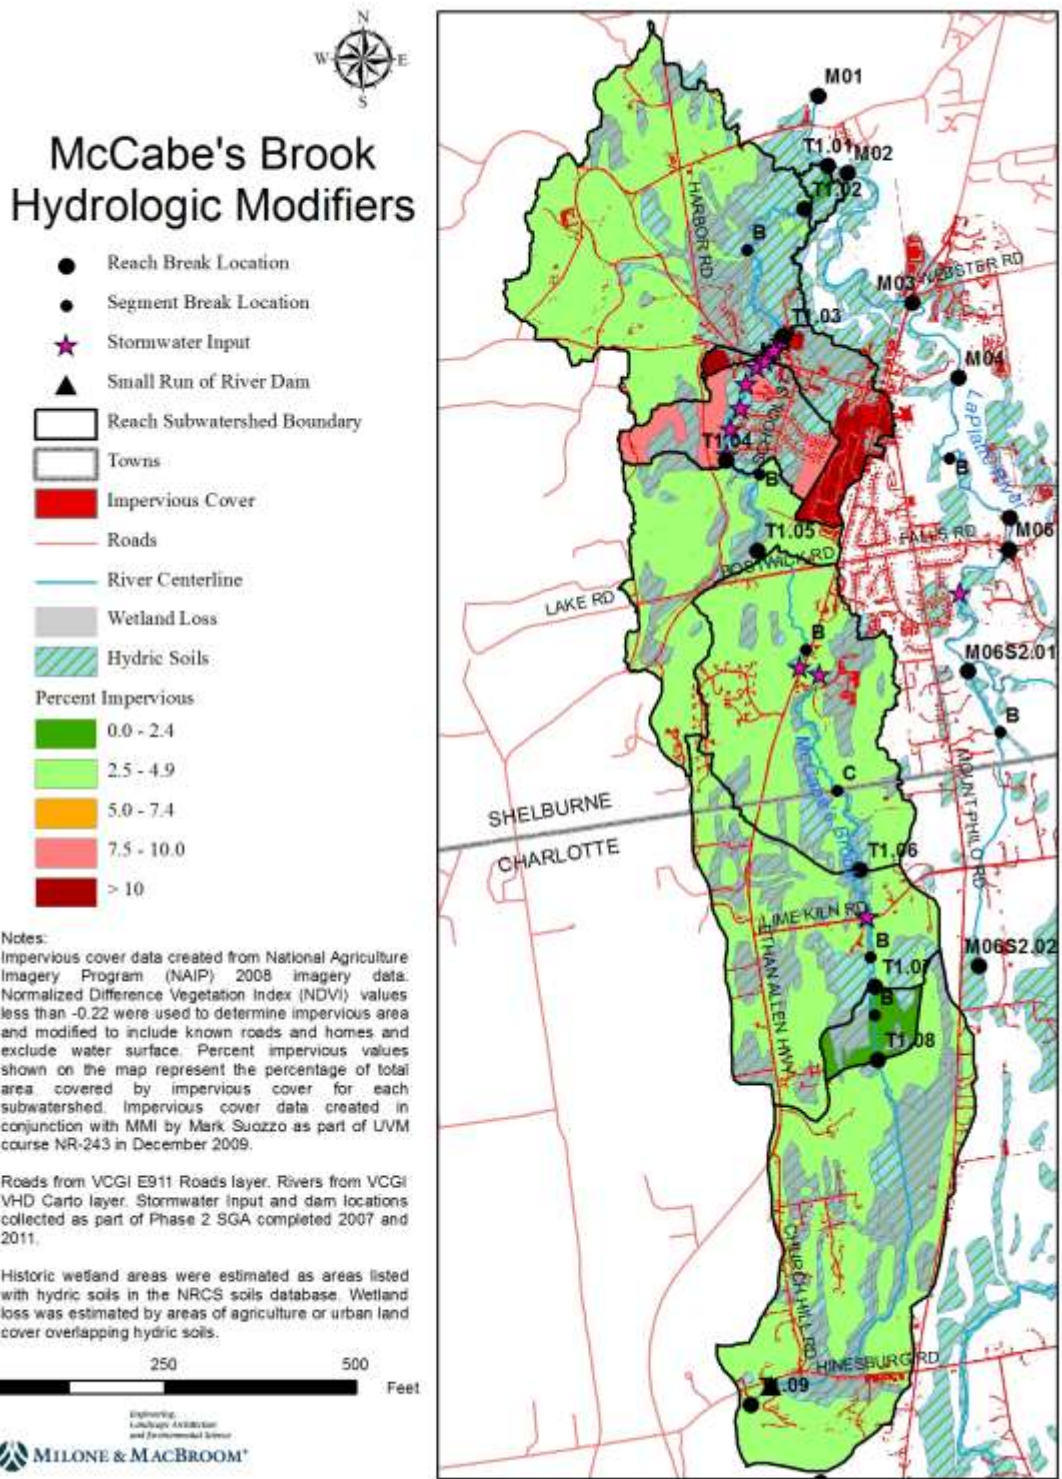
Figure 5: Hydrologic Alterations Map

Impervious area was examined by subwatershed to provide an overview of the stream reaches that are receiving runoff from higher amounts of impervious area (Figure 5). Thresholds of impervious cover above which water quality and stream conditions deteriorate have been found to range between 5 and 10% (e.g., Brabec et al., 2002; CWP, 2003; Schiff and Benoit, 2007). McCabe's Brook subwatersheds had low to moderate amounts of impervious cover except at the village center of Shelburne where impervious cover was up to 37%.

Wetlands naturally detain water, both reducing the volume and timing of runoff to the channels. Hydric soils are an indication of areas that would naturally be wetlands, although may be an overestimation of the area that they would cover. Hydric soils were identified in areas where current landuse is urban or agriculture, assuming that these areas may represent a rough designation of lost wetland areas (Figure 5).

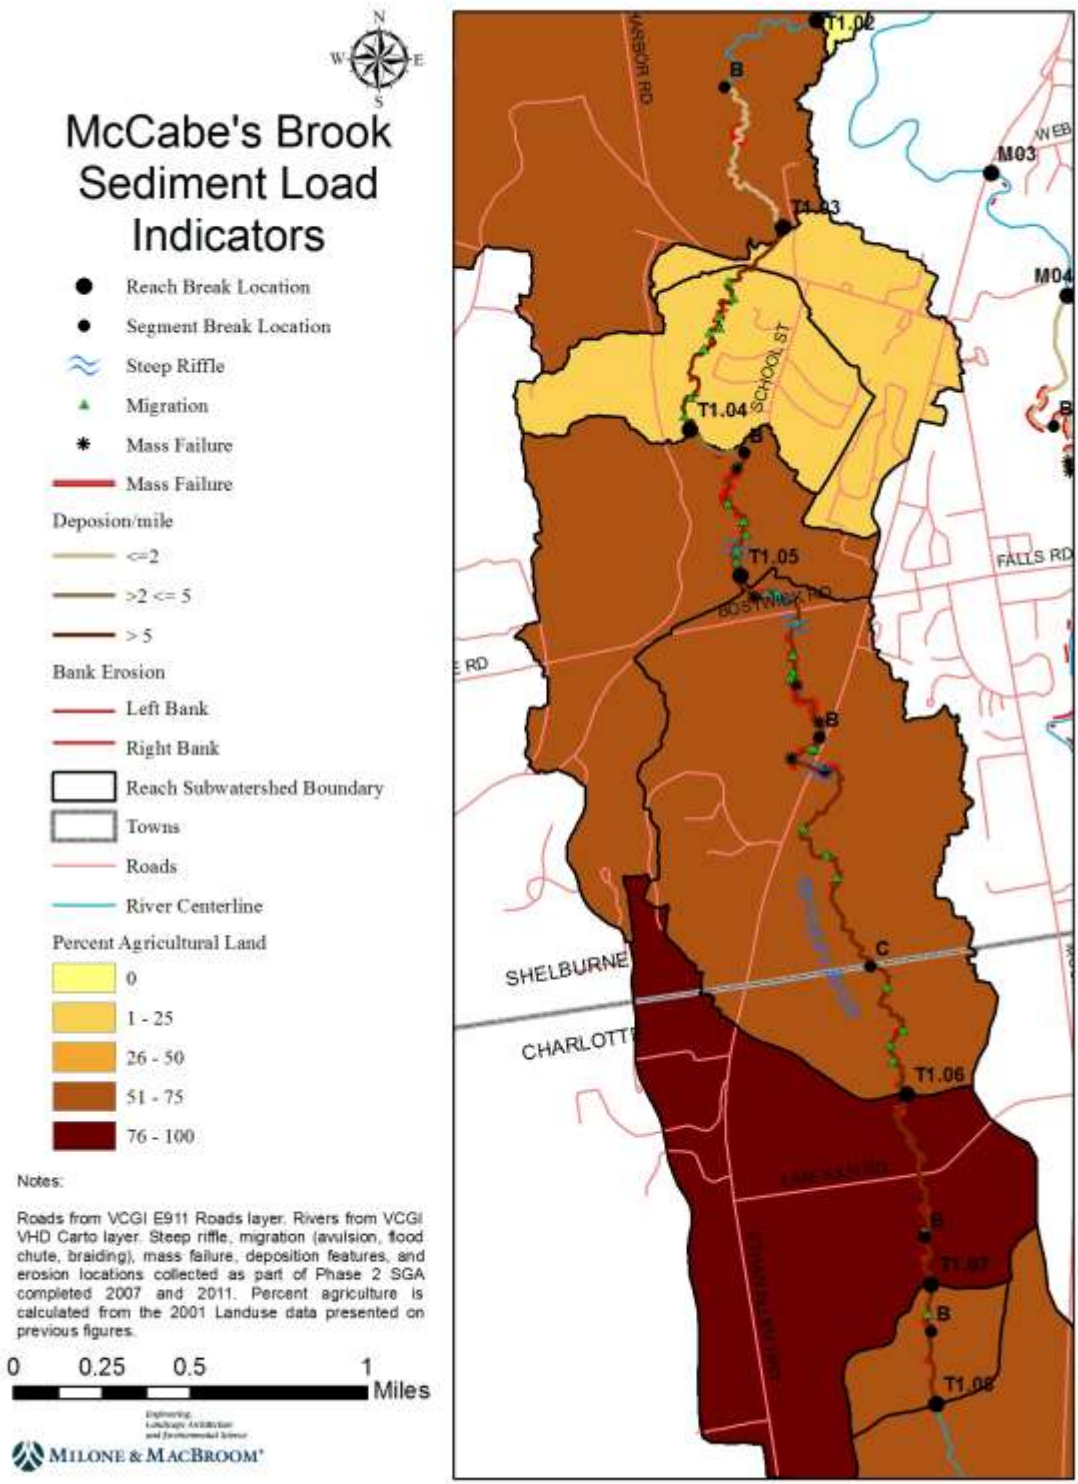
*Figure 6: Sediment Load Indicators Map*

A certain amount of erosion and deposition is natural in an alluvial channel. Some channel features indicate a high sediment load including: steep riffles, mid-channel bars, delta bars, flood chutes, avulsions, and braiding. Significant erosion, mass failures, gully erosion, and tributary rejuvenation contribute to additional instream sediments. When a high number of these features are present, the channel may not be transporting sediment at the equilibrium level (Figure 6).

- High percentage of agricultural land in all subwatersheds except T1.01.
- High bank erosion in T1.04B and T1.05A (greater than 20% of the banks).
- Moderate bank erosion in T1.03 (5-20% of the banks)
- Multiple mass failures in both T1.04B and T1.05A
- High number of steep riffles and migration features in T1.05A and T1.04B.
- High number of migration features, many due to beaver influence, in T1.03 and T1.05C.
- High density of deposition features in T1.03, T1.04B, T1.05 A,B,C, T1.06 A,B, and T1.07 A,B

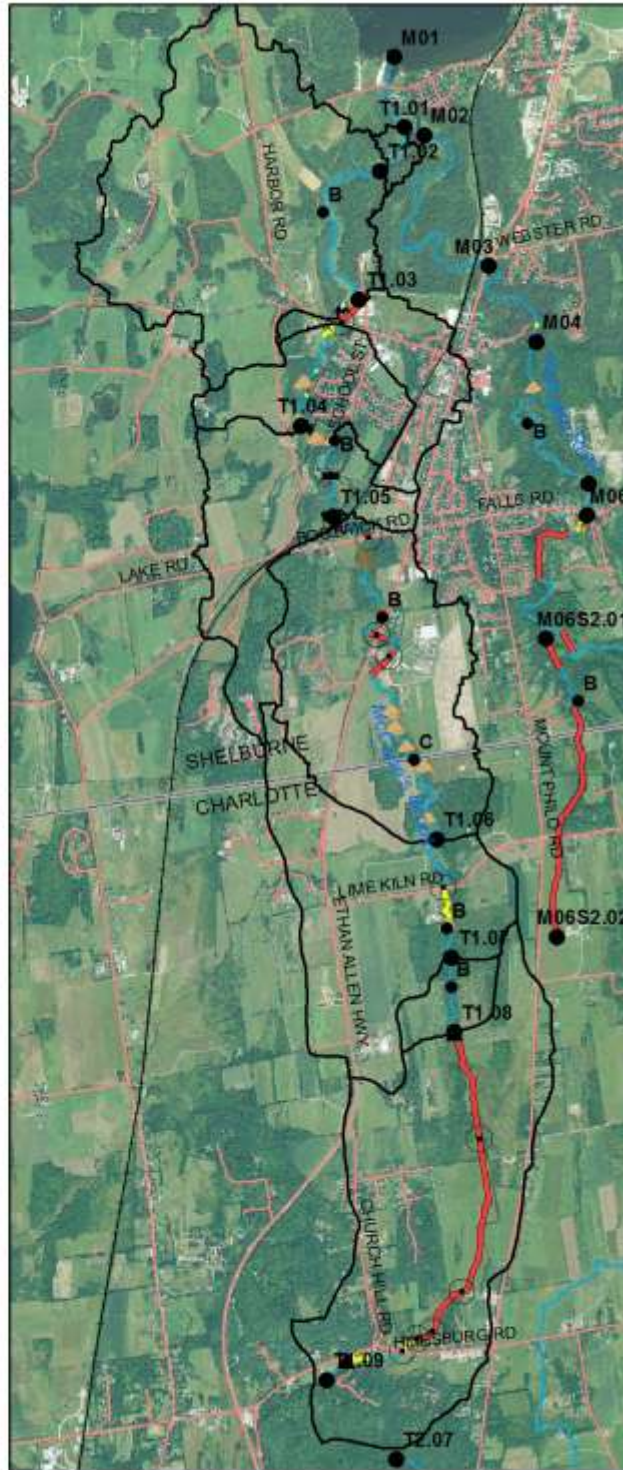
*Figure 7: Channel Slope Modifiers Map*

Constrictions to either the channel or floodplain can cause backwater upstream. These backwater zones cause sediments to settle out of the water column and deposit. This can cause a decrease in the slope of the channel. These constrictions can be natural or manmade grade controls, undersized bridges or culverts (Figure 7).

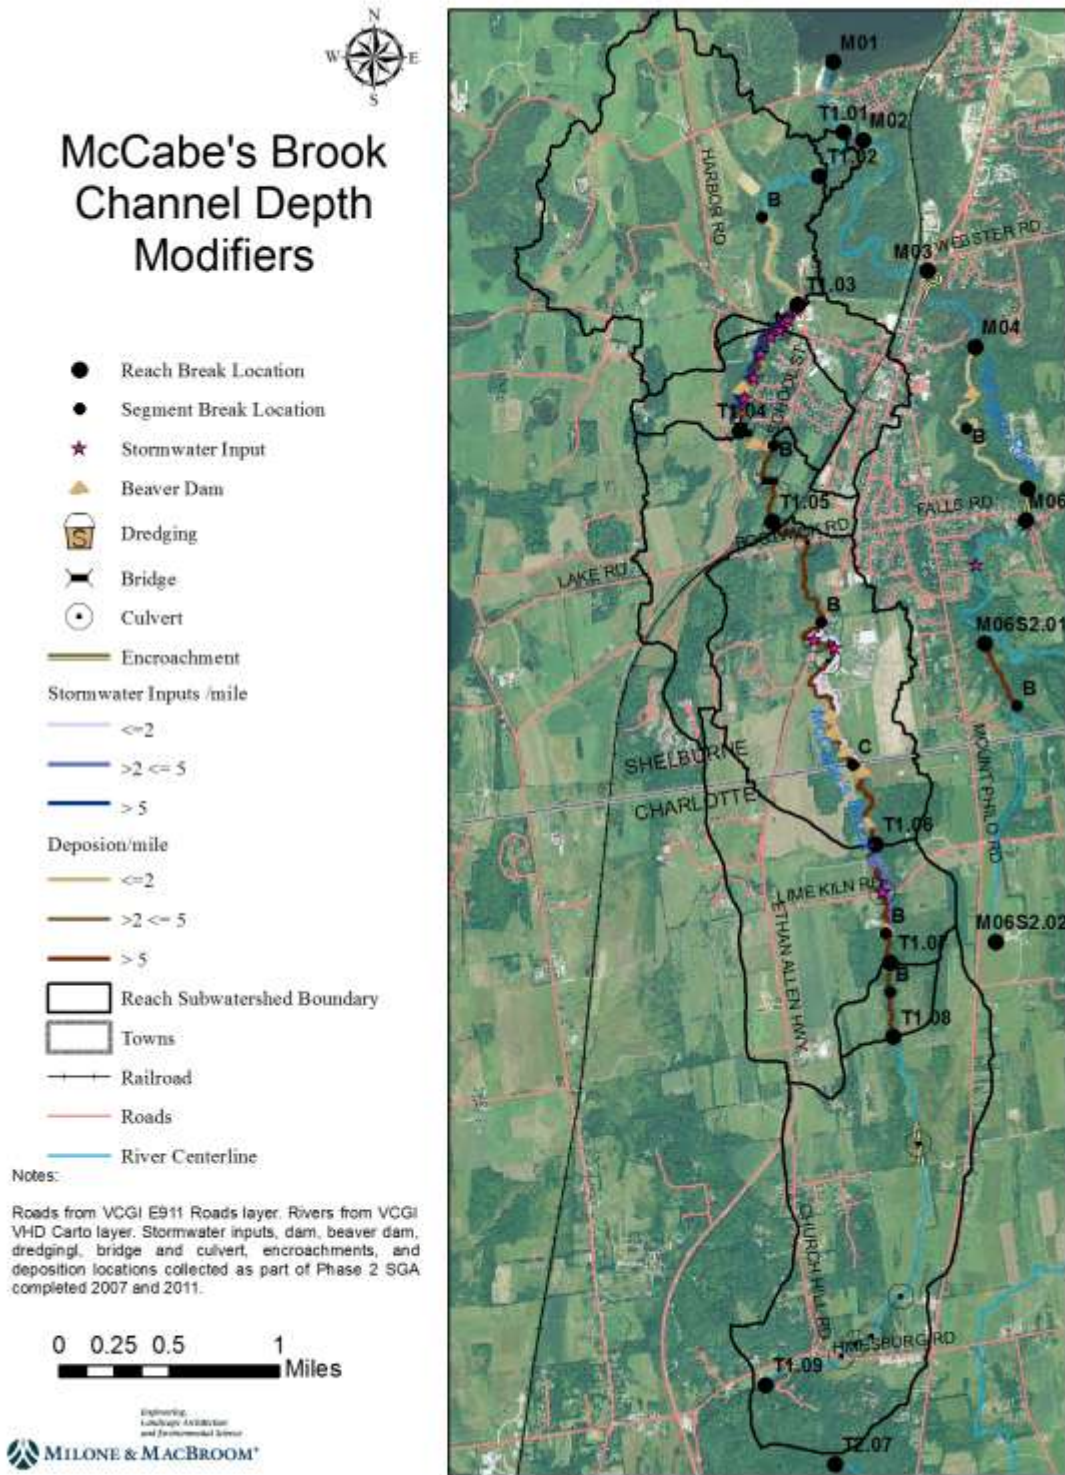
**Figure 8: Channel Depth Modifiers Map**

Channel depth is directly correlated to stream power (Figure 8). Increases in channel depths can increase stream power that can cause bed erosion, incision, and channel evolution. As a channel deepens, the flow has reduced access to its floodplain. This can be caused by filling of a floodplain, dredging, or incision. Roads, homes, railroads, trails, and other development adjacent to river commonly fills, causing an encroachment into the natural floodplain.

- Sedimentation in the backwater area upstream of Bostwick Road has reduced depth in T1.05A.
- Sedimentation in backwater area upstream of beaver dams in T1.05B and T1.05C.

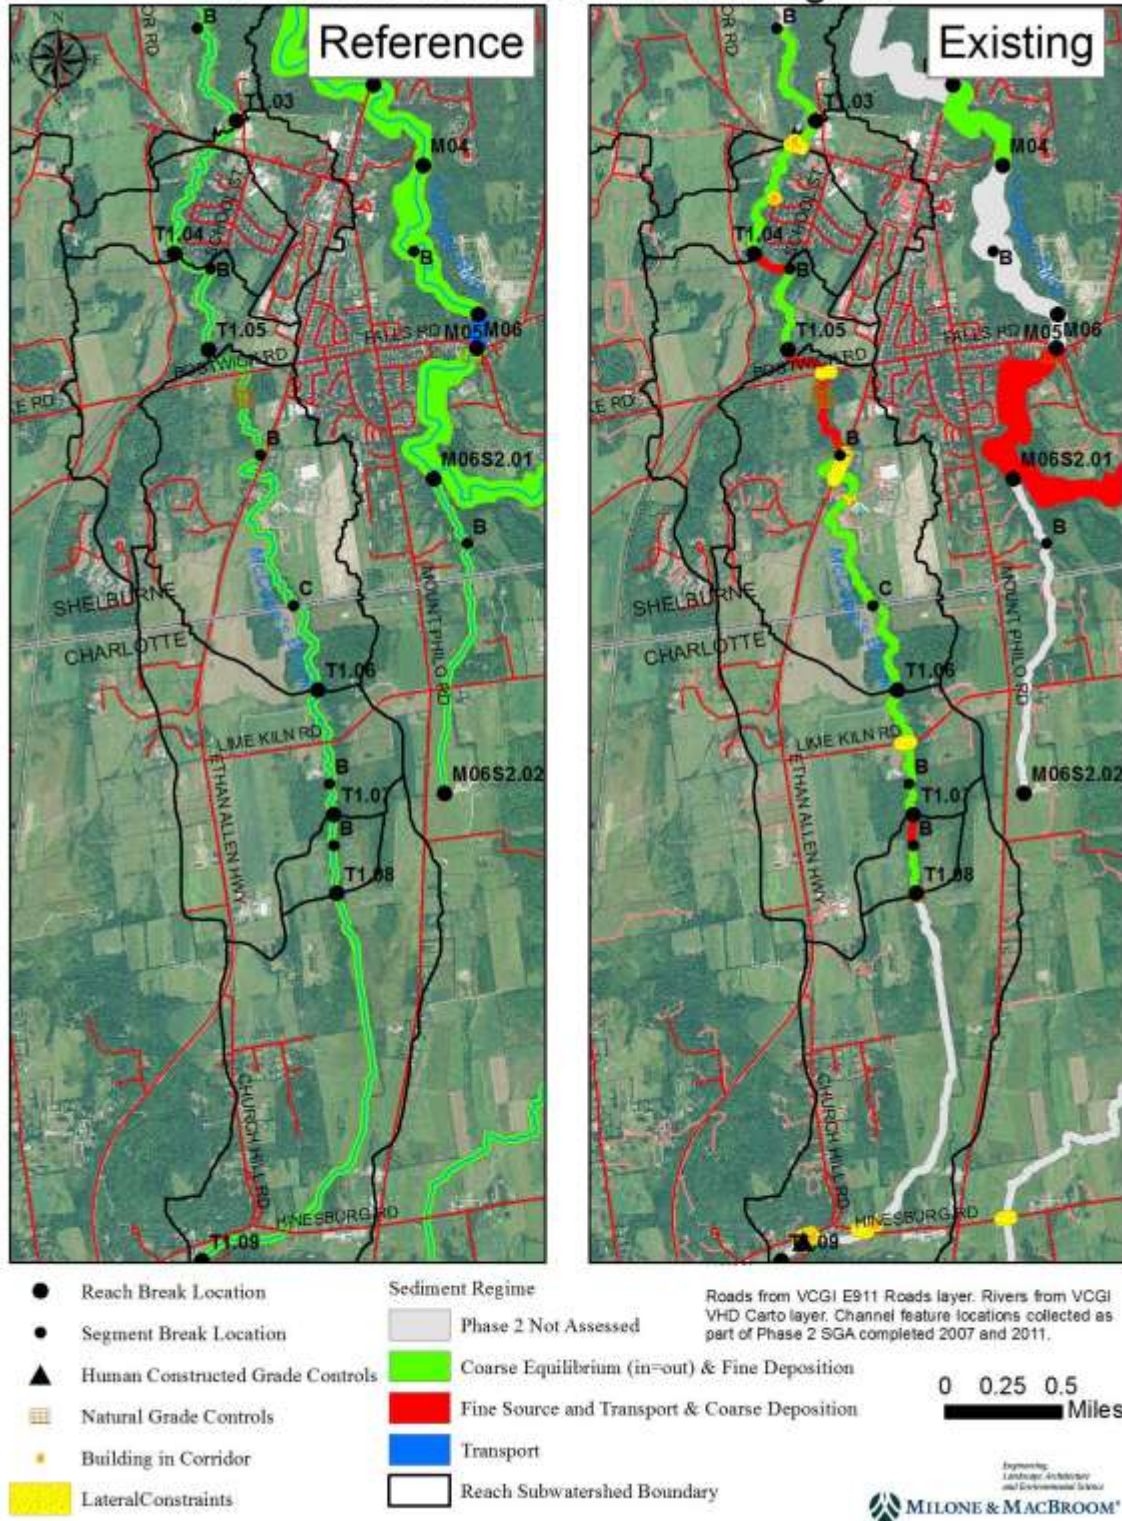
Figure 10: Sediment Regime Departure Map

The Phase 1 analysis has identified that all McCabe’s Brook reaches would naturally be in Coarse Equilibrium with Fine Deposition (Figure 10). Streams of this type are generally sand, gravel or cobble bed streams in an unconfined valley that are not incised or entrenched. Streams
