AHEAD OF THE STORM

Site: Charlotte Park and Wildlife Refuge

Location: U.S. Route 7 and Greenbush Road, Charlotte, Vermont

Existing Conditions Site Summary

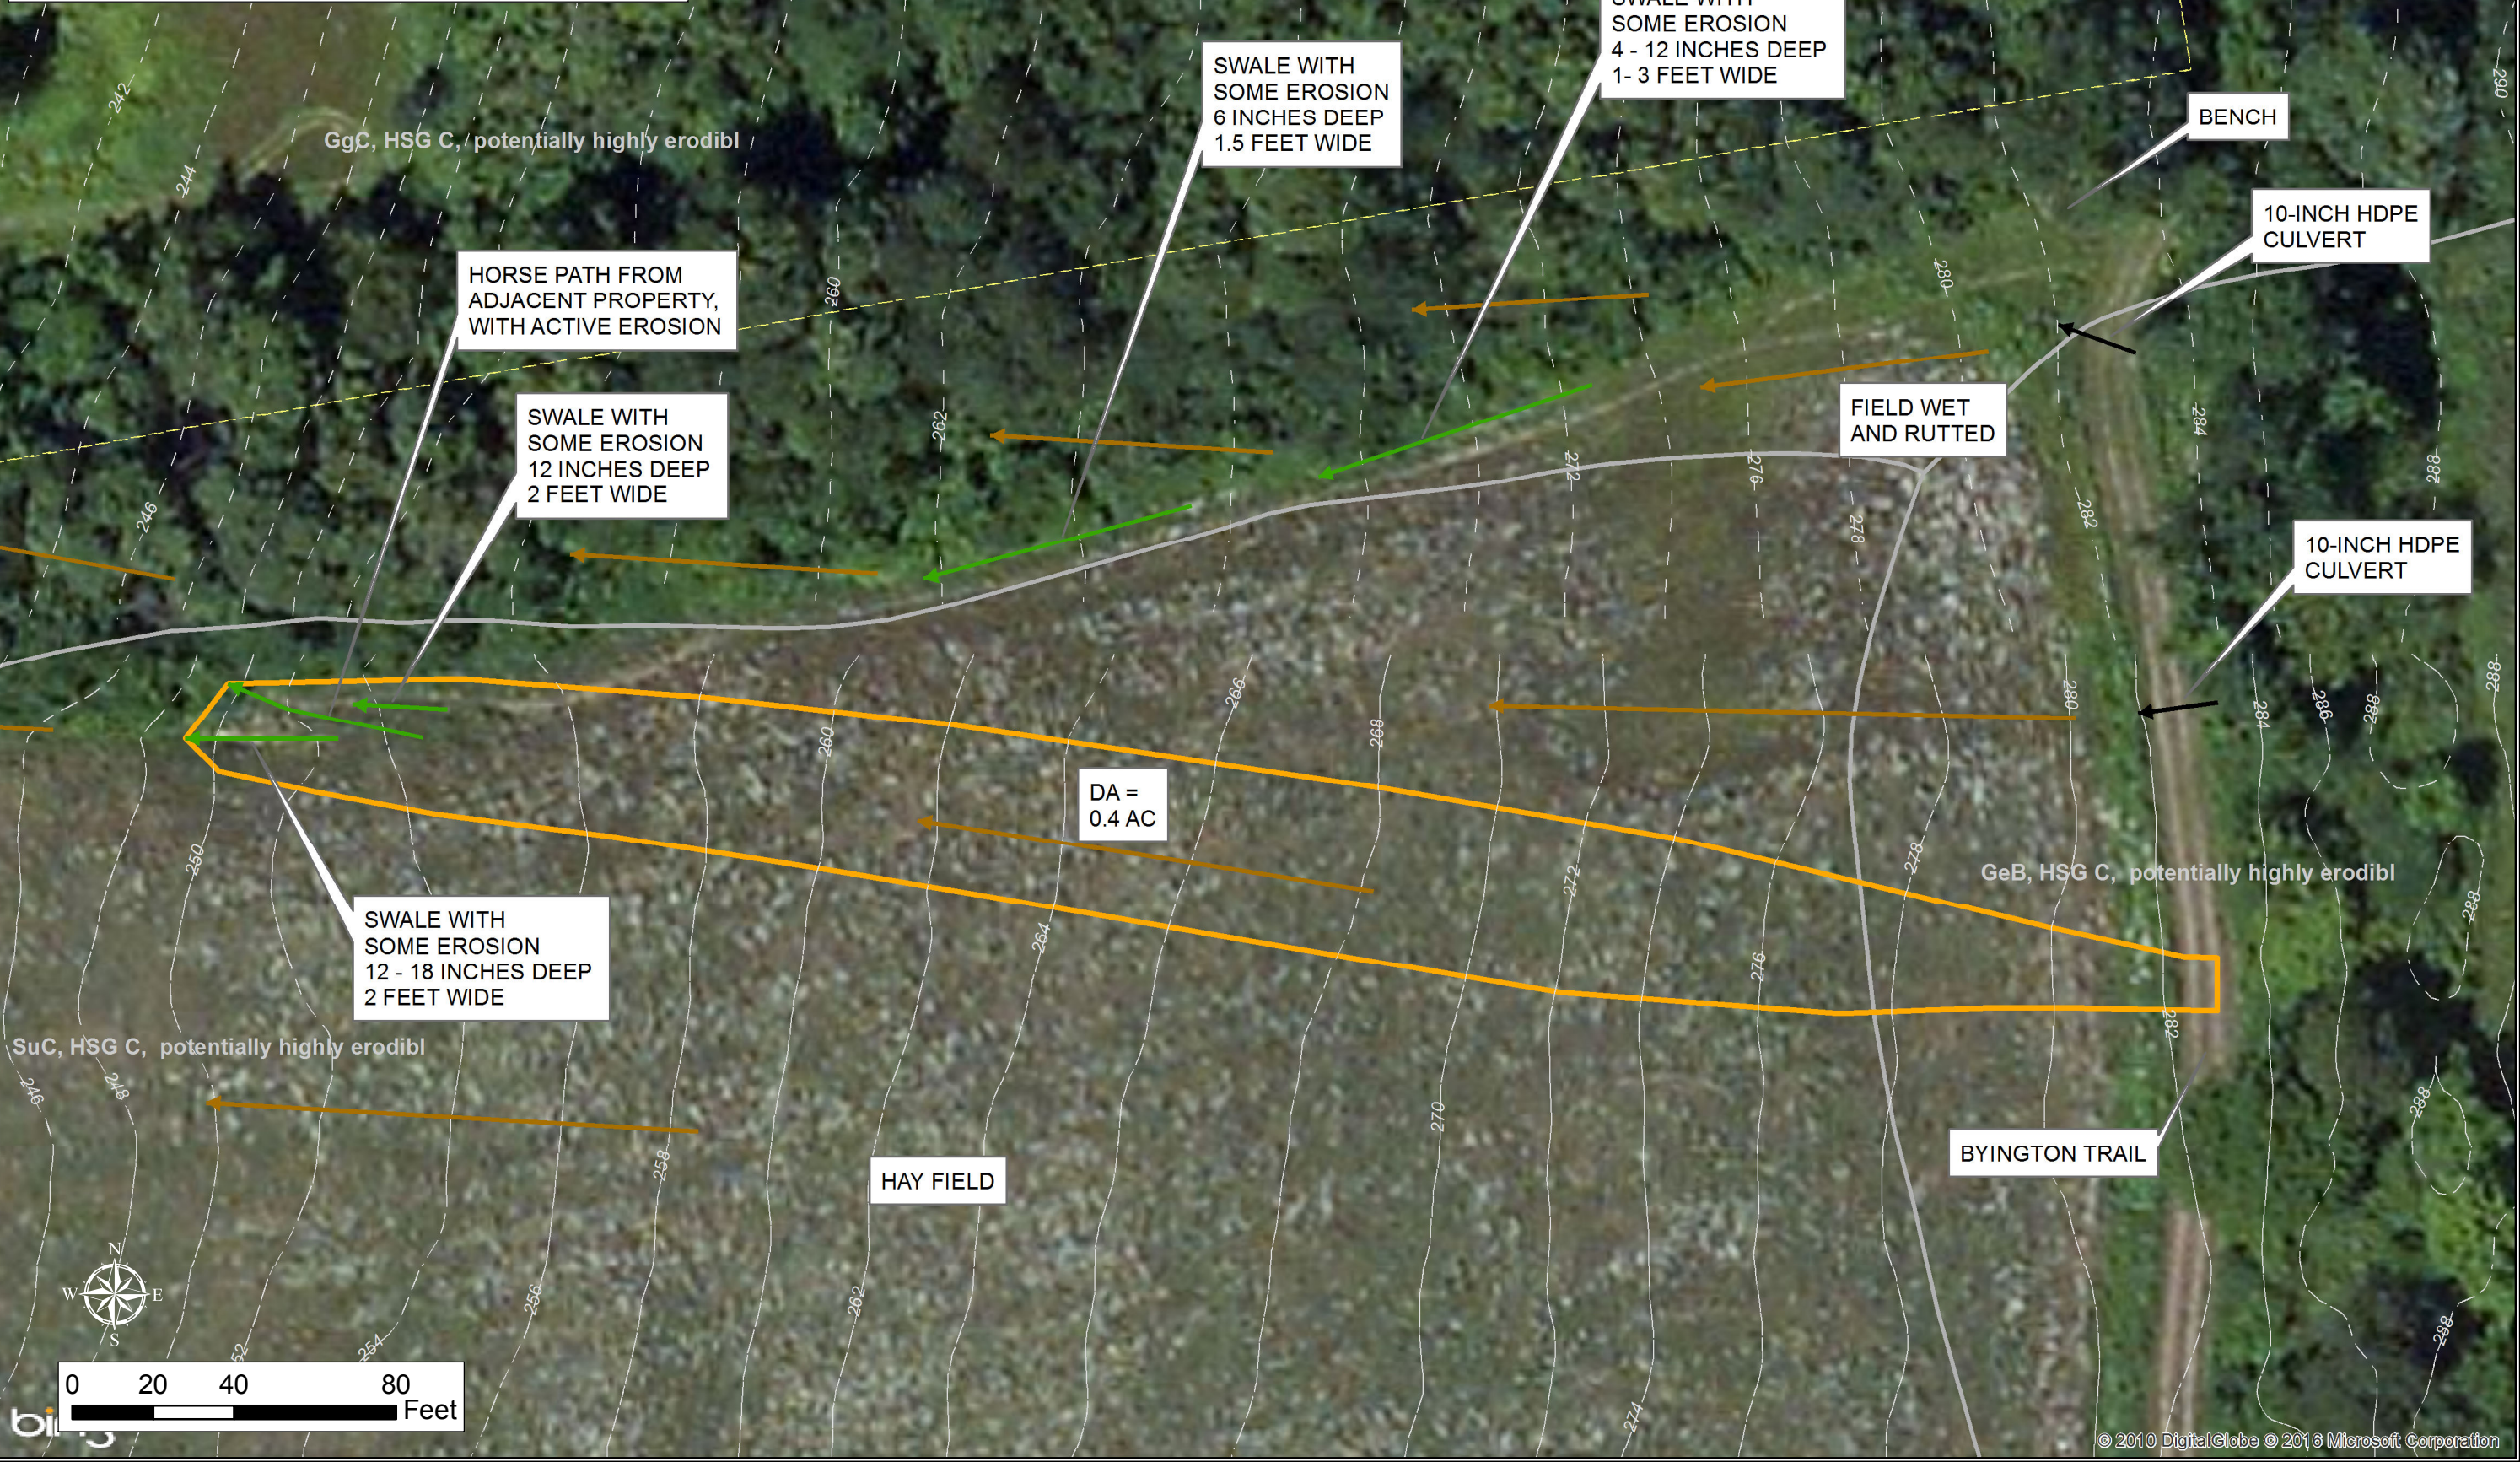
EXISTING CONDITIONS - SITE 1

Two sites have been identified within the Park and Wildlife Refuge where stormwater runoff is concentrated and gully erosion is occurring. Both locations are in the beginning stages of gully formation and recommendations will focus on stopping continued erosion. Site 1 is along the brushline edge of a sloped mowed meadow (Figure 1-1). Site 2 is along a cross-slope swale that was installed to reduce washouts along a park road (Figure 2-1).

The edge of the field where some water concentration and erosion is seen is at the edge of two soil types. Both are stony loams that are potentially highly erodible. Both have been classified as Hydrologic Soil Group (HSG) C indicating moderate runoff potential and slow infiltration rates when thoroughly wet.

1. Stabilize gully erosion by installing logs, brush, and vegetation to reduce erosion and downcutting, filter runoff, and retain sediment before it leaves the site. Install log check dams and log trail crossing at locations of concentrated erosion or headcutting.
2. Increase the vegetated buffer between the hay field and existing swale to act as a filter, slow runoff, and capture sediment and pollutants. This will reduce field rutting by reducing tractor traffic in the wettest portion of the field.

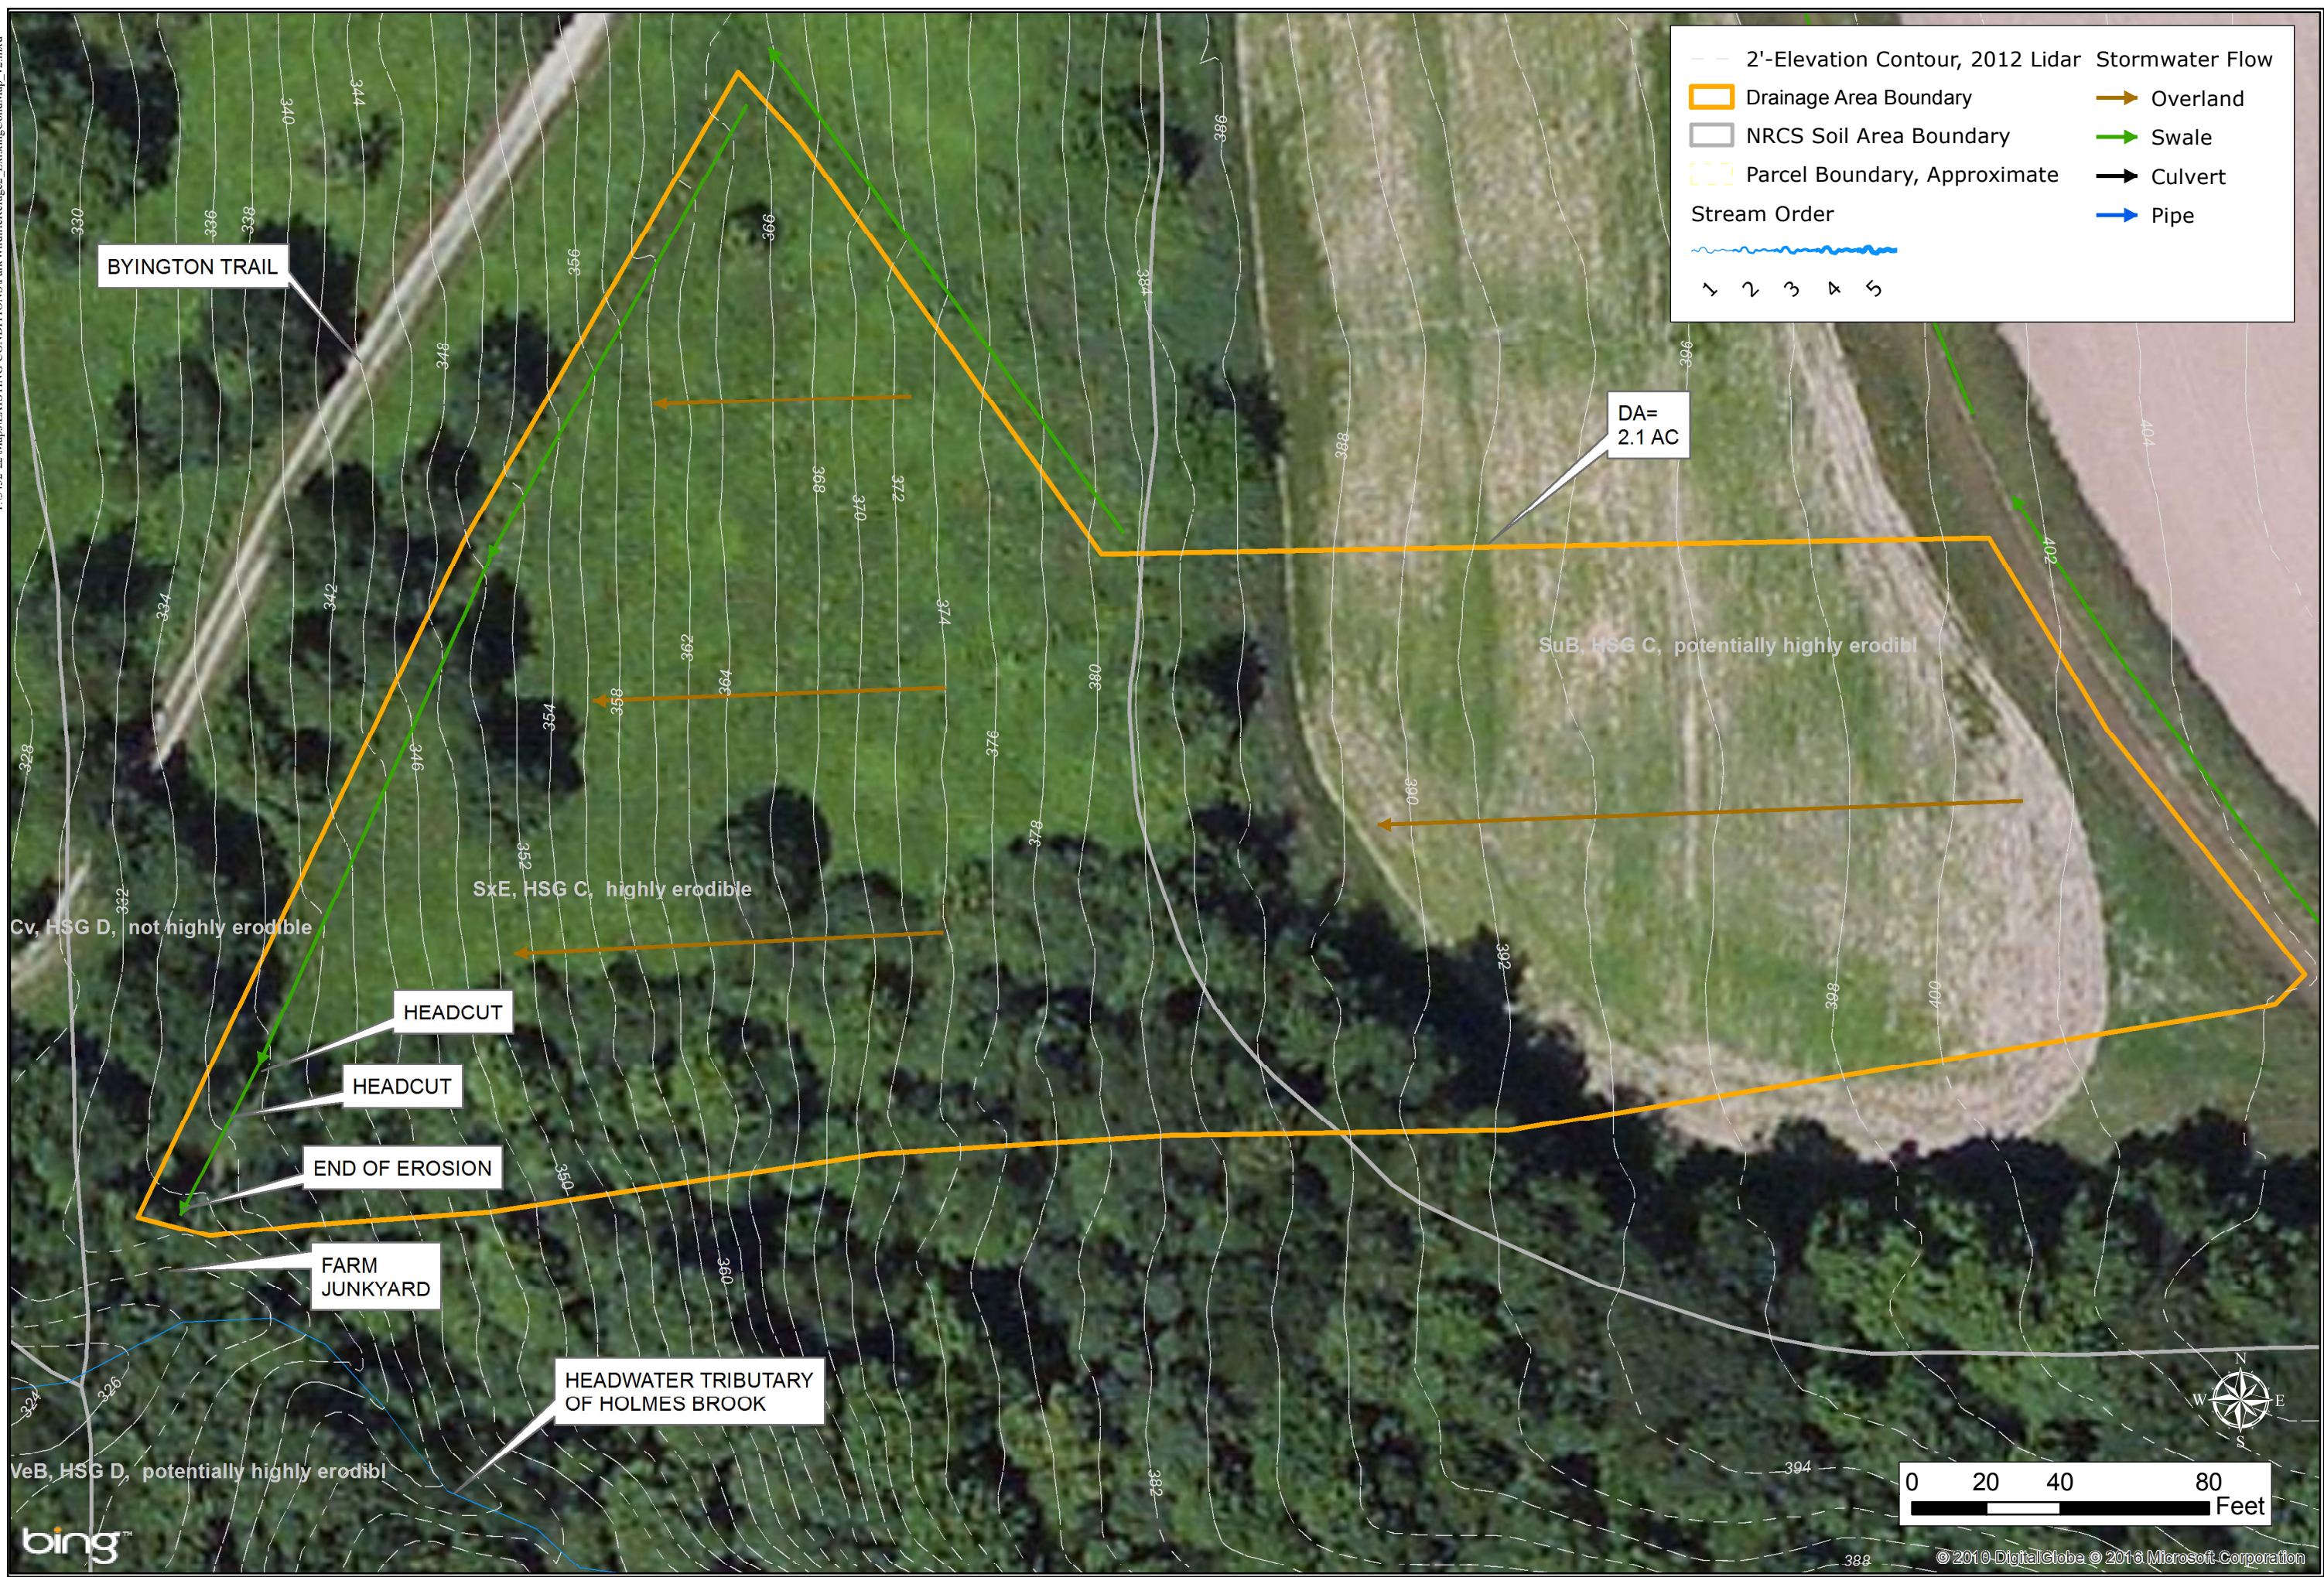
EXISTING CONDITIONS - SITE 2
AHEAD OF THE STORM
CHARLOTTE PARK AND WILDLIFE REFUGE
 U.S. ROUTE 7 AND GREENBUSH ROAD
 CHARLOTTE, VERMONT

The cross slope swale is located in an extremely stony loam soil type that is highly erodible. This soil has been classified as Hydrologic Soil Group (HSG) C indicating moderate runoff potential and slow infiltration rates when thoroughly wet.
