**LaPlatte River Phase 2 Stream Geomorphic Assessment:
Hinesburg Reaches**

**Prepared by the LaPlatte Watershed Partnership
February, 2006**

LaPlatte River Phase 2 Stream Geomorphic Assessment: Hinesburg Reaches

Prepared by the LaPlatte Watershed Partnership

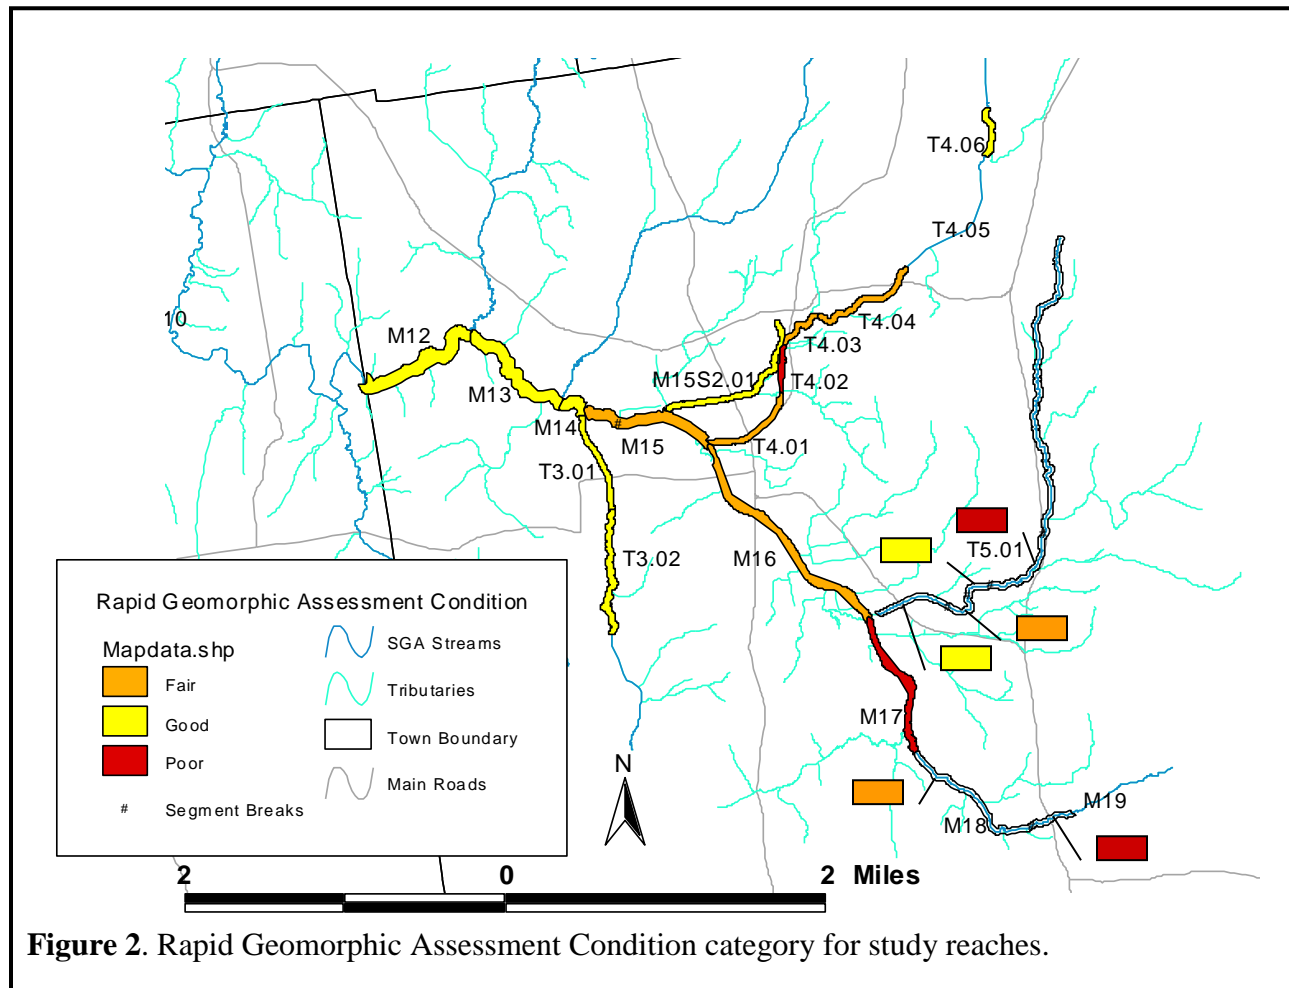
Figure 2. Rapid Geomorphic Assessment Condition category for study reaches.

Figure 2 shows RGA Condition categories for each of the study reaches and segments. Relatively little development has encroached into the stream corridor thus far in Hinesburg. Main factors affecting RGA condition were channel alteration and channel obstructions and constrictions, which are discussed in more detail below.

Straightening combined with berming on M17 and T5.01D resulted in severe channel departure from reference. Reach M17 experienced a stream type departure (C to B) and currently appeared to be widening and aggrading, attempting to gain some floodplain and sinuosity in its incised and entrenched position (Figure 4).

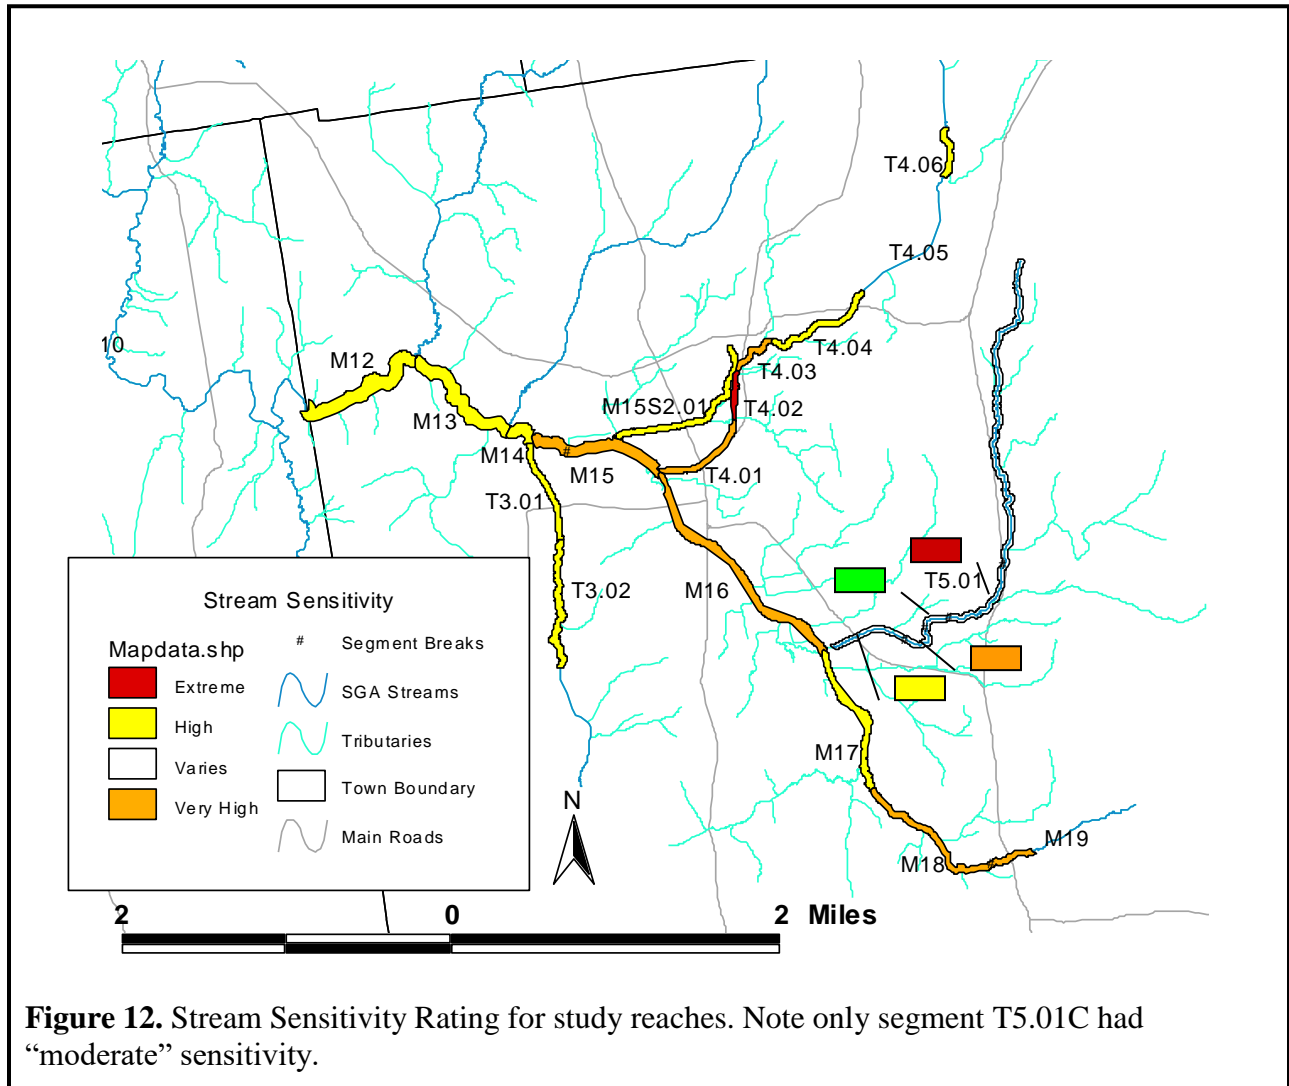
Figure 12. Stream Sensitivity Rating for study reaches. Note only segment T5.01C had “moderate” sensitivity.

Figure 12 shows stream sensitivity ratings for study reaches and segments. Reaches were highly to extremely sensitive to ongoing or future disturbance except for T5.01C, in “moderate” condition, which was bedrock controlled and “in regime.”

Addressing stressors such as stream alteration and channel constrictions could alleviate pressures and reduce potential for further departure or help streams achieve a dynamic equilibrium state.

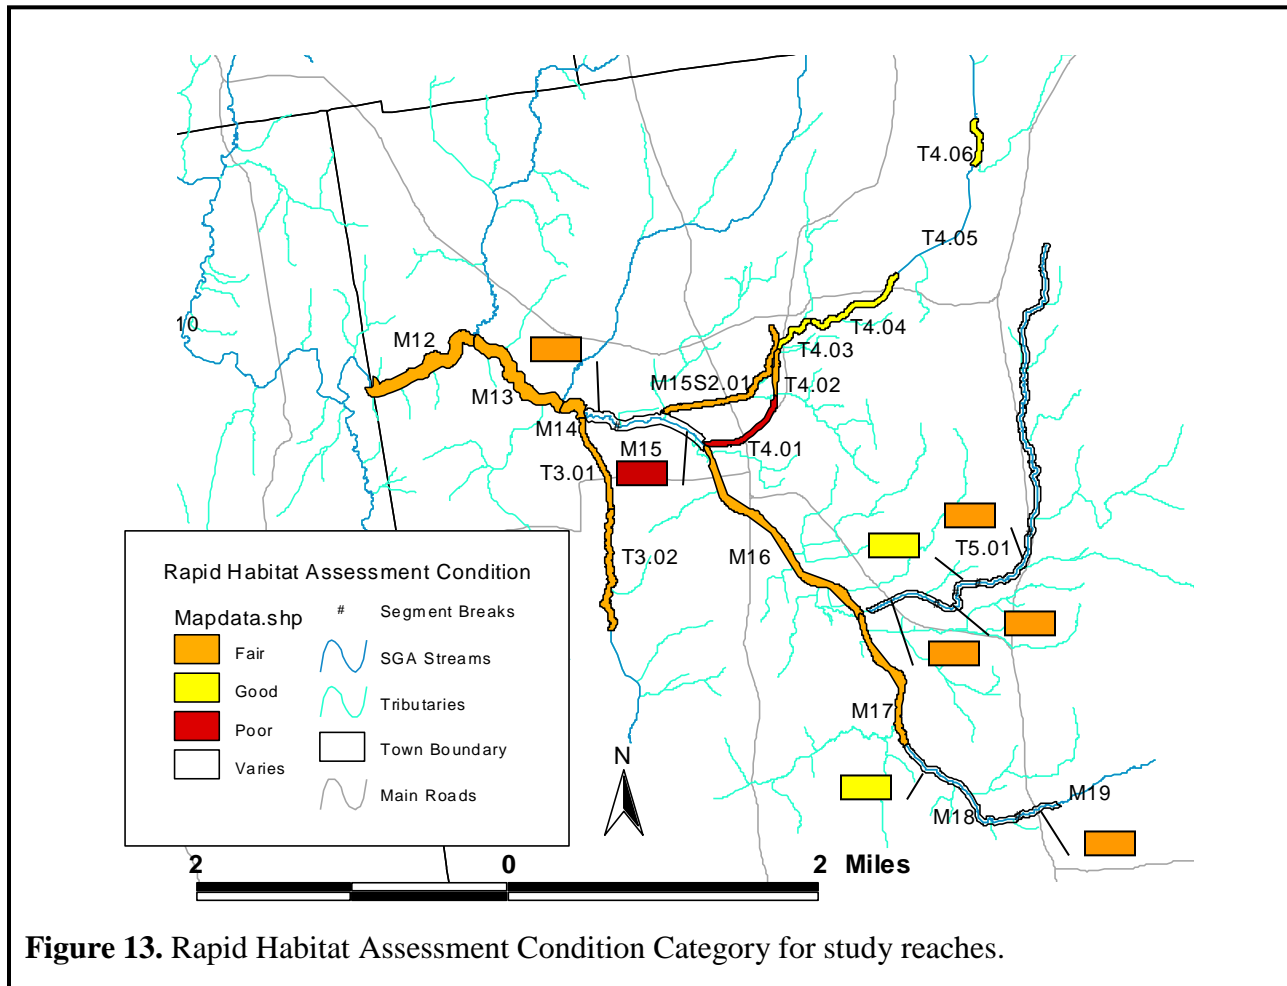
Figure 13. Rapid Habitat Assessment Condition Category for study reaches.

Figure 13 shows RHA condition categories for the study reaches. RHA conditions of the valley reaches were evaluated in “fair” condition except for segment M15B, which was in “poor” condition. Lack of diverse substrates for instream habitat, channel straightening, and lack of riparian buffer were the major factors contributing to these low scores. Segment M15B also suffered from exposed channel substrates, sediment deposition, and moderately unstable banks.
