<u>Site:</u> Wetlands Restoration in Hinesburg Village <u>Location:</u> United Church of Hinesburg, Route 116, Hinesburg, Vermont

PROJECT SUMMARY

WETLANDS RESTORATION IN HINESBURG VILLAGE

FINAL DESIGN DECEMBER 10, 2021

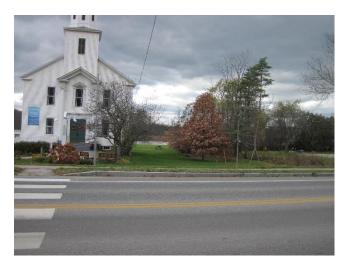
Figure 1: United Church of Hinesburg looking west with culvert outlets and ditched swale shown on the right side of this photo and Route 116 in the foreground (November 1, 2019).

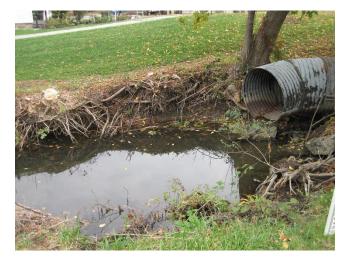
Figure 3: Outlet of 36 inch corrugated metal pipe under Route 116 (October 6, 2020).

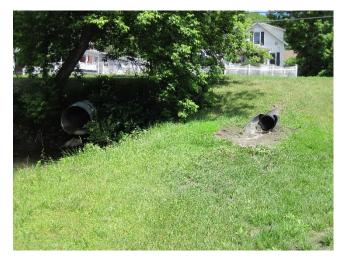
Figure 2: Outlet of 36 inch corrugated metal pipe under Route 116 and 15 inch plastic stormwater culvert (June 23, 2021).

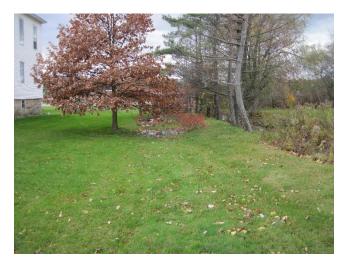
Figure 4: From left to right looking west: Church building, lawn, rain garden, berm, ditched swale (November 1, 2019).

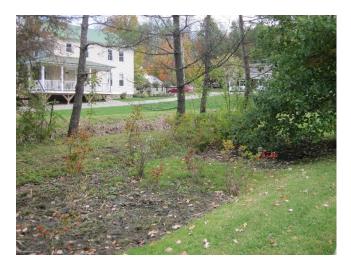
Figure 5: Rain garden along south side of ditched swale looking northeast (October 6, 2020).

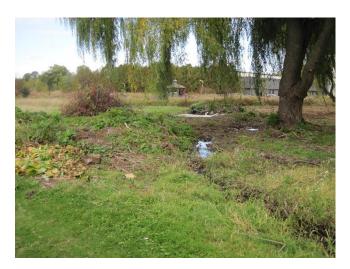
Figure 6: Ditched swale turns north at piles of previous dredge material, looking downstream (October 6, 2020).

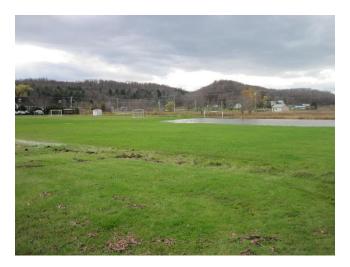
Figure 8: Partially flooded lawn area behind United Church of Hinesburg and town recreational fields looking southwest (November 1, 2019).

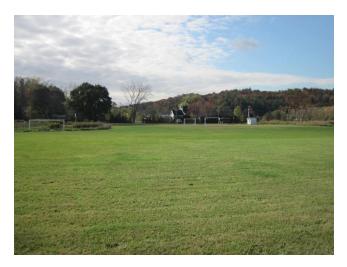
Figure 9: Dry lawn area behind United Church of Hinesburg and town recreational fields looking south. Existing wetlands are visible at image left (October 6, 2020).

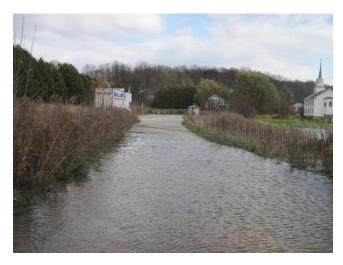
Figure 10: Flooded drive to Cheesefactory gravel parking area looking east from Stella Road (November 1, 2019).

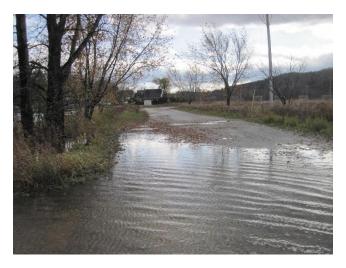
Figure 12: Stella Road partially flooded looking south from junction with drive to Cheesefactory gravel parking area (November 1, 2019).

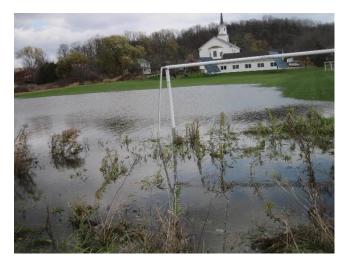
Figure 13: Partially flooded lawn area behind United Church of Hinesburg looking east (November 1, 2019).

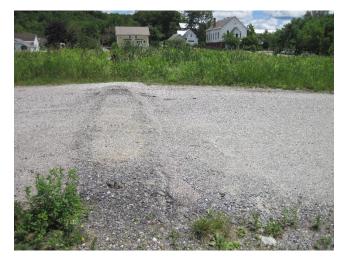
Figure 15: Heaved 18 inch corrugated metal pipe under Stella Road (June 23, 2021).

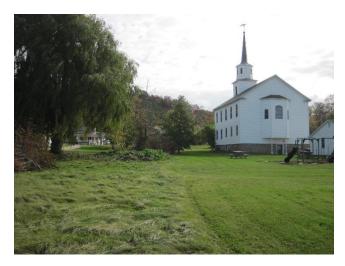
Figure 19: North edge of mowed lawn area looking east. Piles near ditched swale turn visible on image left (October 6, 2020).

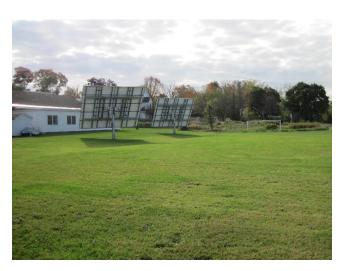
Figure 20: Wetland at image right with wetland finger extending into swale along solar panels (October 6, 2020).

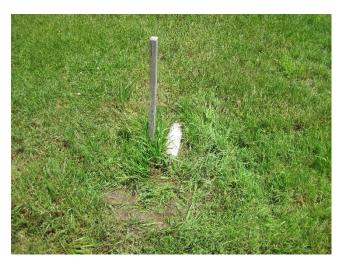
Figure 21: 3 inch PVC drainage pipe extending from church into mowed lawn area (June 23, 2021).

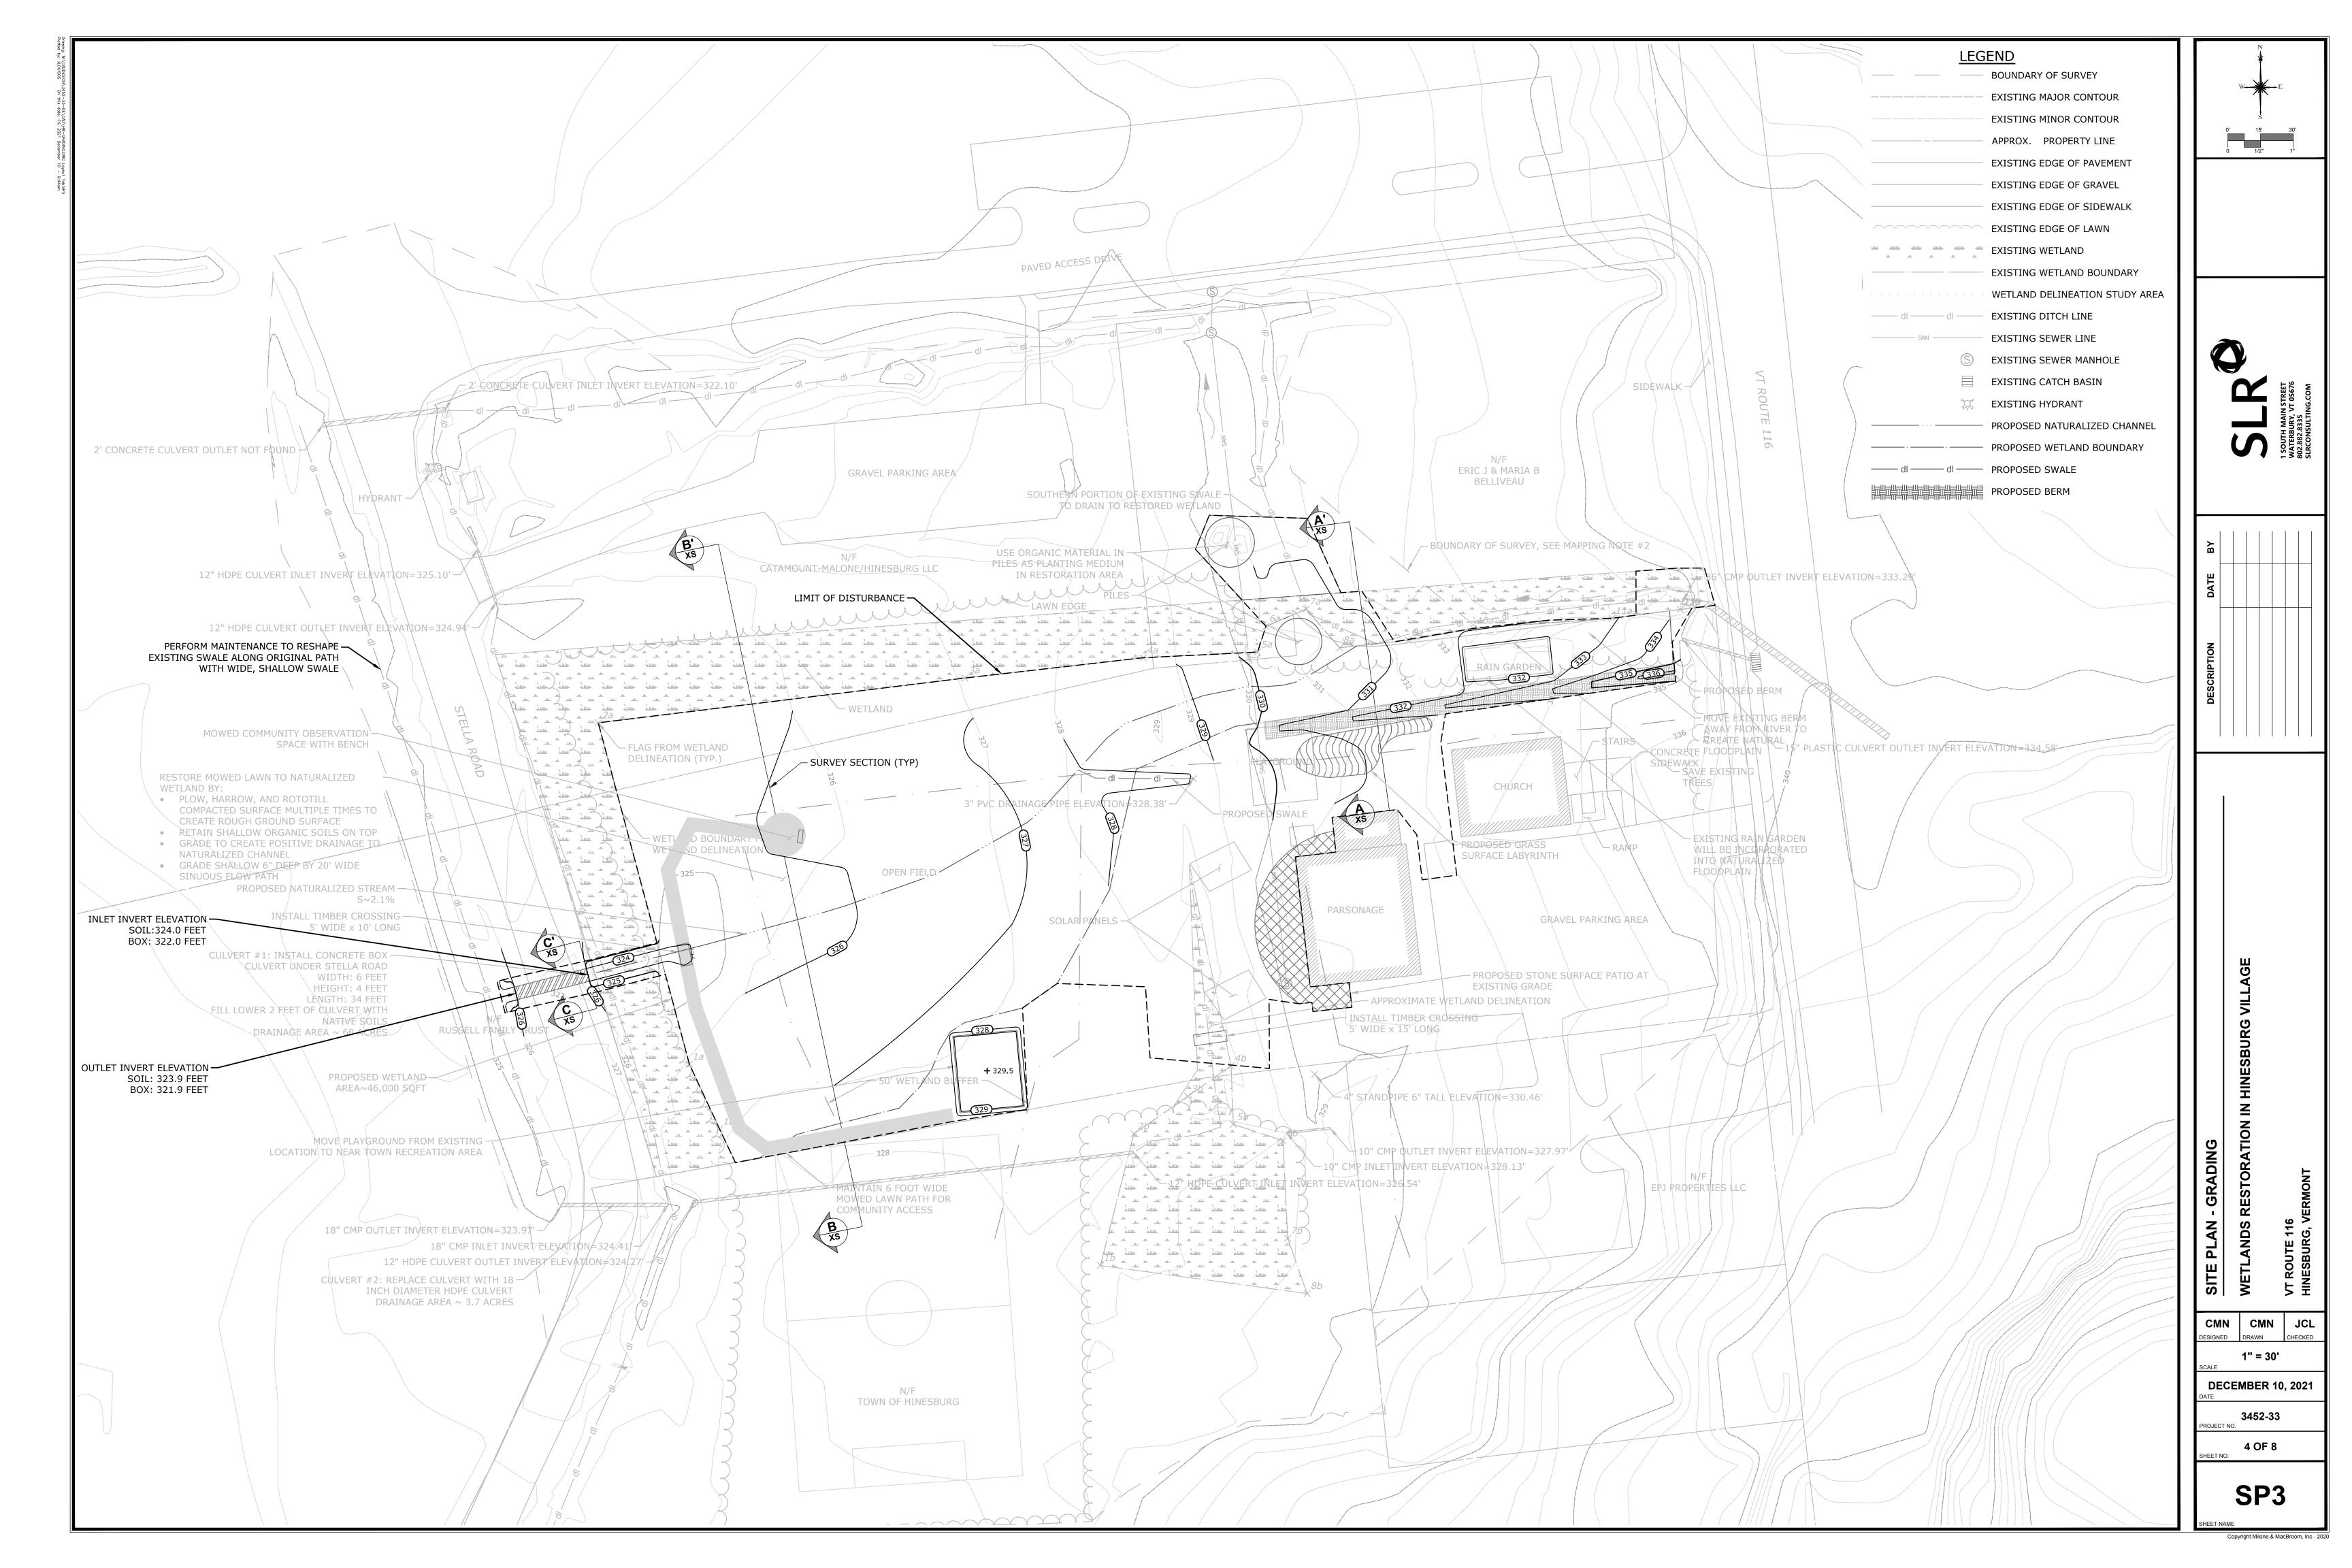
DESCRIPTION								
DESCI								
SITE PLAN - RESTORATION		WETLANDS RESTORATION IN HINESBURG VILLAGE			VT ROUTE 116			
SIGNE	D	dra 1"		30'	СН	IECK	ED	
DECEMBER 10, 2021								
3452-33 ROJECT NO.								
5 OF 8								
SP4 IEET NAME Copyright Milone & MacBroom, Inc - 2020

2' CONCRETE CULVERT INLET INVERT ELEVATION=322.10' 2' CONCRETE CULVERT OUTLET NOT FOUND HYDRANT 12" HDPE CULVERT INLET INVERTELEVATION=325.10' -12" HDPE CULVERT OUTLET INVERT ELEVATION=324.94'-PERFORM MAINTENANCE TO RESHARE -EXISTING SWALE ALONG ORIGINAL PATH WITH WIDE, SHALLOW SWALE \ MOWED COMMUNITY OBSERVATION'-SPACE WITH BENCH RESTORE MOWED LAWN TO NATURALIZED WETLAND BY: • PLOW, HARROW, AND ROTOTILL COMPACTED SURFACE MULTIPLE TIMES TO CREATE ROUGH GROUND SURFACE RETAIN SHALLOW ORGANIC SOILS ON TOP GRADE TO CREATE POSITIVE DRAINAGE TO NATURALIZED CHANNEL GRADE SHALLOW 6" DEEP BY 20' WIDE SINUOUS ELOW PATH PROPOSED NATURALIZED STREAM -S~2.1% INSTALL TIMBER CROSSING 5' WIDE x 10' LONG

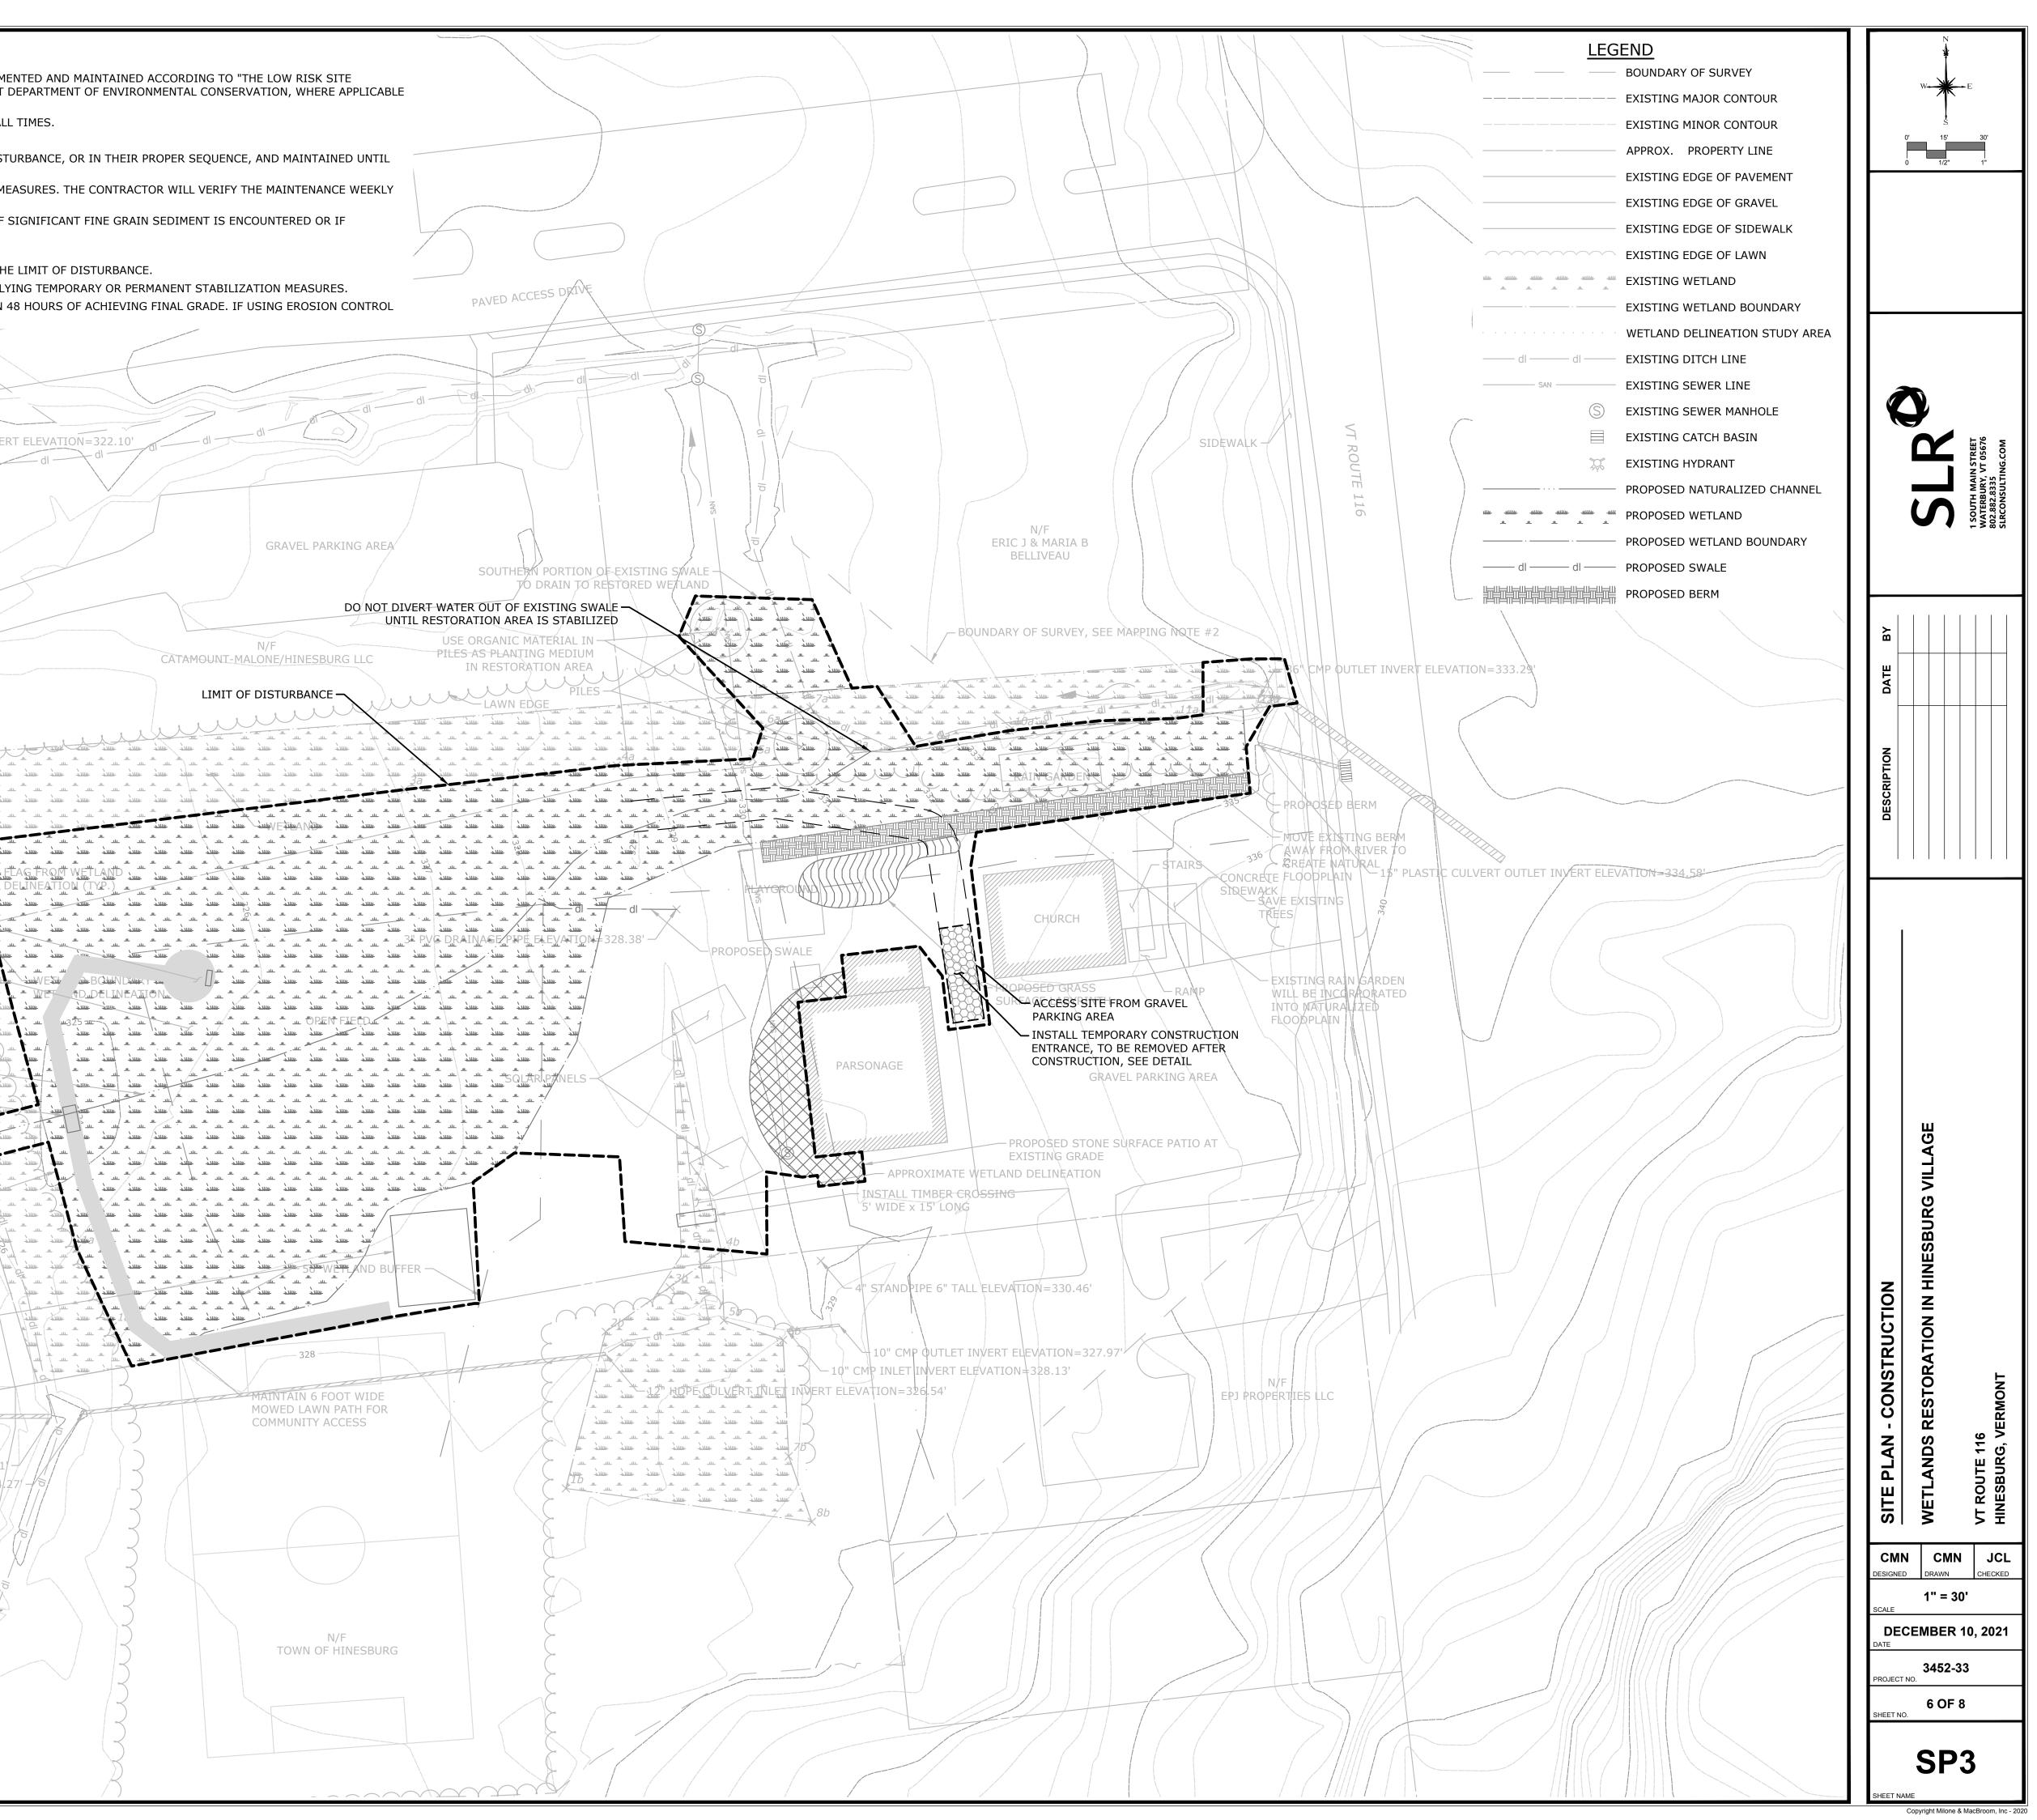
2' CONCRETE CULVERT INLET INVERT ELEVATION=322.10 2' CONCRETE CULVERT OUTLET NOT FOUND 12" HDPE CULVERT INLET INVERT ELEVATION=325.10' -12" HDPE CULVERT OUTLET INVERTELEVATION=324.94 PERFORM MAINTENANCE TO RESHARE -EXISTING SWALE ALONG ORIGINAL PATH WITH WIDE, SHALLOW SWALE \ MOWED COMMUNITY OBSERVATION' SPACE WITH BENCH RESTORE MOWED LAWN TO NATURALIZED WETLAND BY: • PLOW, HARROW, AND ROTOTILL COMPACTED SURFACE MULTIPLE TIMES TO CREATE ROUGH GROUND SURFACE RETAIN SHALLOW ORGANIC SOILS ON TOP July Me BQue Dimer - GRADE TO CREATE POSITIVE DRAINAGE TO NATURÀLIZED CHANNEL GRADE SHALLOW 6" DEEP BY 20' WIDE SINUOUS ELOW PATH PROPOSED NATURALIZED STREAM ----S~2.1% INSTALL TIMBER CROSSING -5' WIDE x 10' LONG CULVERT #1: INSTALL CONCRETE BOX -CULVERT UNDER STELLA ROAD TH. 6 FEE ACCESS FOR CULVERT REPLACEMENT IS ON STELLA HEIGHT: 4 FEET LÈNGTH: 34 FEET ROAD FROM CHARLOTTE ROAD FILL LOWER 2 FEET OF CULVERT WITH NATIVE SOILS DRAINAGE AREA ~ 68 ACRES RUSSELL FAMILY TRUS PROPOSED WETLAND----AREA~46,000 \$QFT MOVE PLAYGROUND FROM EXISTING -LOCATION TO NEAR TOWN RECREATION AREA 18" CMP OUTLET INVERT ELEVATION=323.97' ---/ 18" CMP INLET INVERT/ELEVATION=324/41 12" HDPE CULVERT OUTLET INVERT ELEVATION ≠ 324 27 - - - -CULVERT #2: REPLACE CULVERT WITH 18 INCH DIAMETER HDPE CULVERT DRAINAGE AREA ~ 3.7 ACRES

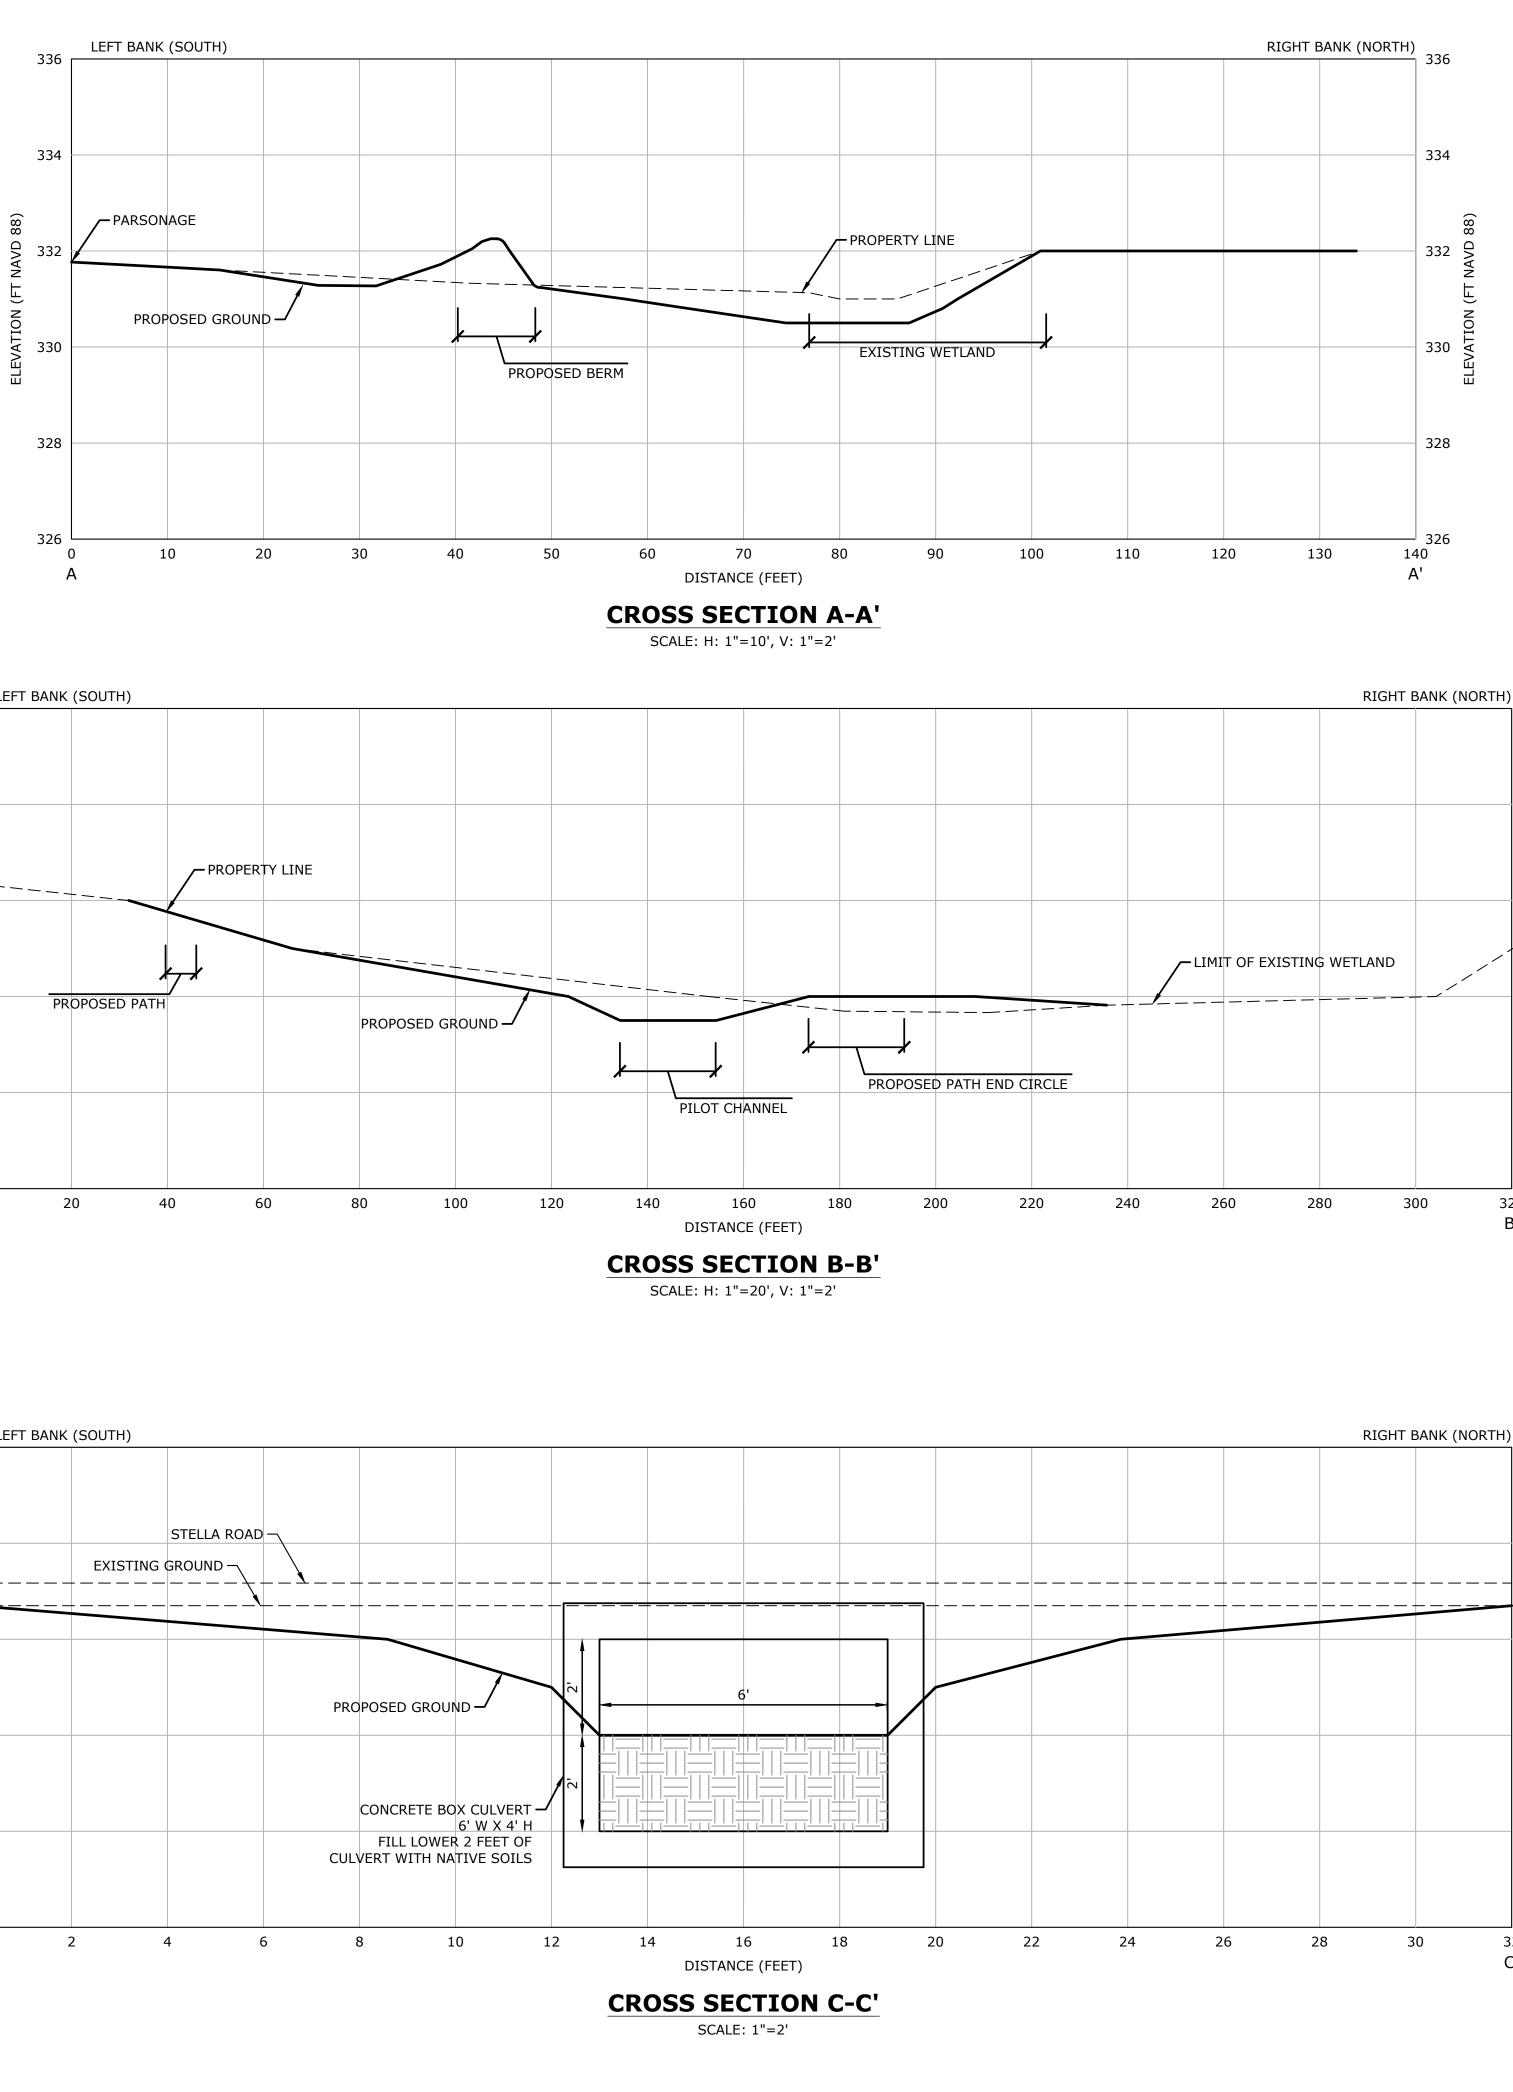
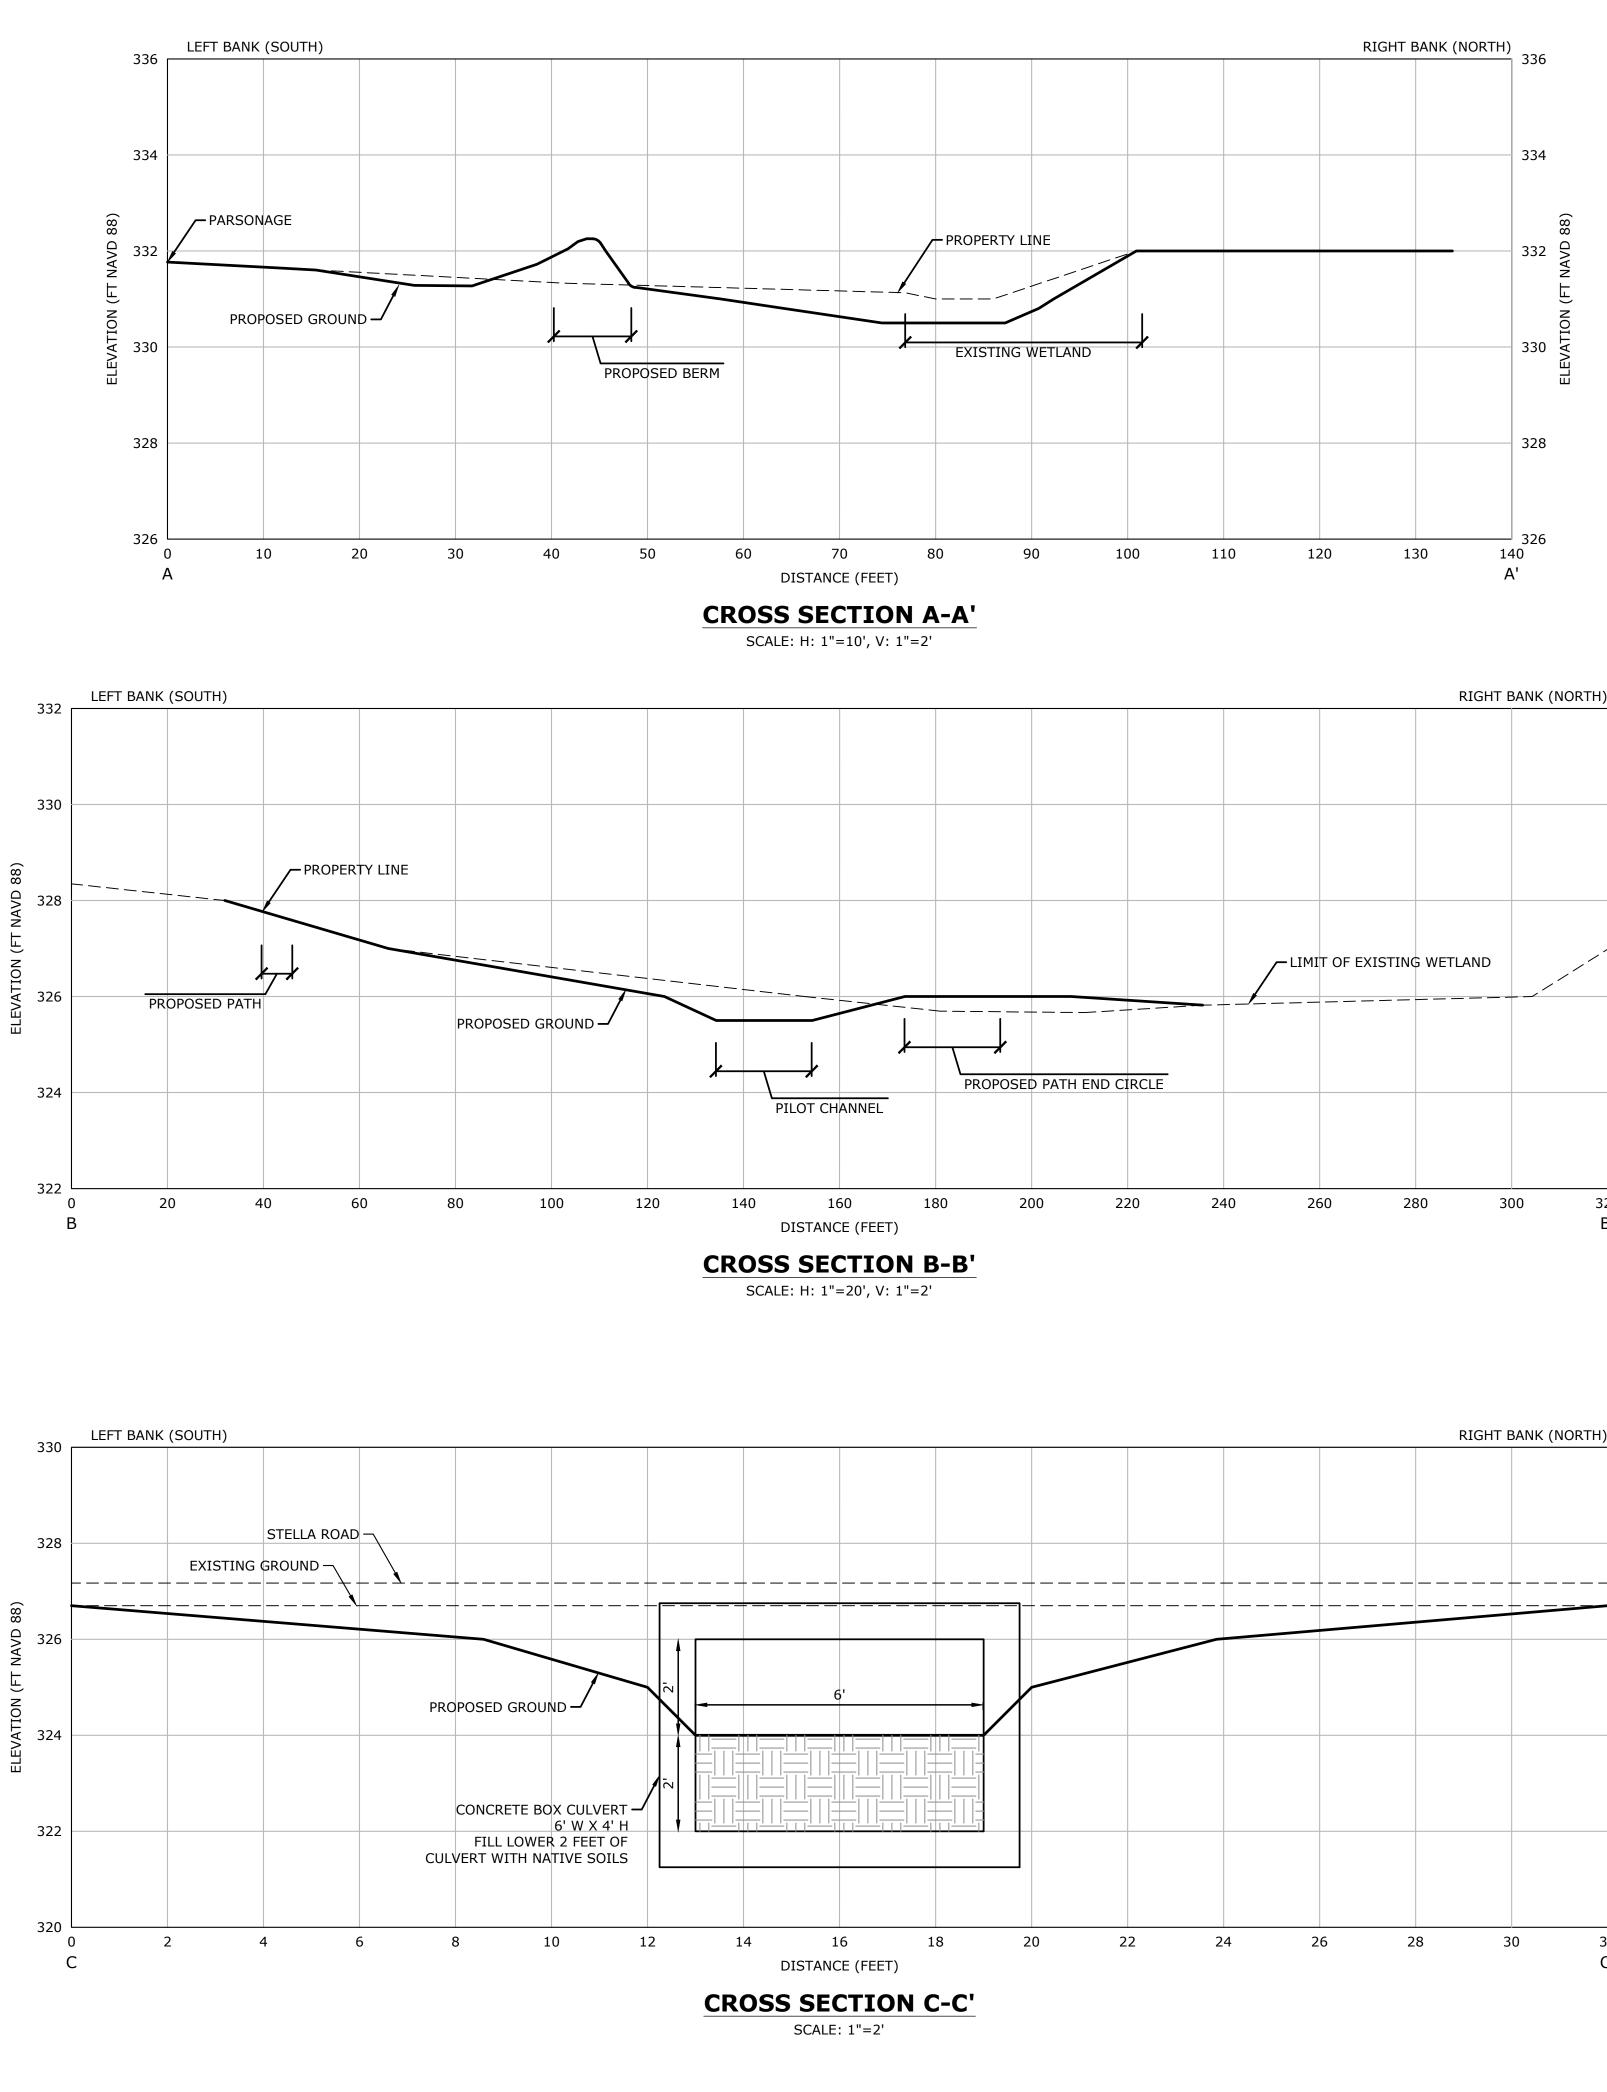
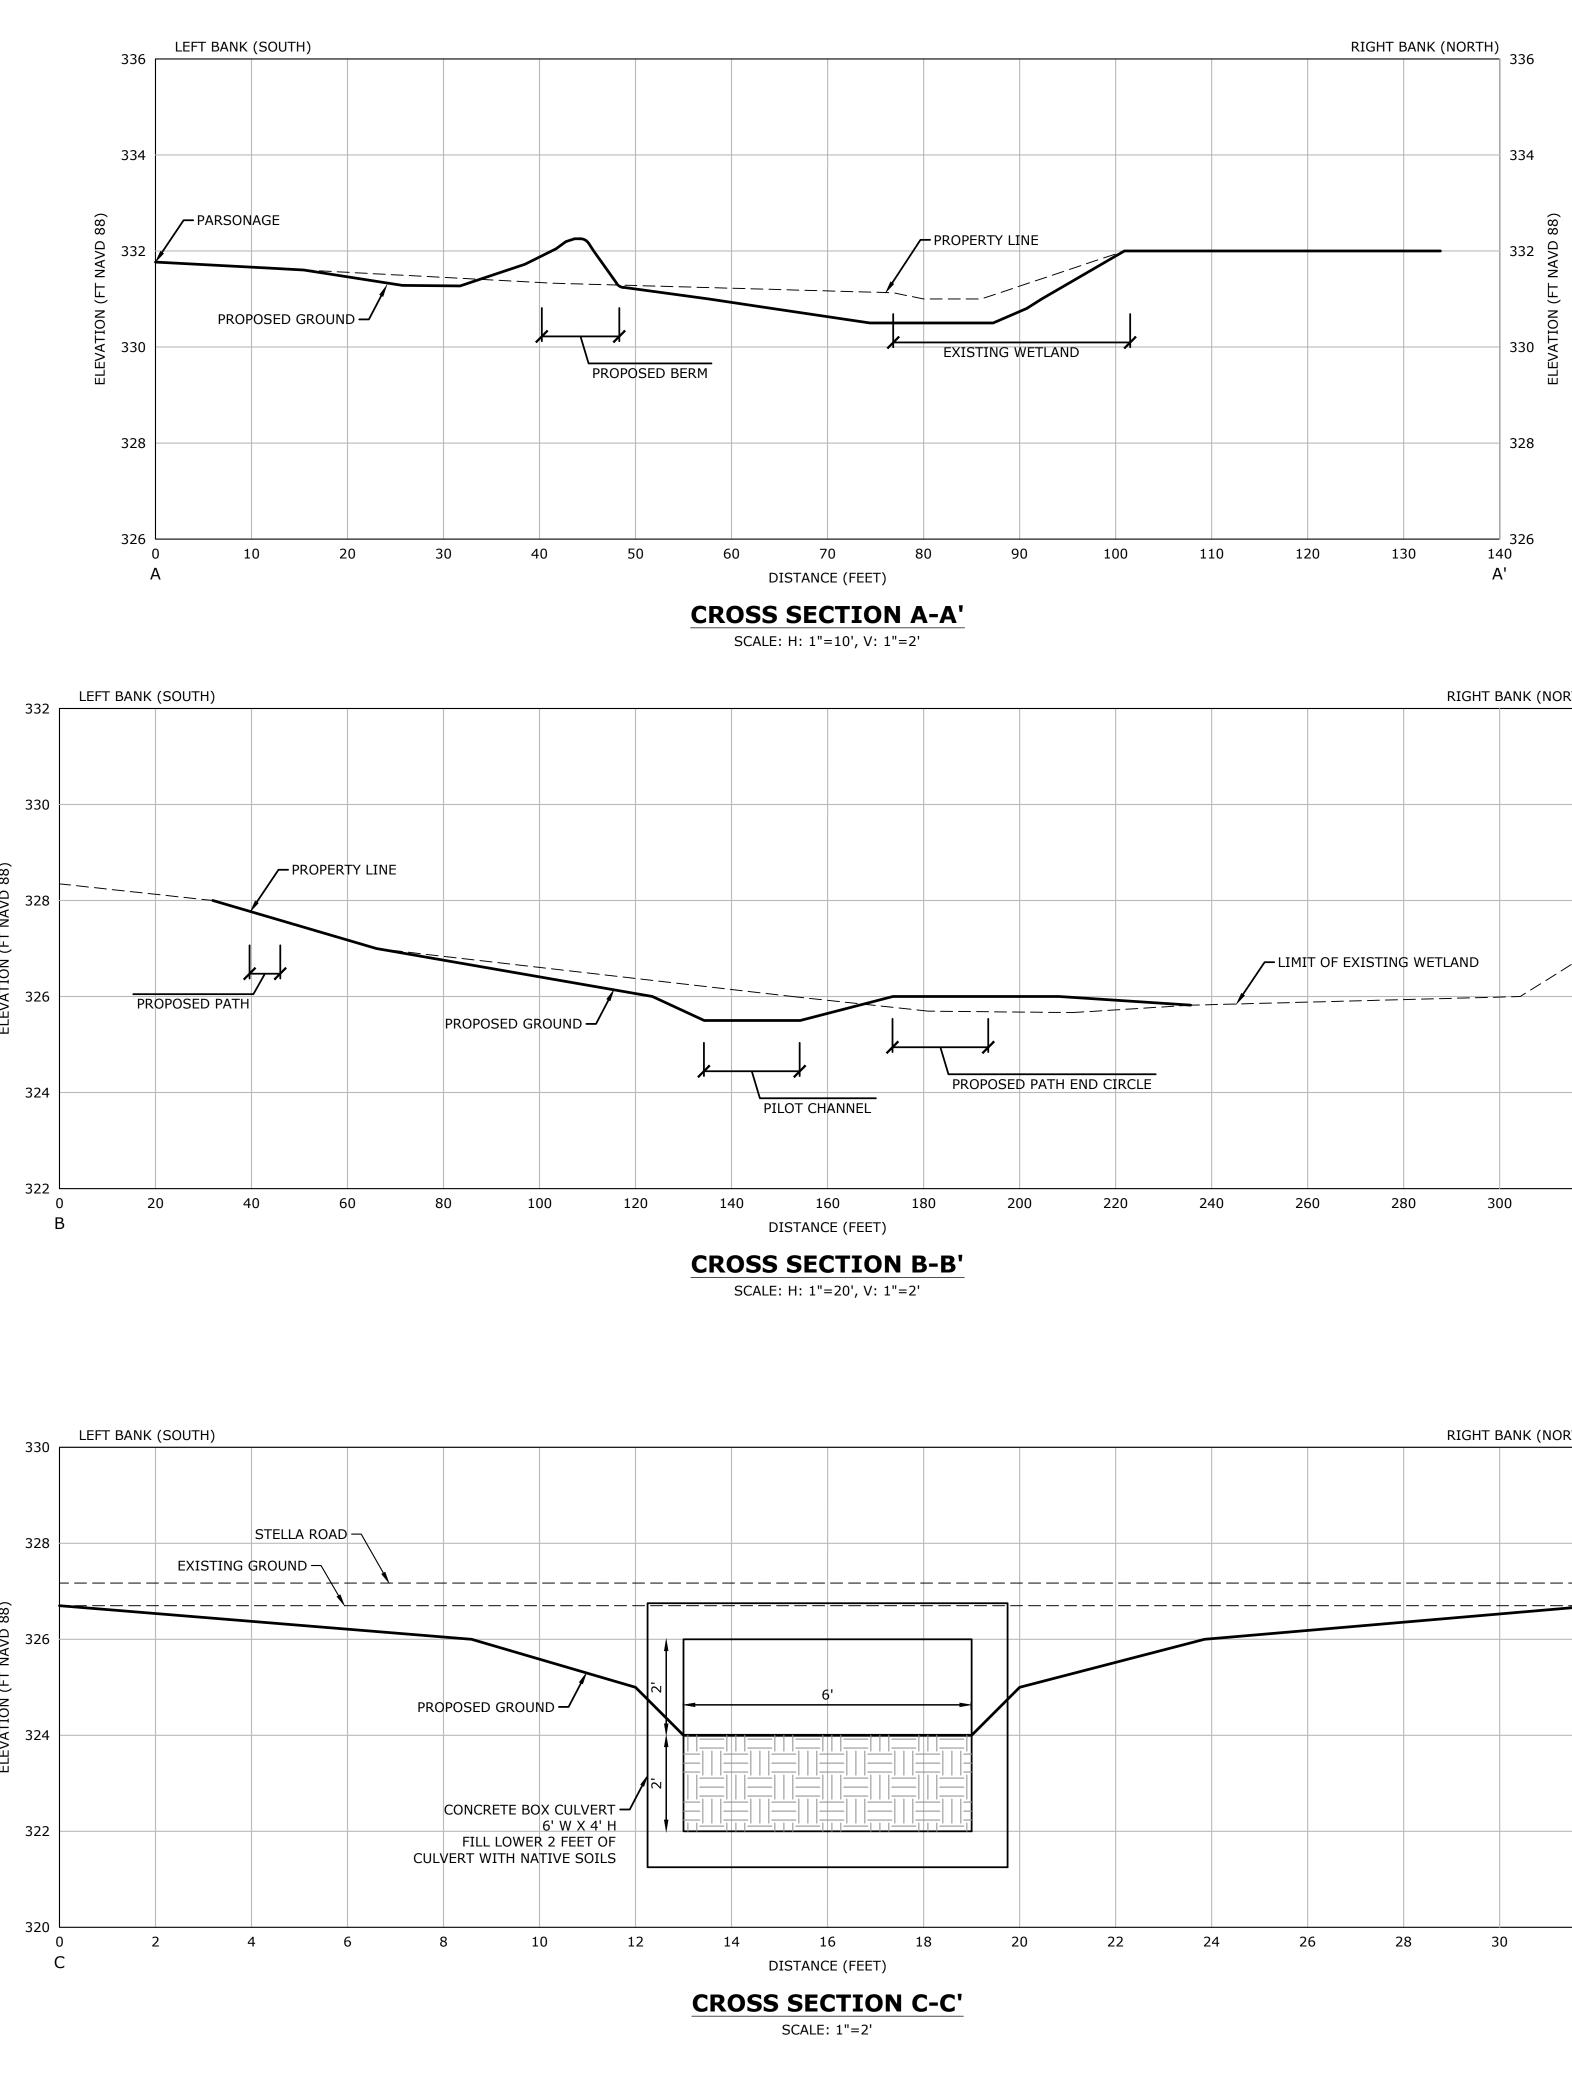
0' 10' 20' 0 1/2" 1" SCALE 1" = 20'H 1" = 2'V
			Selfactors of the second secon
TH) 332 330 328 (8 OVPN LI) NOLLY III 326 324			
TH) 330 B' 328 328 326 (88 ONV) L) NOILY 324 L] NOILY 324 L]			UCCUSS SECTIONS WETLANDS RESTORATION IN HINESBURG VILLAGE VT ROUTE 116 HINESBURG, VERMONT
322 320 32 C'		DES SCA DAT PRC SHE	DECEMBER 10, 2021

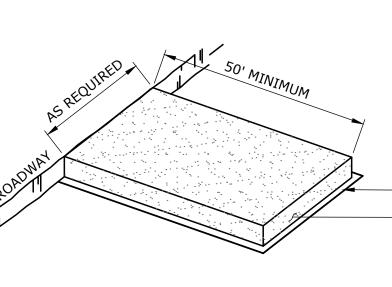
FILTER FABRIC ON COMPACTED SUBGRADE NO 3. (2") BROKEN OR CRUSHED STONE. 6" MINIMUM THICKNESS
